## RIO GRANDE DIVERSION INFRASTRUCTURE INVENTORY

KANE CALLAN DITCH

PHOTO LOG

Rio Grande Stream Management Plan

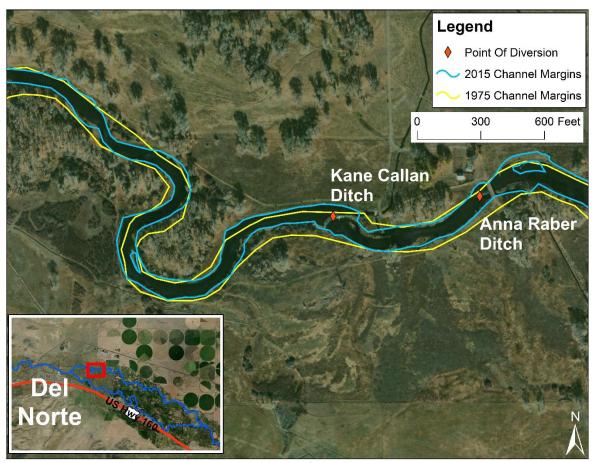
Headgate with channel margins from 1975 and 2015 overlaid.
