RIO GRANDE DIVERSION INFRASTRUCTURE INVENTORY

Structure Name: KNOBLAUCH D

Date: May 7, 2019

**Rio Grande Stream
Management Plan**

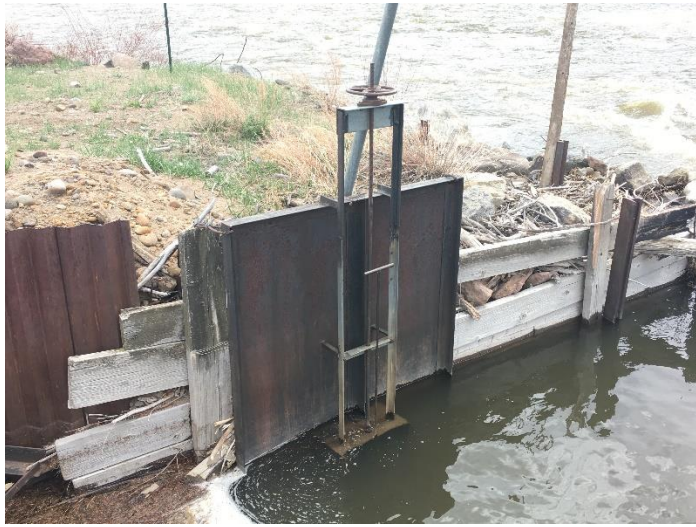
Headgate looking downstream

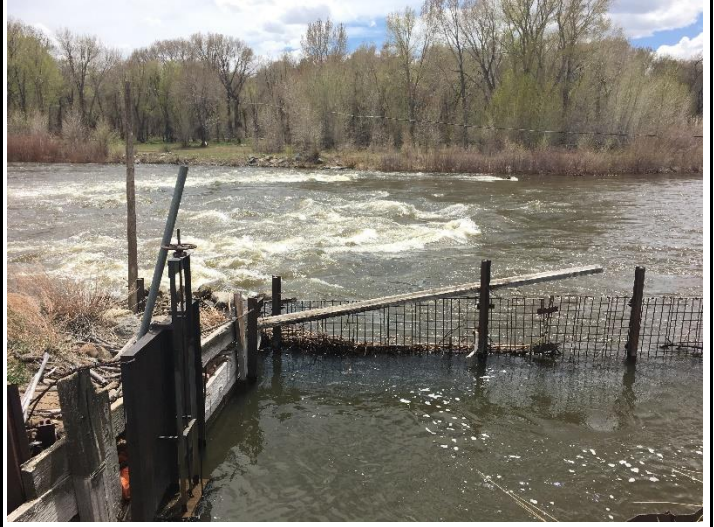
Structure Description: This structure shares a diversion dam and headwall with the Independent Ditch #2. The W-shaped diversion dam, made up of boulders, directs water to a headgate located on the north bank of the river. Recent high flow events have shifted some of the boulders which make up the diversion, resulting in a boating hazard and making water diversion at low flows very challenging. A trash rack made of 4-inch galvanized metal fence sits in front of the headgate, which does not seal properly. Beginning at the headgate, water is conveyed via a subterranean pipeline for ~100 ft and then delivered to an open ditch. There are various materials stabilizing the banks upstream of the structure and around the headwall. However, the banks that are not reinforced are largely unstable and subject to erosion. This structure is located on the outside of a bend just upstream of the apex. According to the 2001 Rio Grande Headwaters Restoration Project, this meander is tightening and there is potential for the entire meander to be cut off during a high flow event, making this structure unusable.

Headgate and diversion dam

Repair(s) or Improvement(s) Currently Needed: Given these issues, the SMP Technical Advisory Team (TAT) recommends improving the diversion dam, repairing or replacing the headgate, and revegetating and stabilizing the adjacent streambanks. An improved diversion could be designed to be easily passable by boats while also effectively diverting water at all flows. Streambank stabilization and riparian revegetation would mitigate erosion and reduce the risk of bank failure and future impacts to the structure.

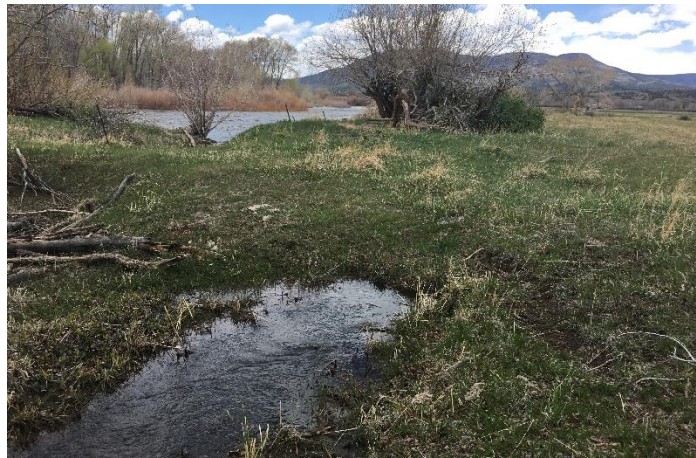
Pipeline outlet, beginning of open ditch

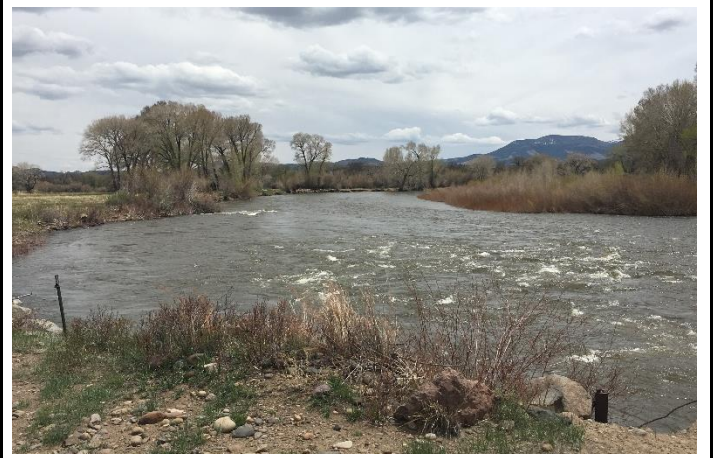
Rio Grande downstream of diversion dam

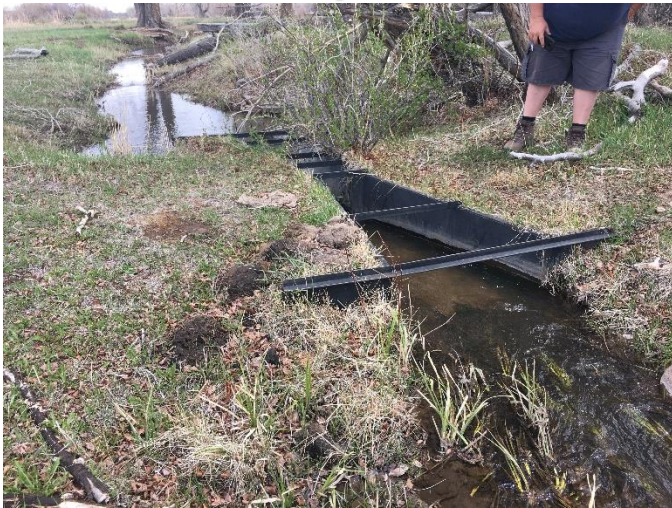
Flume looking downstream

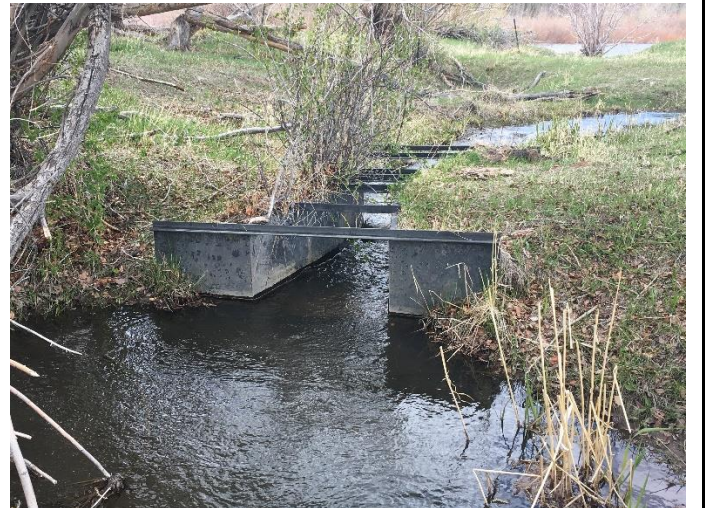
Flume looking upstream

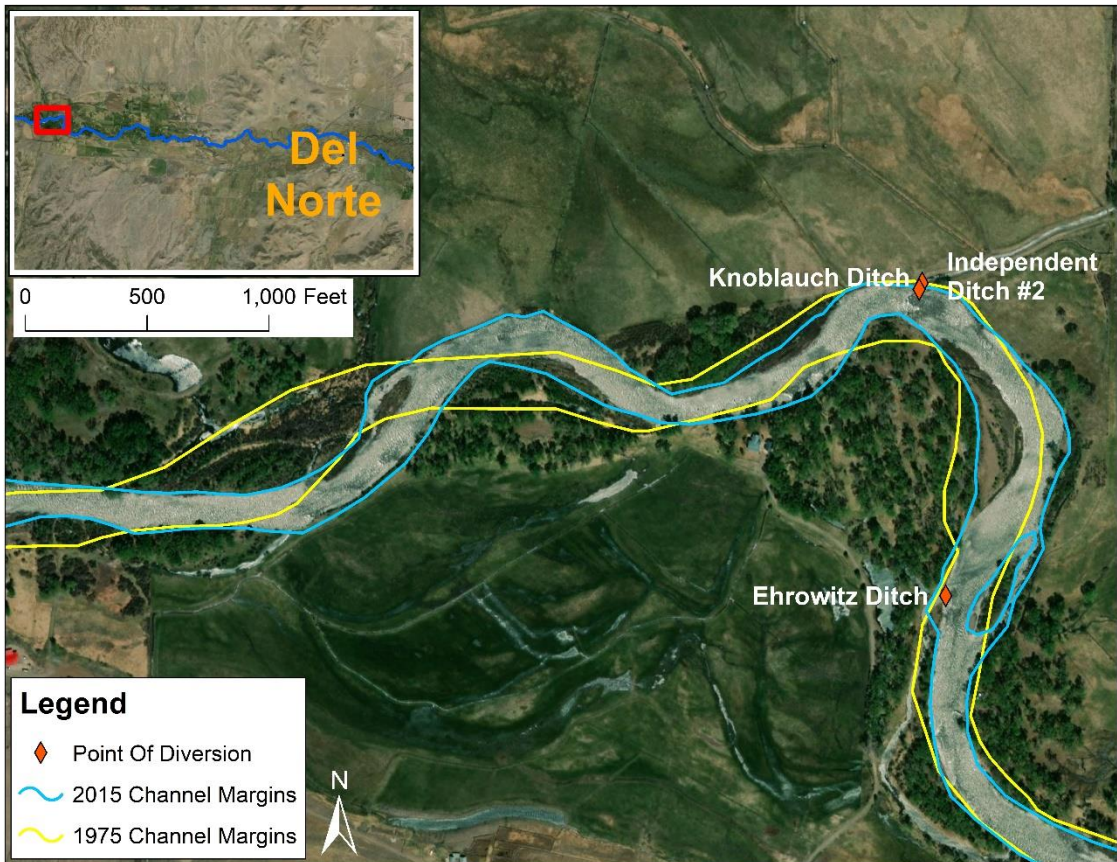
Knoblauch Ditch relative to the Independent #2 and Ehrowitz ditches. Diversion and headgate locations with 1975 and 2015 channel margins are overlaid. This highlights the tightening of the bend on which this structure is located.

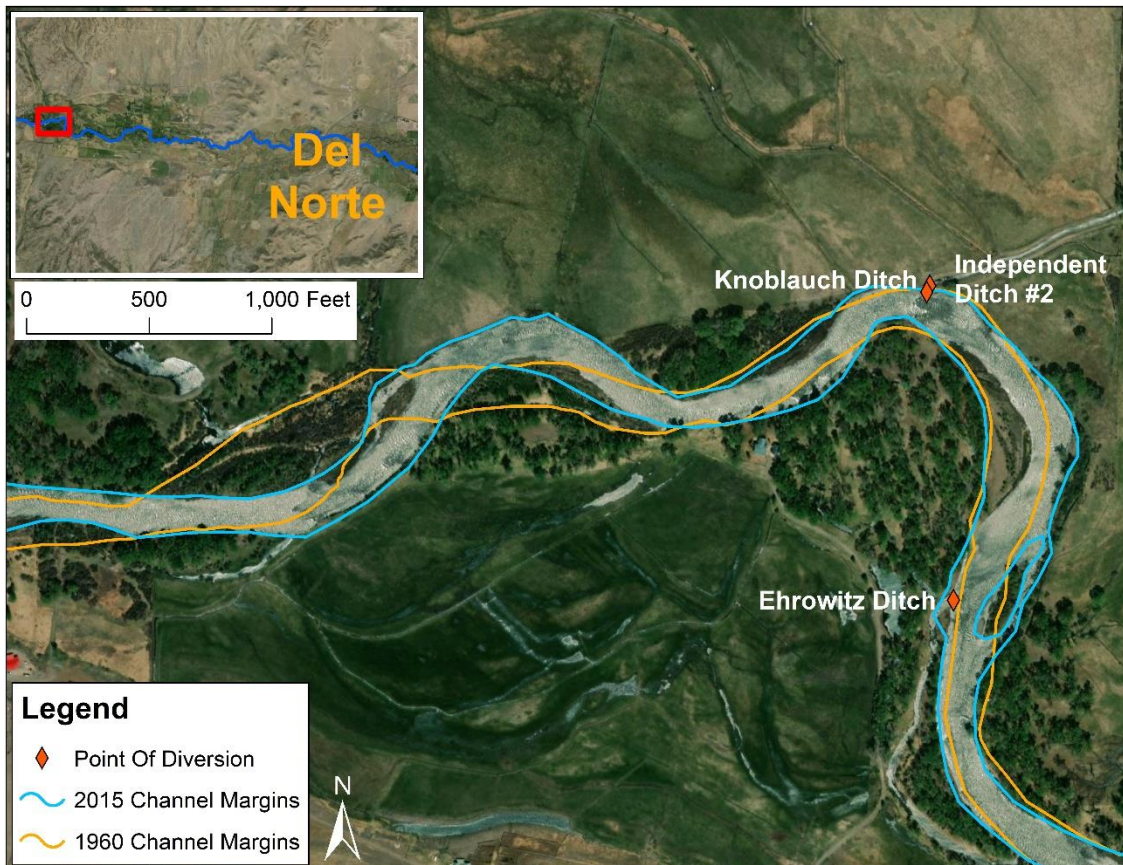
Knoblauch Ditch headgate with 1960 and 2015 channel margins
