RIO GRANDE DIVERSION INFRASTRUCTURE INVENTORY

Structure Name: MARAJO D

Date: April 1, 2019

MARAJO DITCH

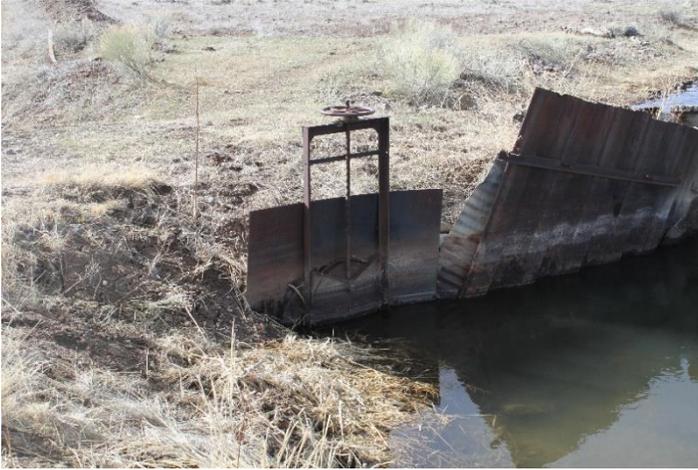
Headgate looking downstream

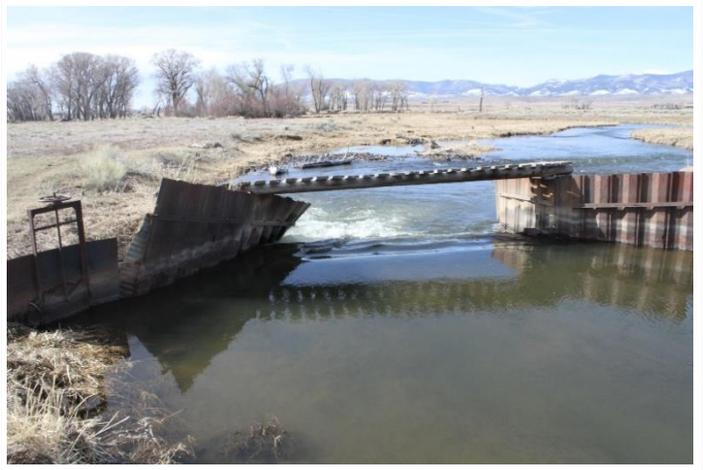
Headgate and diversion dam (on feeder ditch)

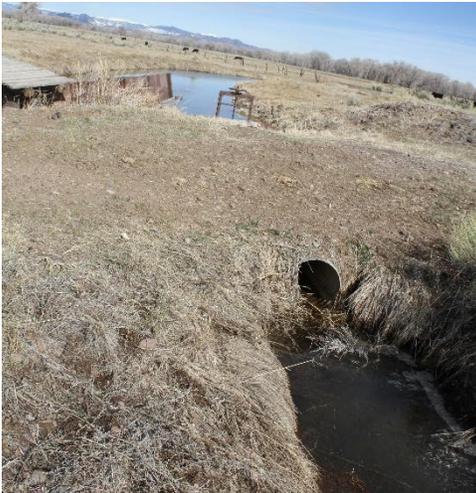
Headgate outlet

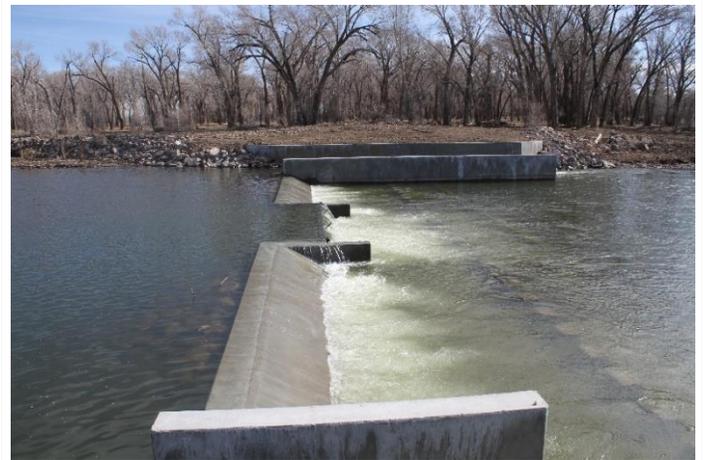
Diversion dam on Rio Grande

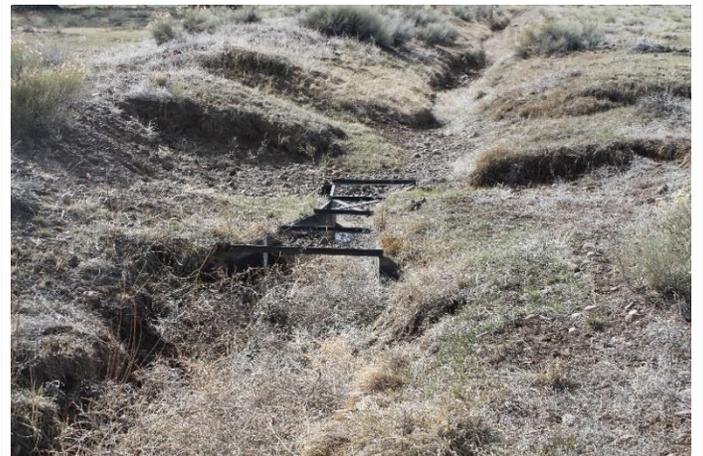
Flume looking downstream

Repair(s) or Improvement(s) Currently Needed: Based on the issues identified at this structure, the SMP Technical Advisory Team (TAT) recommends replacing the diversion dam and associated materials, resetting or replacing the flume, and considering headgate replacement in the future. These improvements would increase water delivery efficiency and reduce maintenance needs.
