RIO GRANDE DIVERSION INFRASTRUCTURE INVENTORY

Structure Name: MCDONALD D

Date: April 9, 2019

PHOTO LOG

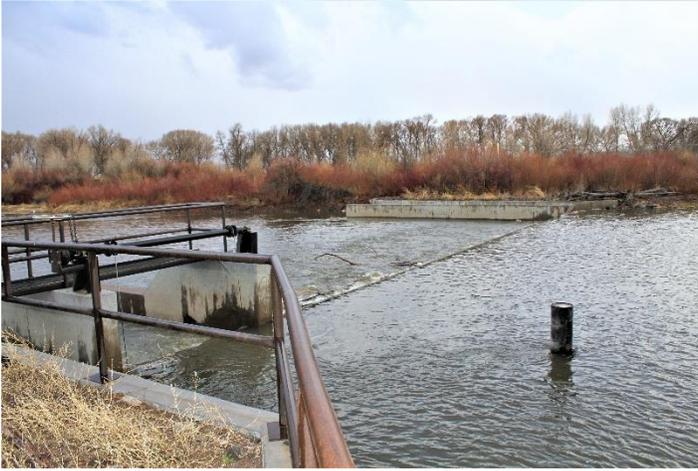
Headgate and diversion dam

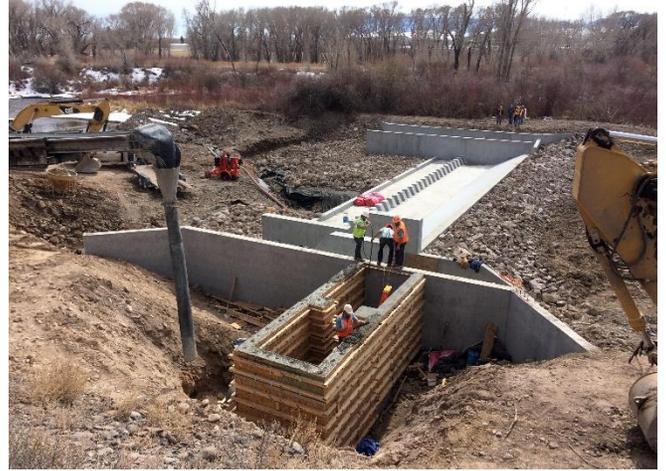
New headgate under construction

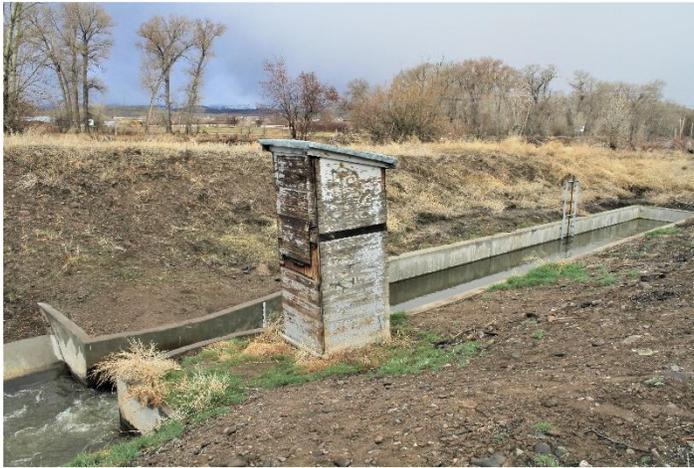
Headgate outlet and flume

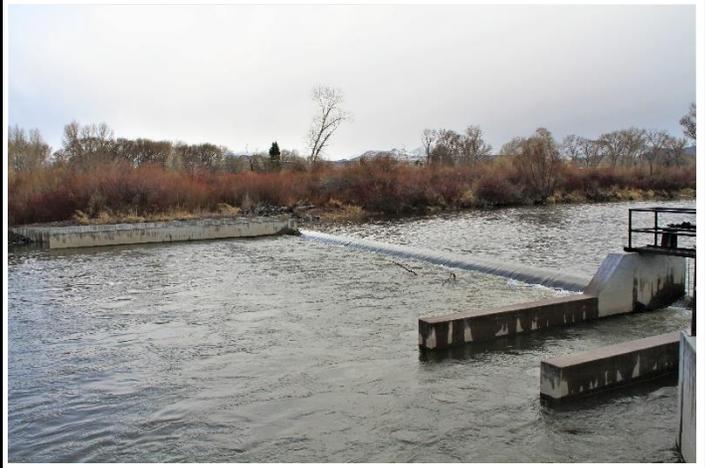
Diversion dam looking upstream

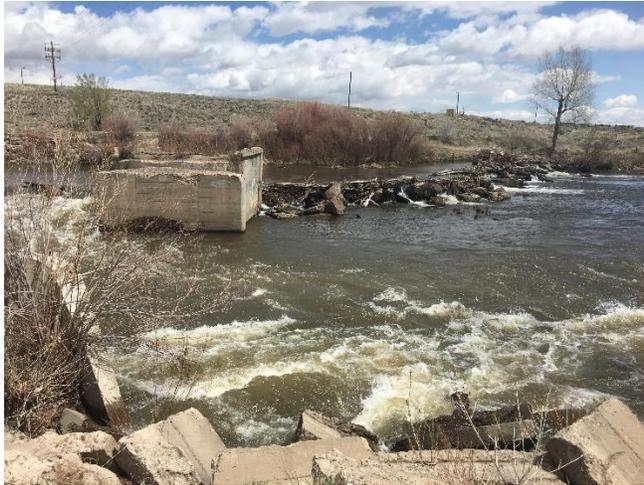
Old diversion dam

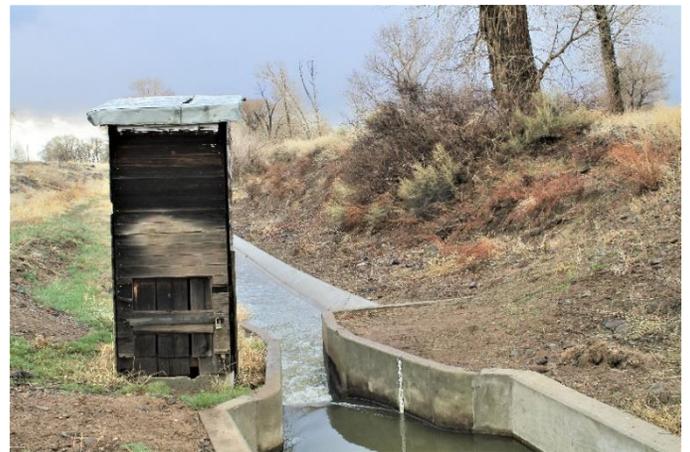
Flume looking downstream
