RIO GRANDE DIVERSION INFRASTRUCTURE INVENTORY

Structure Name: MCINTOSH ARROYA D

Date: April 9, 2019

MCINTOSH ARROYA DITCH

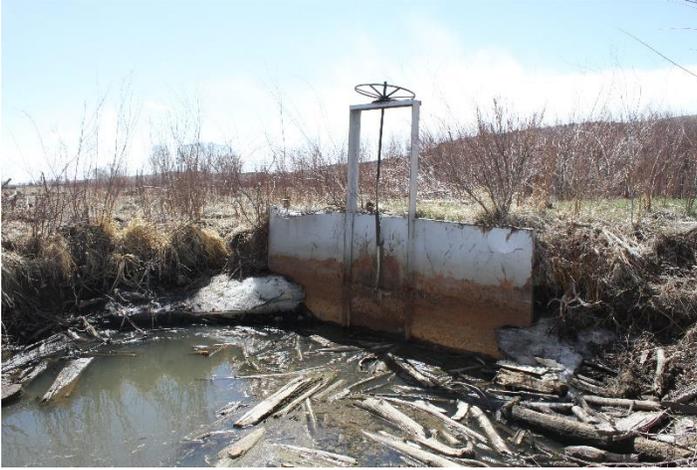
Repair(s) or Improvement(s) Currently Needed: The headgate leaks and, according to the 2006 inventory, the headwall was replaced approximately 23 years ago. Woody debris accumulation, especially in the feeder channel and near the headgate, is also an issue. The flume is functional, however the channel is beginning to erode at its downstream end. Given these issues, the SMP Technical Advisory Team (TAT) recommends headgate repair or full replacement, installation of a trash rack or relocation of the headgate closer to the point of diversion, and flume repairs. Alternatively, the entire structure could be relocated to a more desirable point of diversion, which would reduce maintenance and allow for other restoration efforts on the South Channel.

Headgate looking downstream

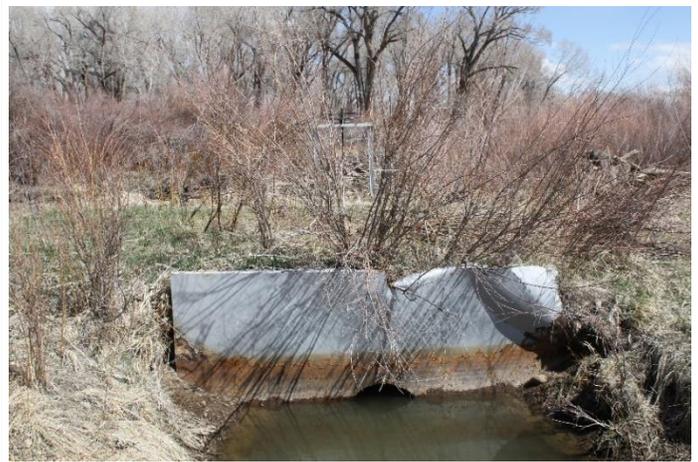
Headgate outlet

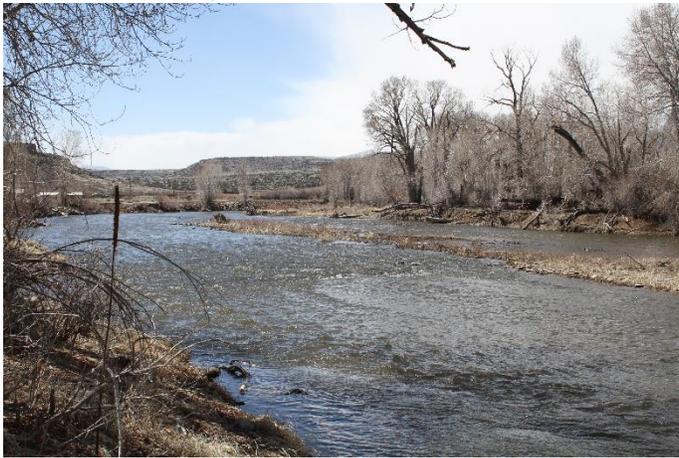
Rio Grande upstream of diversion dam

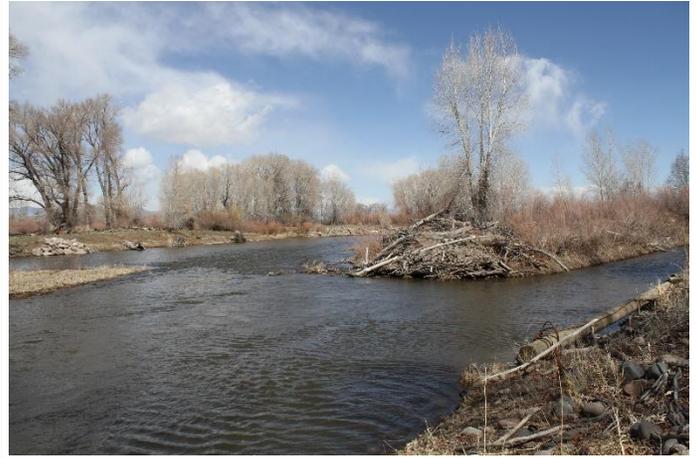
Diversion dam

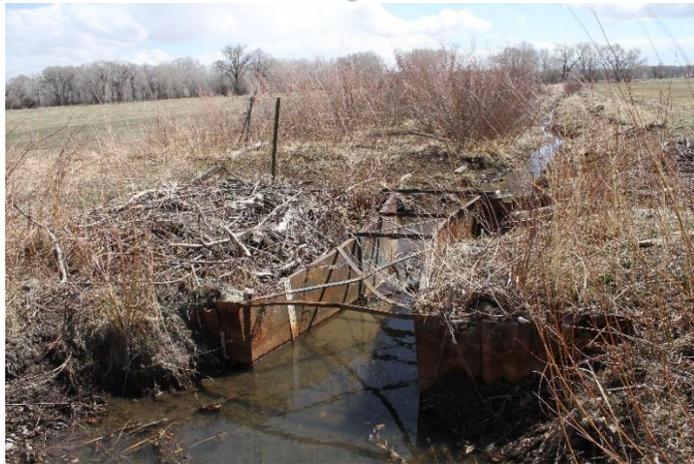
Flume looking downstream

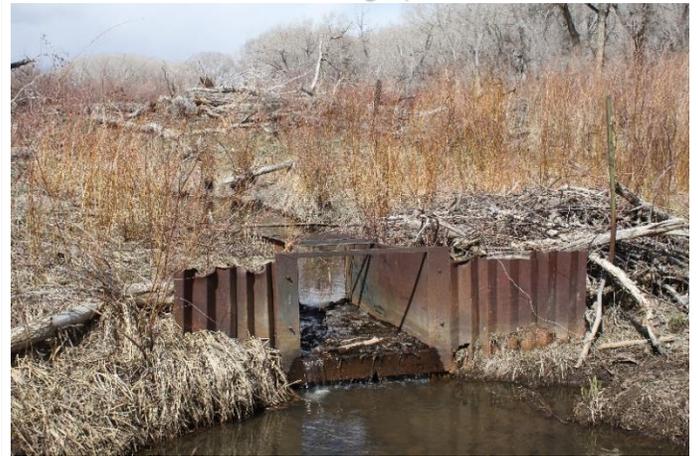
Flume looking upstream
