RIO GRANDE DIVERSION INFRASTRUCTURE INVENTORY

Structure Name: MEADOW GLEN D

Date: May 7, 2019

MEADOW GLEN DITCH

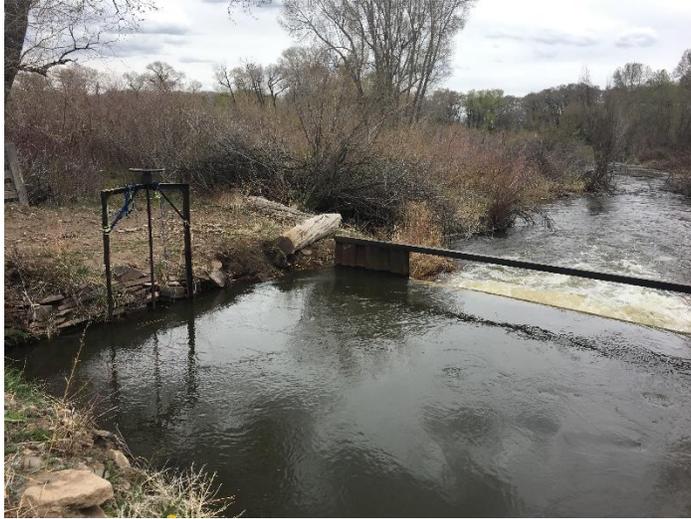
Headgate looking downstream

Repair(s) or Improvement(s) Currently Needed: Given these issues, the SMP Technical Advisory Team (TAT) recommends extending the trash rack and repairing the headgate. An improved trash rack would prevent woody debris from entering the feeder channel and reduce maintenance, while headgate repairs would eliminate the leak and improve ditch efficiency.

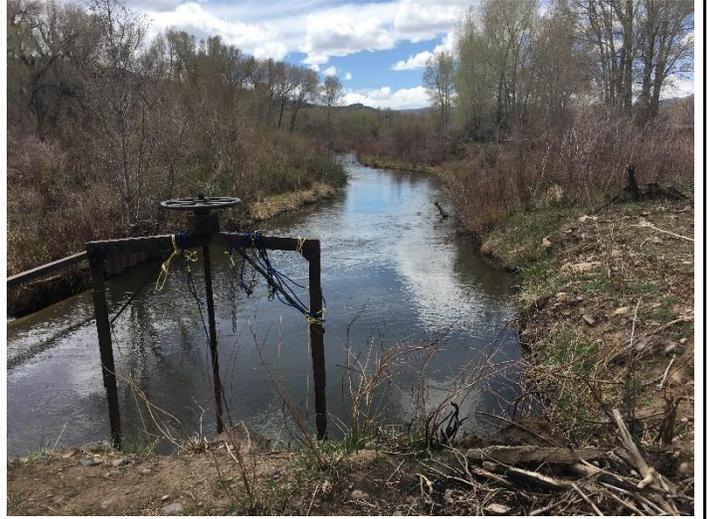
Headgate and feeder ditch

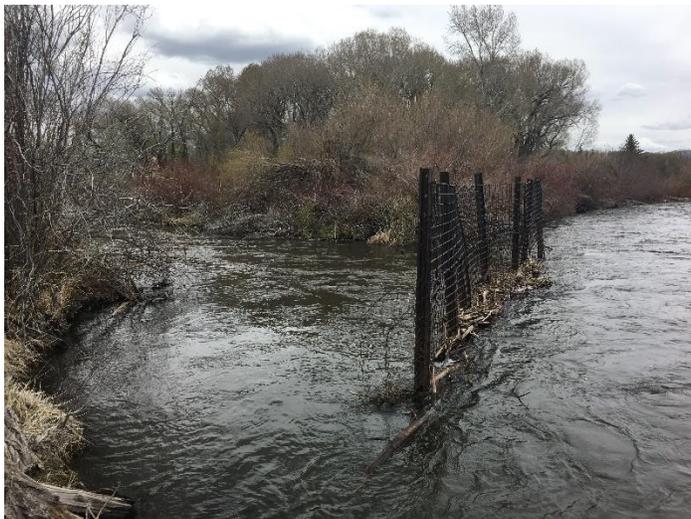
Headgate outlet

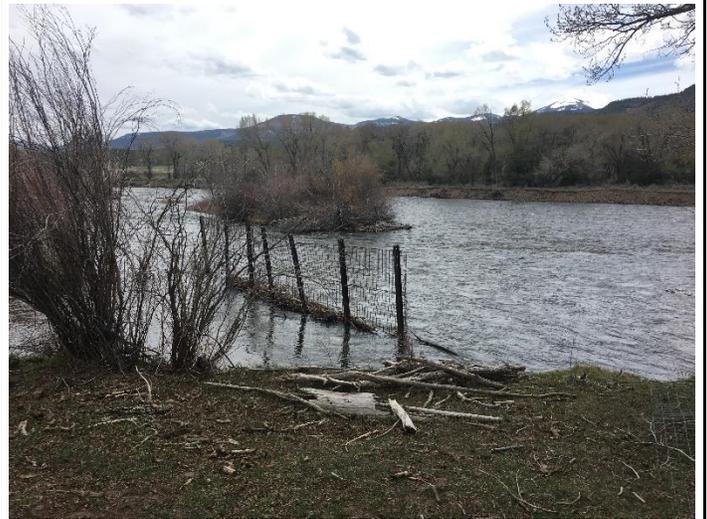
Diversion dam

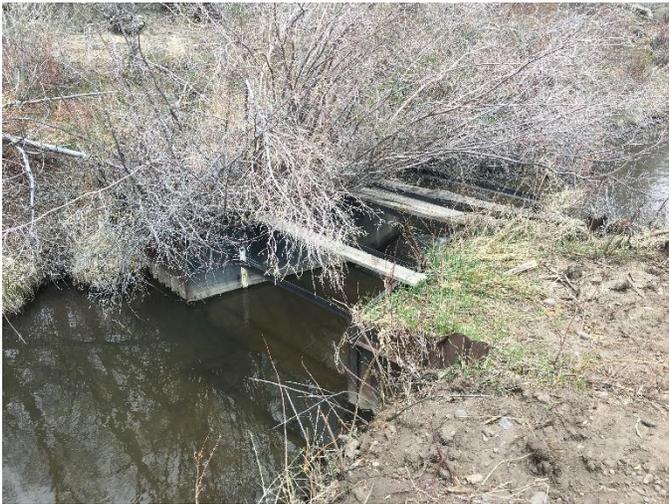
Flume looking downstream

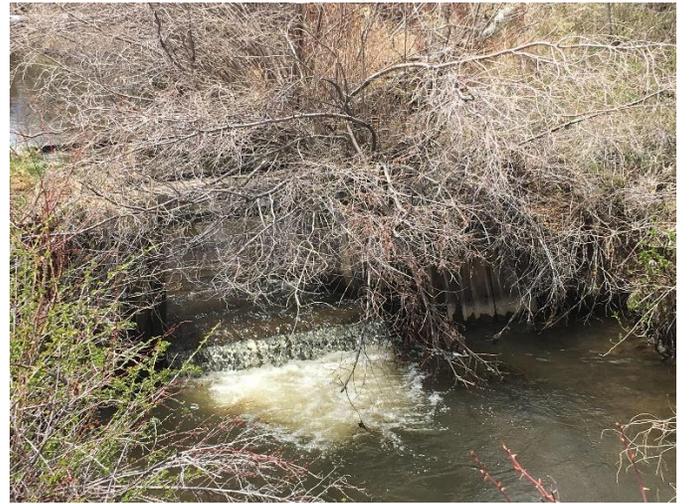
Flume looking upstream

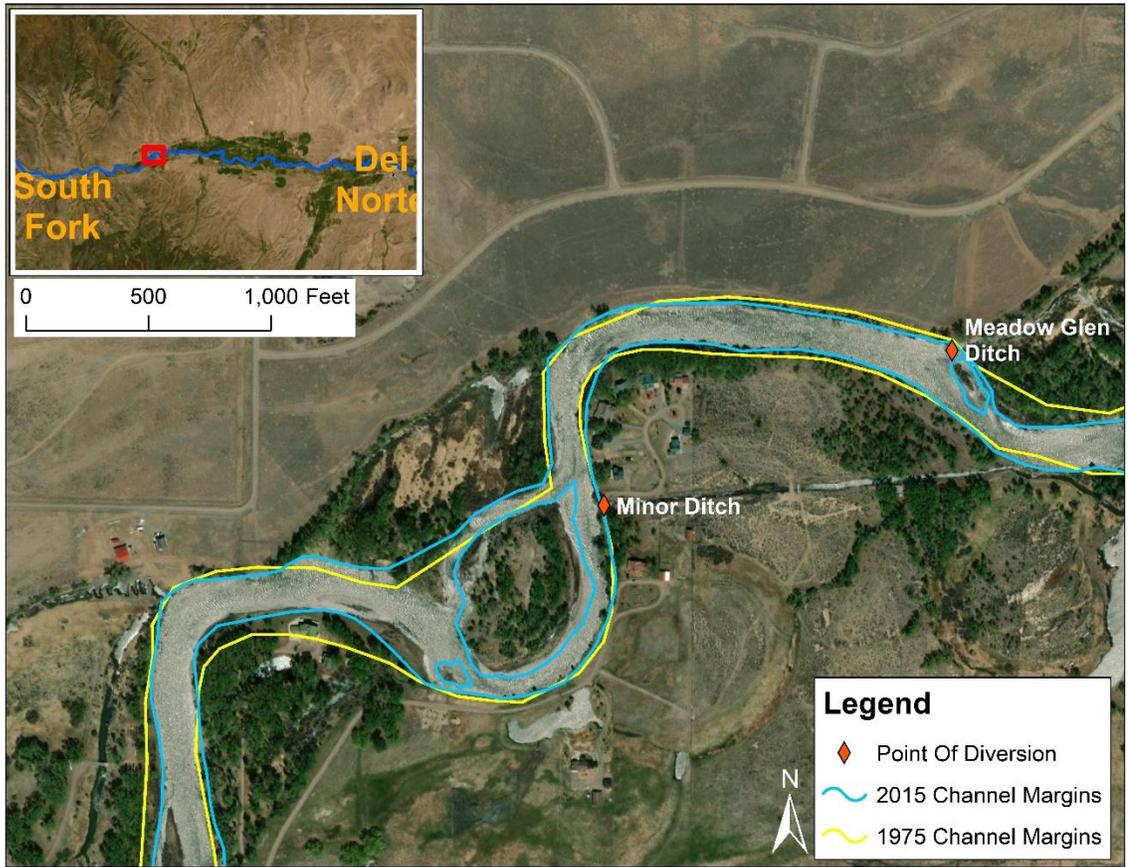
Meadow Glen Ditch and Minor Ditch diversions with 1975 and 2015 channel margins overlaid.

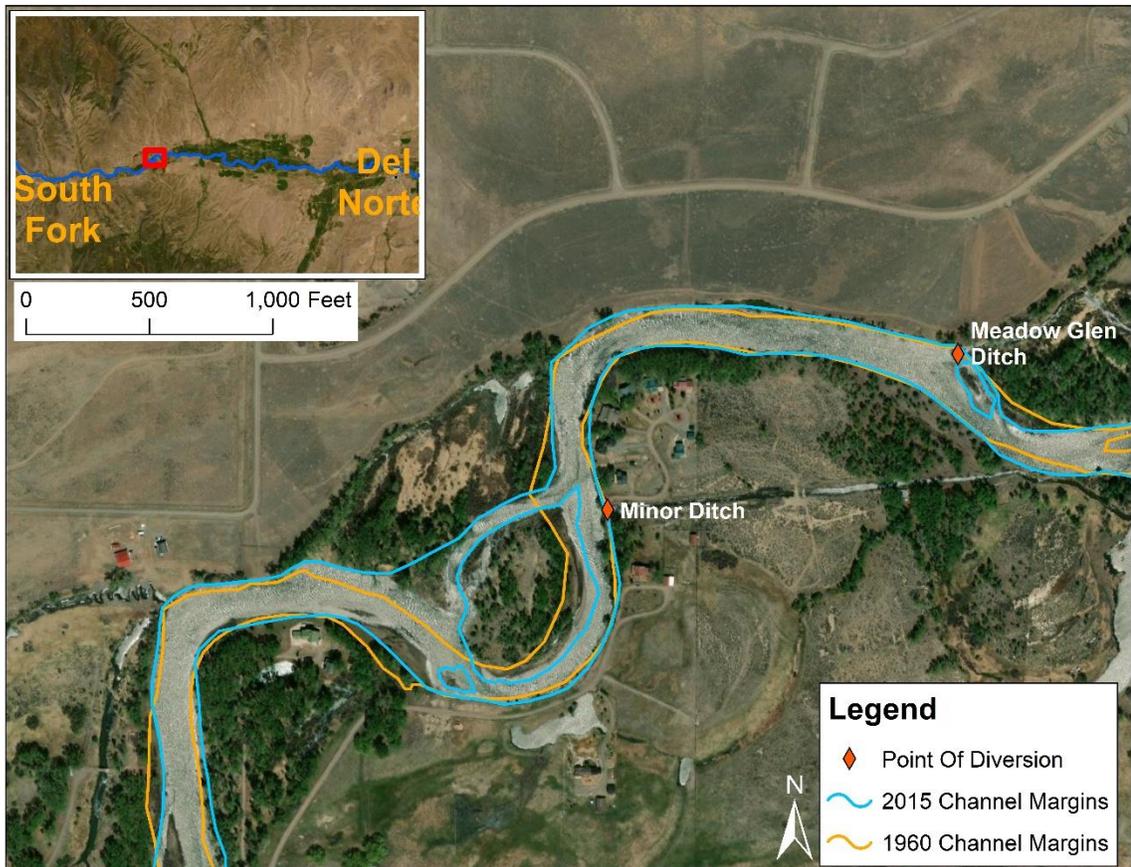
Meadow Glen Ditch and Minor Ditch diversions with 1960 and 2015 channel margins overlaid.
