RIO GRANDE DIVERSION INFRASTRUCTURE INVENTORY

Structure Name: MEADOW OVERFLOW D

Date: April 11, 2019

MEADOW OVERFLOW DITCH

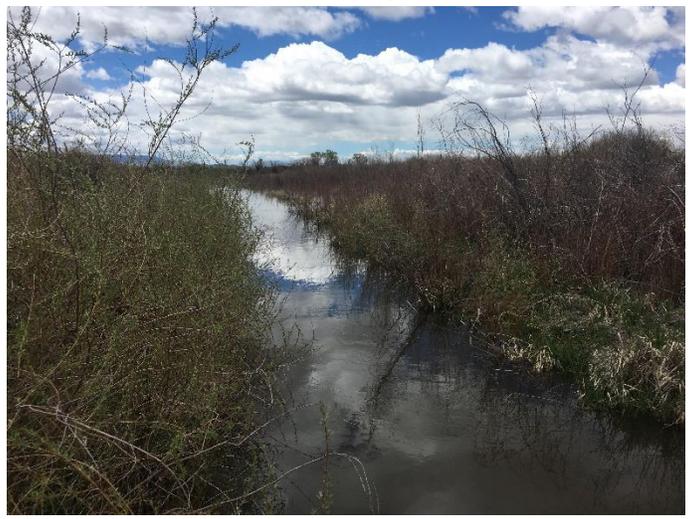
Feeder ditch looking downstream

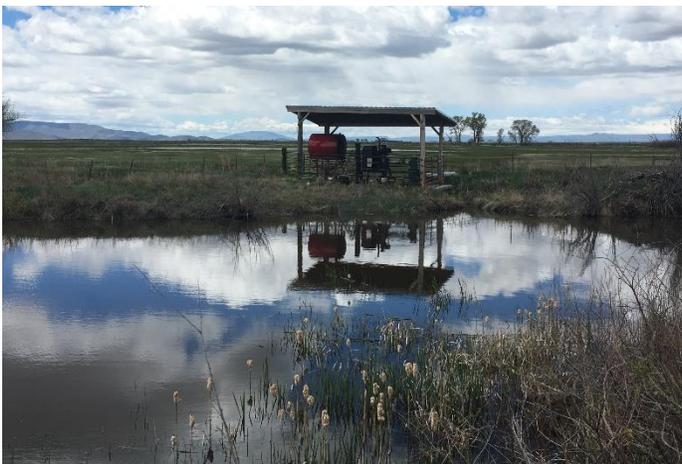
Pump used for irrigating adjacent field

Repair(s) or Improvement(s) Currently Needed: The SMP Technical Advisory Team (TAT) recommends repairing the existing headgate or improving the lift pump, replacing the flume, and implementing channel and bank restoration near the diversion to reconnect the river with its floodplain and to restore native riparian vegetation. Headgate replacement or an improved pump would improve ditch function and efficiency and adjacent restoration would improve river function by slowing and dispersing water during high flow events. Channel and bank restoration would enhance riparian vegetation recruitment and reduce erosion.

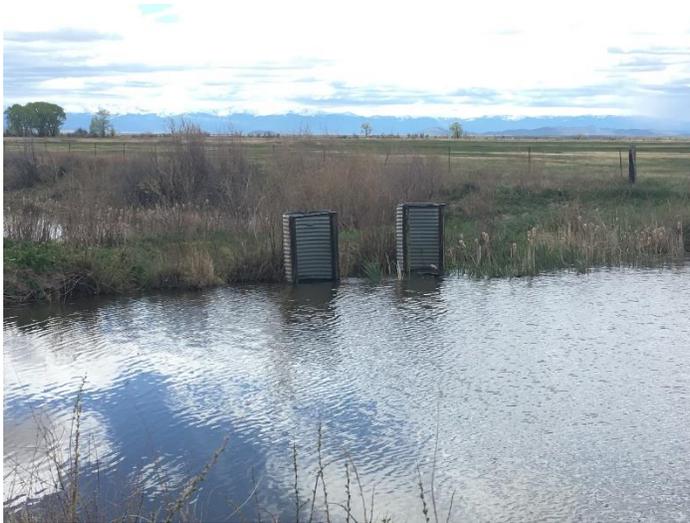
Return flow structures
