RIO GRANDE DIVERSION INFRASTRUCTURE INVENTORY

Structure Name: MIDLAND D

MIDLAND DITCH

Rio Grande Stream
Management Plan

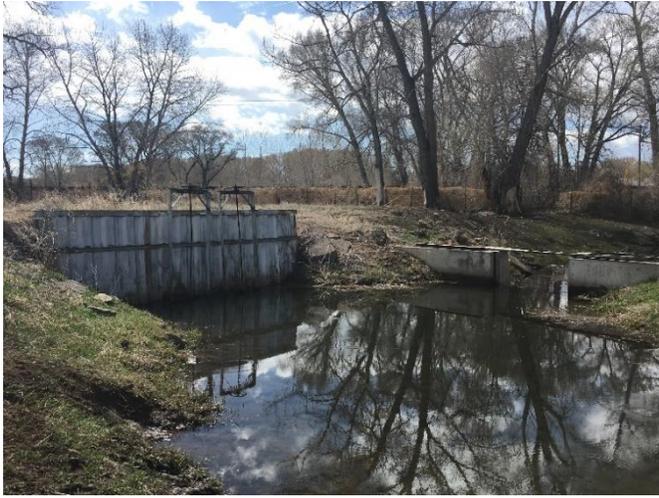
Headgate looking downstream

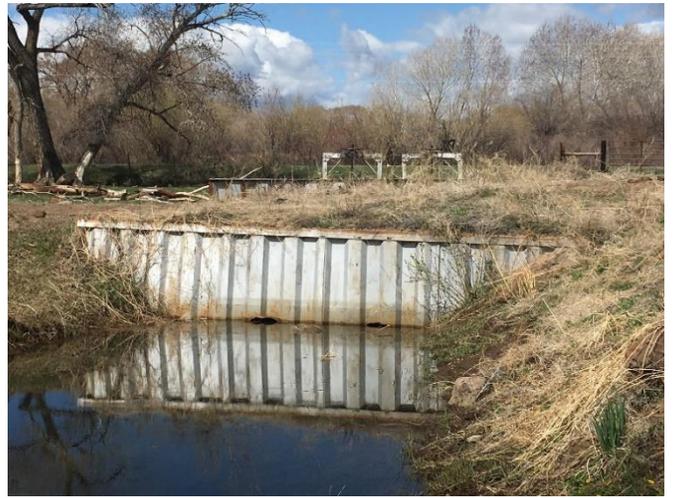
Headgate outlet

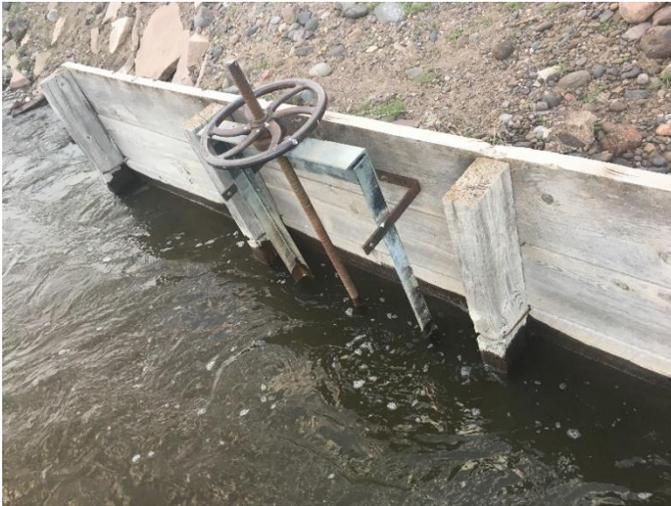
Headgate off Rio Grande Canal

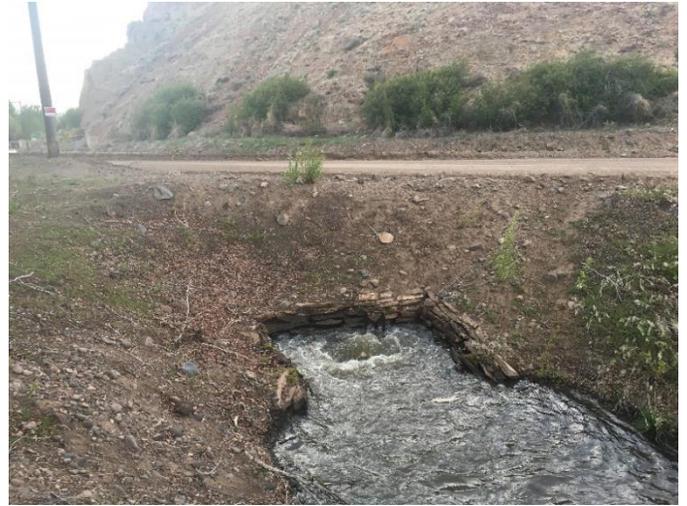
Headgate outlet off Rio Grande Canal

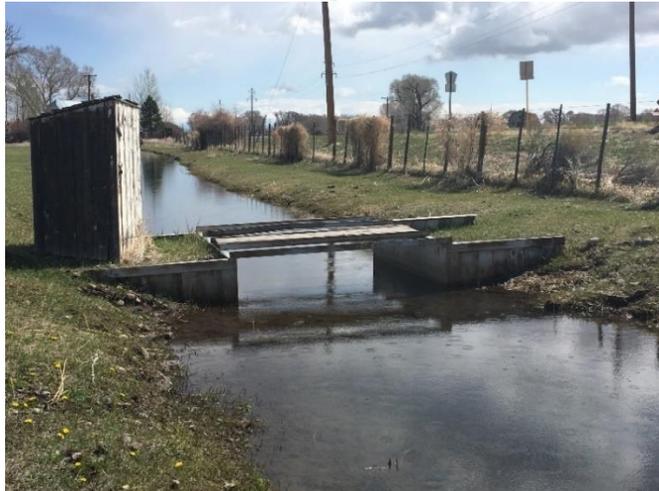
Flume looking downstream

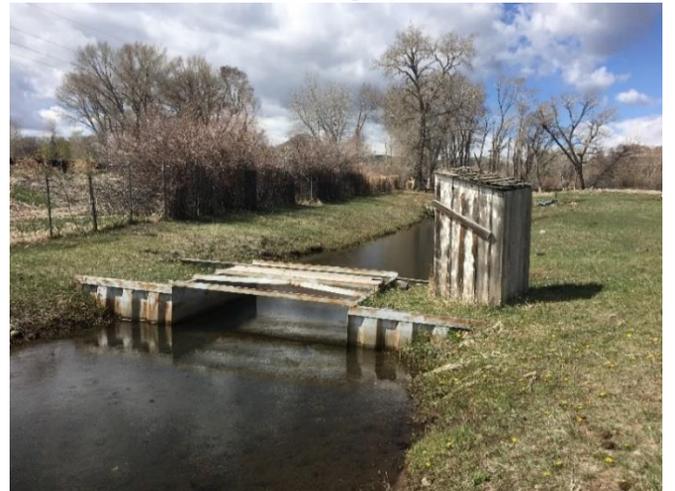
Flume looking upstream
