RIO GRANDE DIVERSION INFRASTRUCTURE INVENTORY

Structure Name: MINOR D

Date: May 7, 2019

Rio Grande Stream
Management Plan

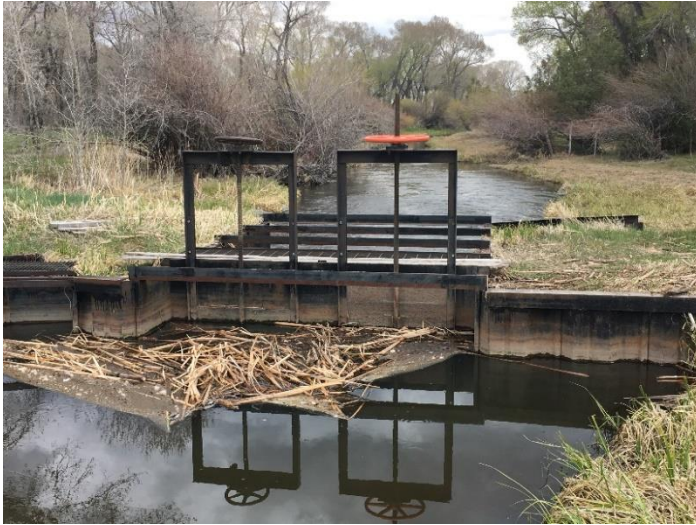
Headgate looking downstream

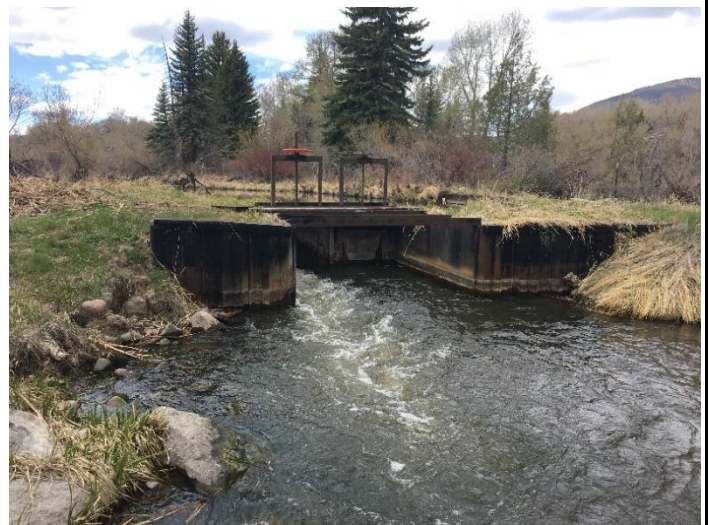
Headgate outlet

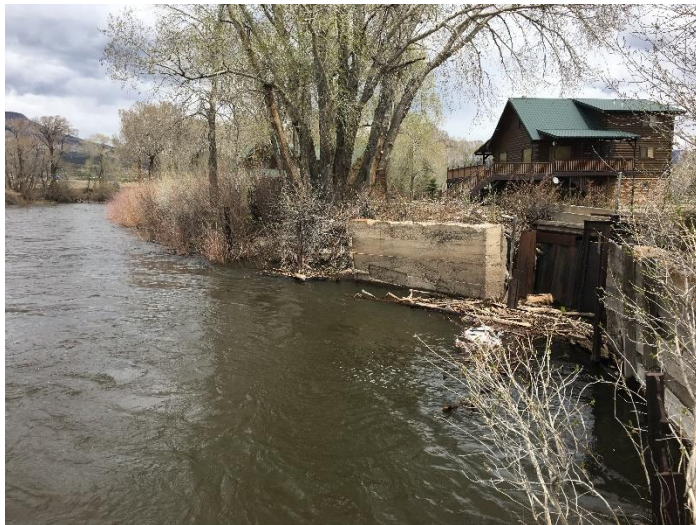
River headgate on Rio Grande

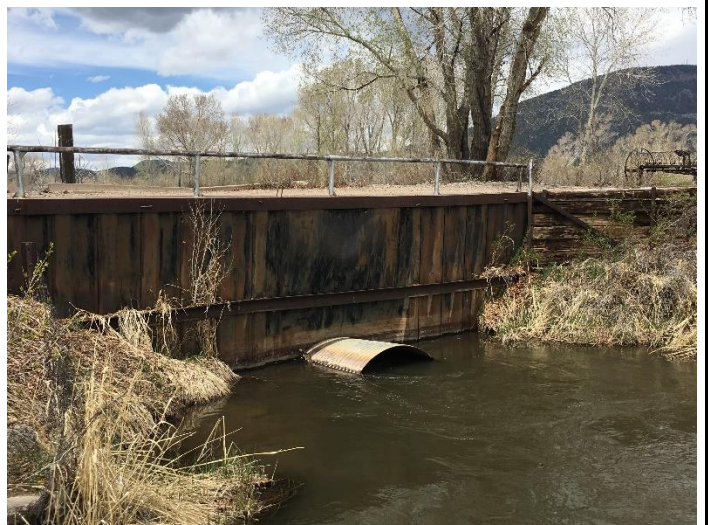
River headgate outlet

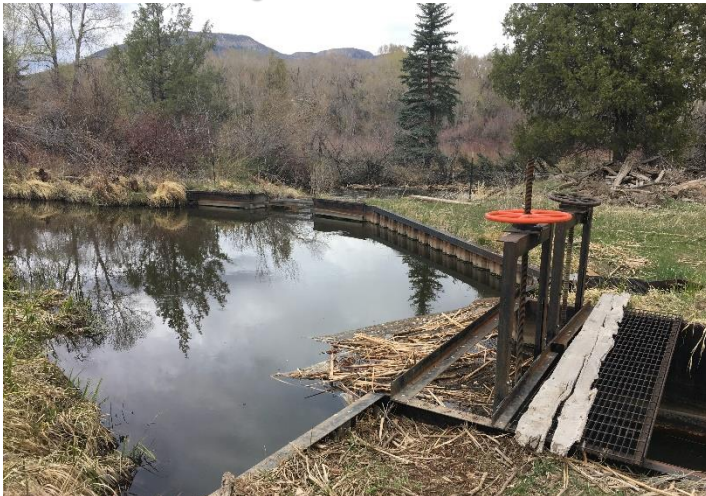
Main headgates and overflow channel

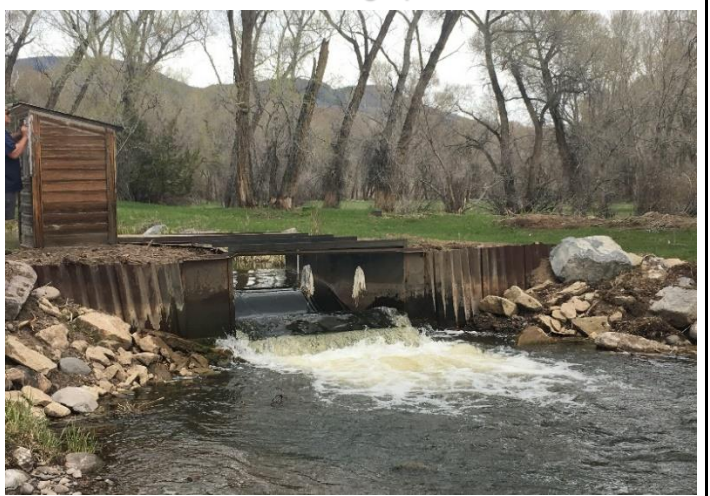
Flume looking upstream

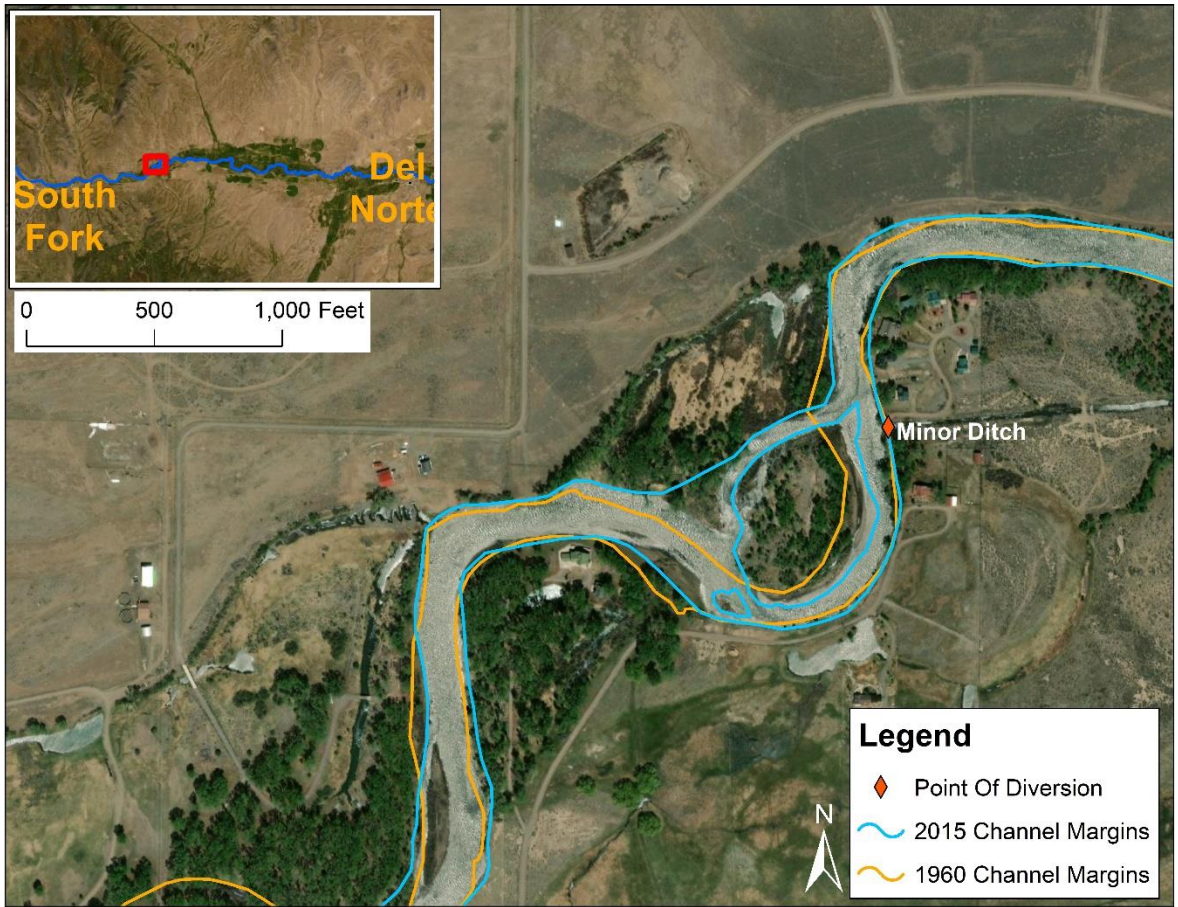
Structure Description: The Rio Grande splits around an island upstream of the structure's river headgate. The river headgate is located on the south bank of the channel. A roughly 0.5 mile feeder channel delivers water to the main headgates. An overflow channel directs unused water from the ditch back to the Rio Grande. This structure suffers from the poor condition of the river headgate, the potential for the structure to be cut off from the river in the event of a rerouting of the main channel to the north, and sediment and debris accumulation in the ditch. The concrete wingwalls on either side of the river headgate are heaving and falling in towards the river. The river channel is unstable and there is potential for the upstream meander to be cut off, causing the full capacity of the river to flow through the north channel. During spring 2019 runoff, significant flow entered the channel north of the island. If this continues to develop, the river will abandon the south channel, making the diversion nonfunctional. Additionally, debris accumulation occurs at the main headgate and in the feeder channel. Finally, there is a point on the feeder channel roughly halfway between the river headgate and main headgate where the ditch is dangerously close to the river and could fail at high flow (see maps below).

Map of point of diversion and headgate location with 1960 and 2015 channel margins overlaid.

Repair(s) or Improvement(s) Currently Needed: Given the current and potential issues at this structure, the SMP Technical Advisory Team (TAT) recommends bank stabilization upstream of the island and on the feeder channel and headworks repair. Bank stabilization upstream of the diversion would help prevent potential channel avulsion, stabilization or feeder channel rerouting would prevent ditch failure, and new wingwalls adjacent to the headgate would ensure the headworks are stable.

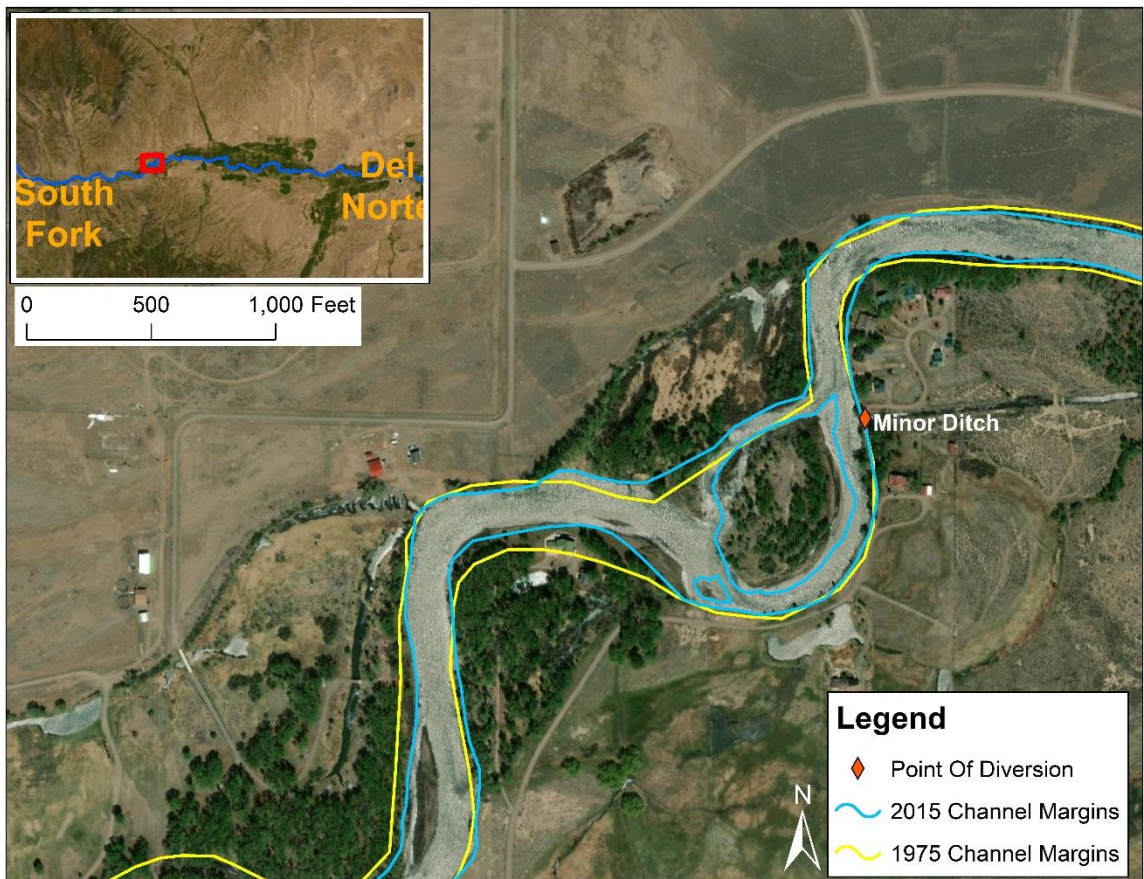
Map of headgate location with 1975 and 2015 channel margins overlaid. This illustrates the channel avulsion occurring, with the north channel widening.

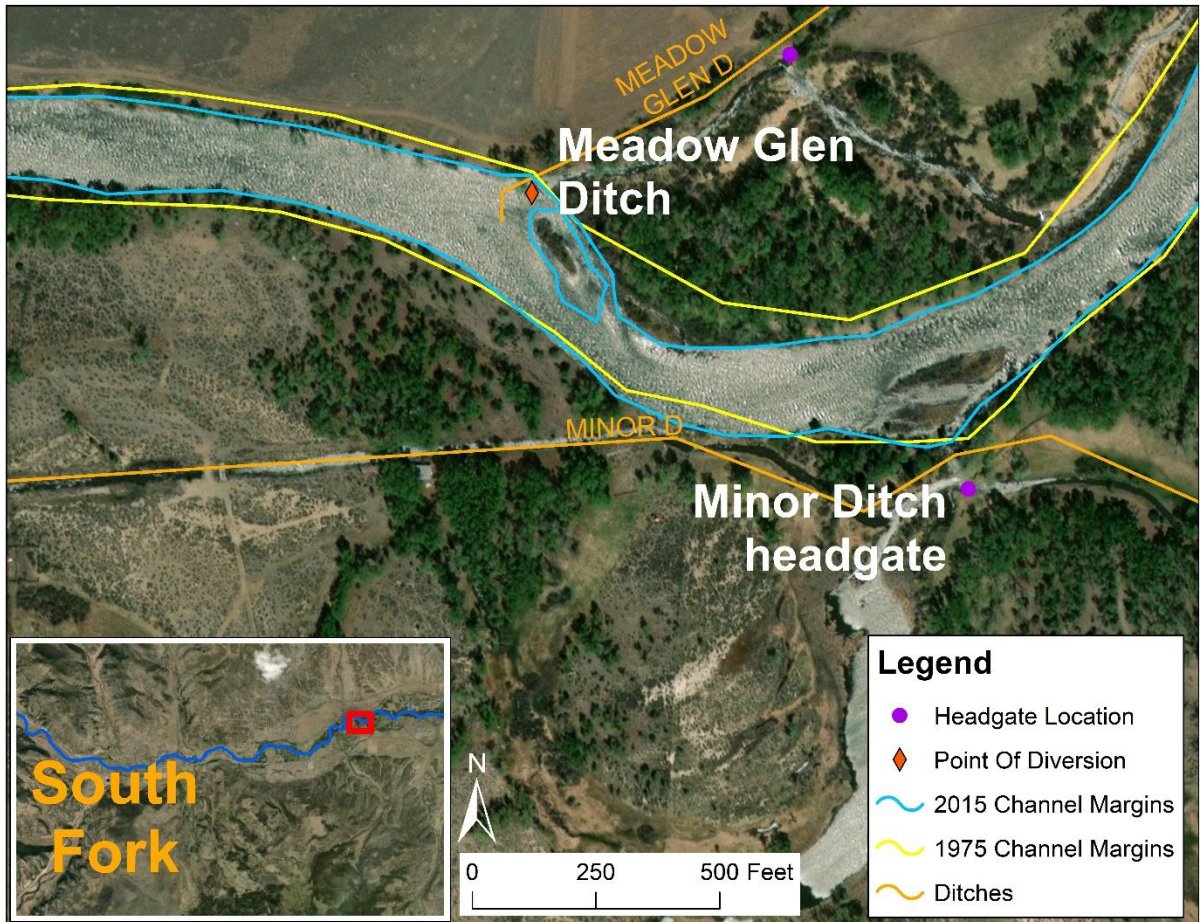
Map showing 1975 and 2015 channel margins relative to ditch location.

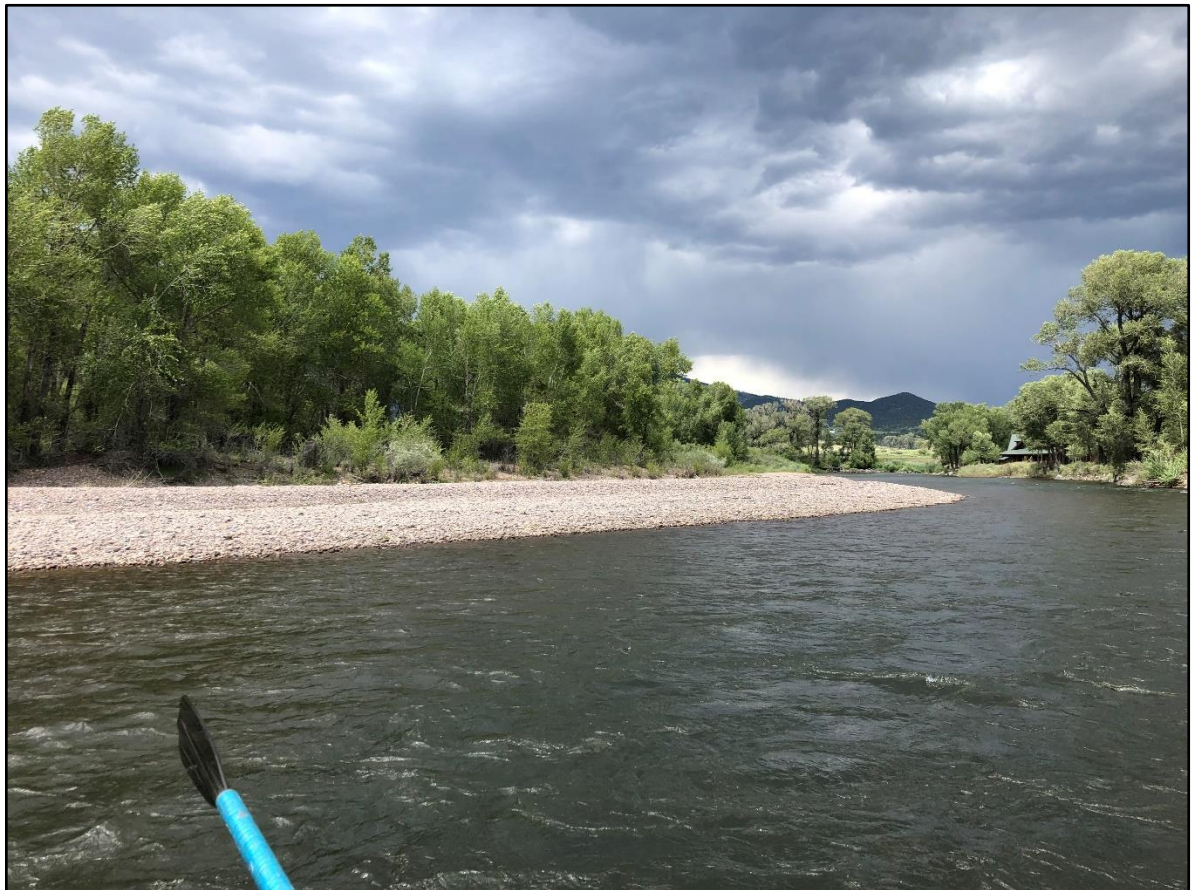
Comments: The channel on the south side of the island that the feeds the headgate frequently silts in during times of low flow. The ditch owners have to dredge the channel approximately once every 10 years. This ditch includes priorities 105, 184, 190, 1903-34I, 1903-45H, 1916-40, 1934-10 and 1934-13.

Photo showing sand bar development upstream of diversion.
