# RIO GRANDE DIVERSION INFRASTRUCTURE INVENTORY

**Structure Name:** MONTE VISTA CANAL

**Date:** April 1, 2019

PHOTO LOG

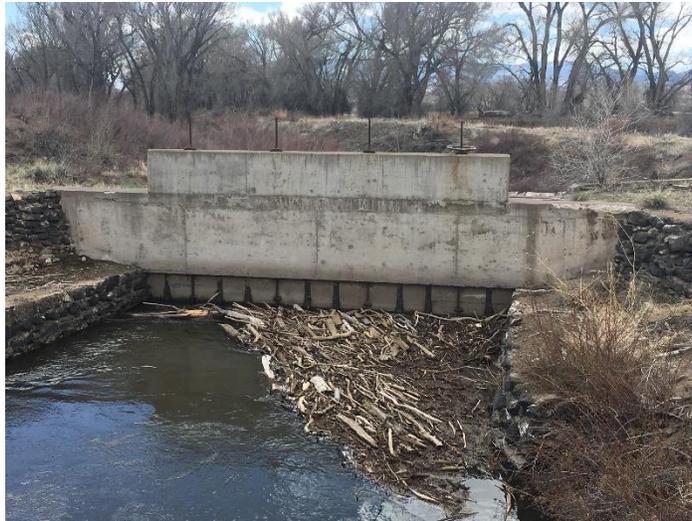
River headgate looking downstream

**Structure Description:** The river headgate for this structure is on the south bank of the river just upstream of the Rio Grande Piedra Valley Ditch headgate. The diversion dam for this structure is a rock structure with check boards and is shared with the Rio Grande Piedra Valley Ditch (see maps in report card). The diversion dam directs water to a short feeder channel that comes off of the river and delivers water to the river headgate. A catwalk with a trash boom serves as the trash rack at the entrance of the feeder channel. From the river headgate, a long feeder channel (approximately 1.2 miles long) delivers water to the main headgate. An overflow structure from this feeder channel runs approximately 550 ft to the feeder channel for the Rio Grande Piedra Valley Ditch/San Jose or Lucero Ditch. An overflow channel runs approximately 1.5 miles from this feeder channel to the Consolidated Ditch Slough, where it enters between Marajo Ditch and John Anderson Ditch. The concrete around the river headgate is spalling and sediment accumulation is an issue.

**Repair(s) or Improvement(s) Currently Needed:** Given the issues identified, the Technical Advisory Team (TAT) recommends installing a sluice gate or other sediment transport structure, such as an Obermeyer, at the river headgate or on the diversion dam. Additionally, to increase efficiency and decrease maintenance, this ditch's headgate could be combined with that of the Rio Grande Piedra Valley Ditch.
