# RIO GRANDE DIVERSION INFRASTRUCTURE INVENTORY

**Structure Name:** NEW DITCH

**Date:** April 11, 2019

Rio Grande Stream Management Plan

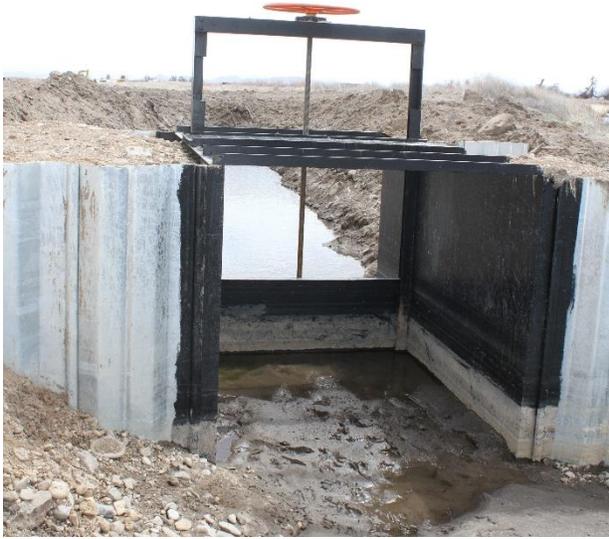
Headgate looking downstream

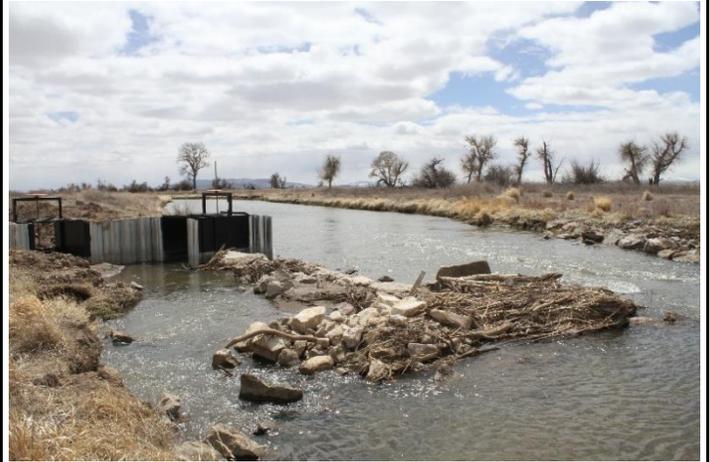
**Repair(s) or Improvement(s) Currently Needed:** This is the last diversion structure on the Rio Grande before the New Mexico state line. The channel in this reach is entrenched and is not connected with the floodplain in many locations. The diversion dam was recently repaired but is still not functioning optimally. During 2019 spring runoff, the river flooded around the dam. There are plans to raise the elevation of the diversion for improved function. The flume is on the east side of Closed Basin Canal and does not measure very accurately. The headgate and diversion dam were replaced in 2019. The culvert where the New Ditch crosses under Chicago Ditch was also replaced.

Headgate and diversion dam

**Structure Description:** Given the issues identified at this structure, the SMP Technical Advisory Team (TAT) recommends diversion dam replacement, resetting or replacing the flume, and implementing channel and bank restoration. The TAT recommends fish and boat passage in this reach as well as adequate sediment transport. A new diversion could be designed to effectively divert the ditch's water rights while also allowing for sediment transport and fish and boat passage. River restoration would reconnect the river with its floodplain and restore native riparian vegetation. Restoration would also improve the function of this structure by slowing and dispersing water during high flow events, thereby protecting diversion infrastructure. Flume improvements would reduce maintenance and improve measurement accuracy.

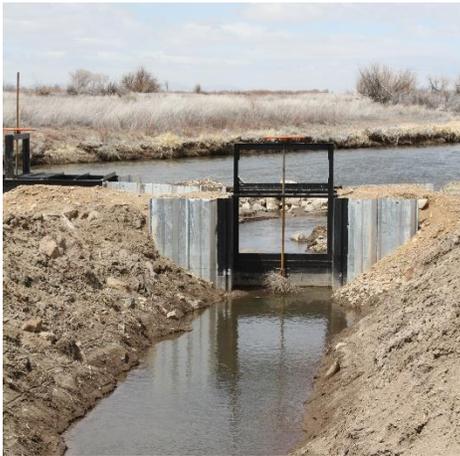
Headgate outlet

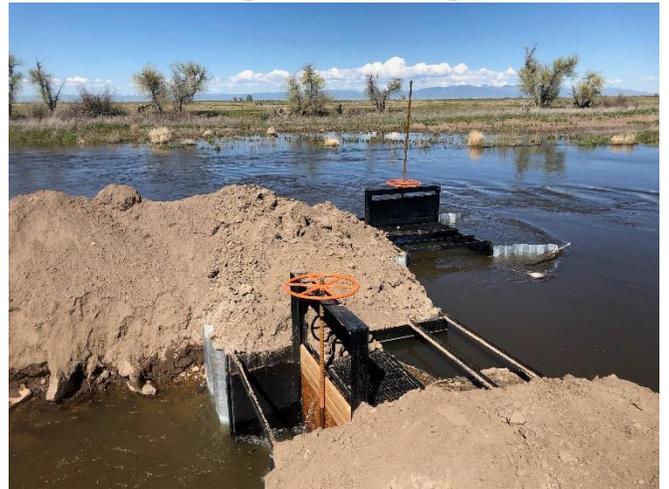
Headgate and sluice gate

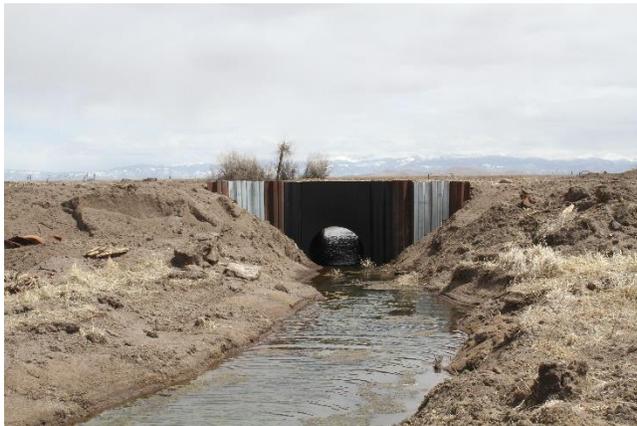
**Repair(s) or Improvement(s) Completed Since 2006:** The headgate and diversion dam were replaced in 2019. The culvert where the New Ditch crosses under Chicago Ditch was also replaced and the location of measurement was also moved.

Culvert where NEW D passes under CHICAGO D

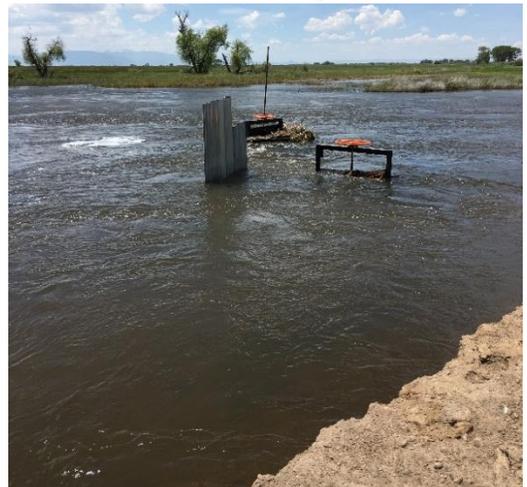
Rio Grande looking upstream
