RIO GRANDE DIVERSION INFRASTRUCTURE INVENTORY

Structure Name: NICHOL D

Date: April 1, 2019

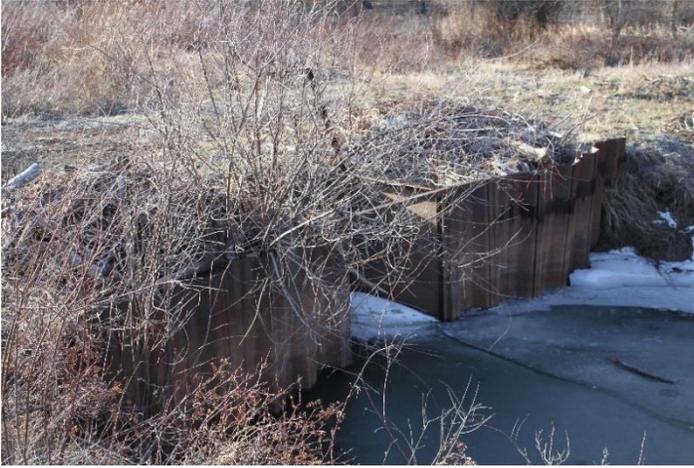
Headgate Condition:	A <input type="checkbox"/>	Diversion and Other Condition:	A <input type="checkbox"/>	River Miles from New Mexico State Line (Point of Diversion):	Structure Submerged: Yes <input type="checkbox"/>
	B <input checked="" type="checkbox"/>		B <input checked="" type="checkbox"/>		No <input checked="" type="checkbox"/>
	C <input type="checkbox"/>		C <input type="checkbox"/>	85.0 mi	
	D <input type="checkbox"/>		D <input type="checkbox"/>		
	F <input type="checkbox"/>		F <input type="checkbox"/>

Headgate looking downstream

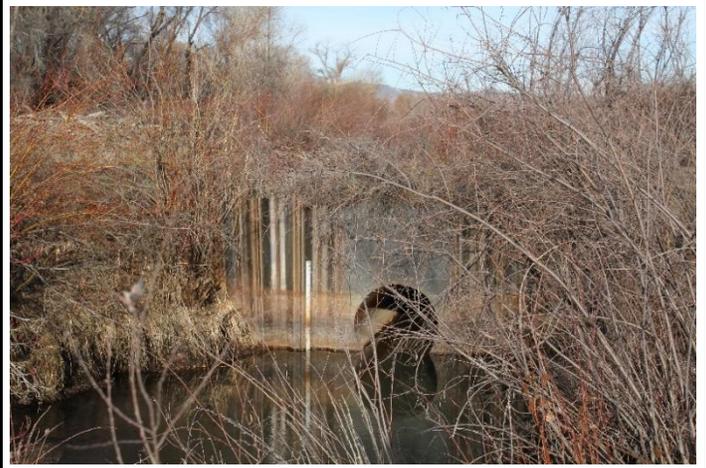
Headgate outlet

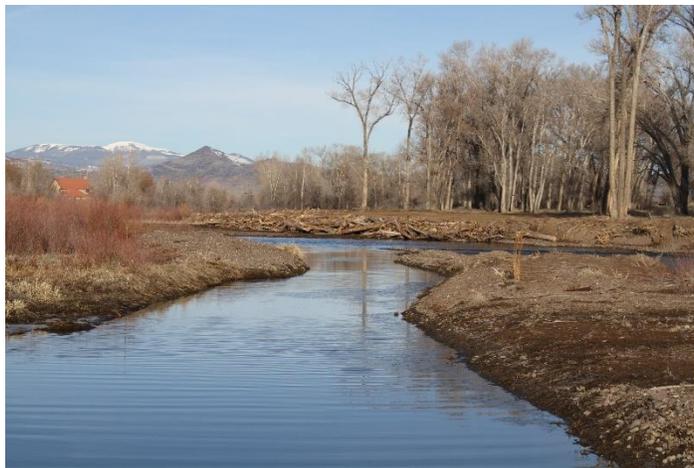
Structure Description: There is no formal diversion dam for this structure. Water flows into a feeder channel located on the south bank of the Rio Grande. The feeder channel travels approximately 0.25 mile to the headgate. The headgate and flume function well. At the point of diversion, the river is migrating northeast, away from the feeder channel entrance. As a result, a small point bar is forming at the point of diversion, resulting in access and maintenance issues for the ditch.

Point of diversion and feeder ditch

Repair(s) or Improvement(s) Currently Needed: To reduce maintenance and ensure long-term function, the SMP Technical Advisory Team (TAT) recommends installing an improved diversion dam. A small stacked rock structure would likely function well for water diversion and could also be used to restore the cut bank on the north bank of the river and create additional fish habitat.

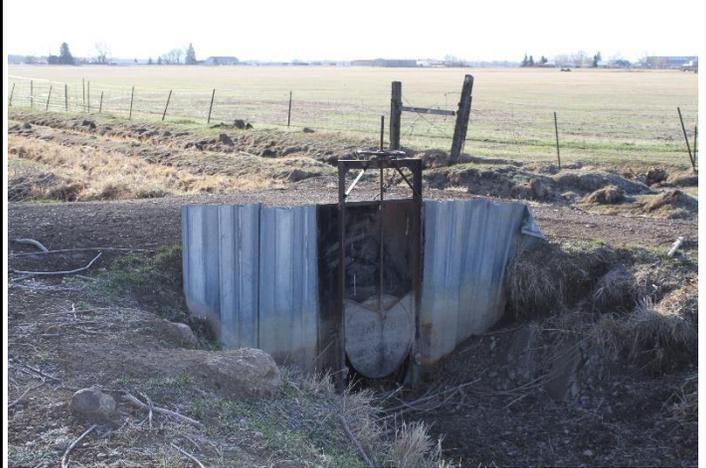
Adjustment gate below main headgate

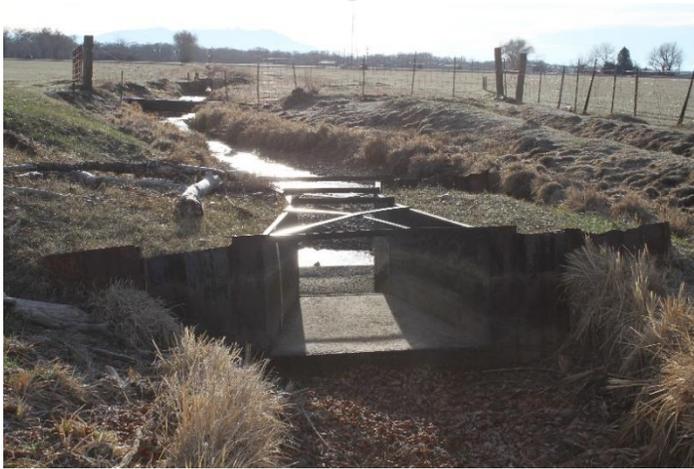
Flume looking downstream

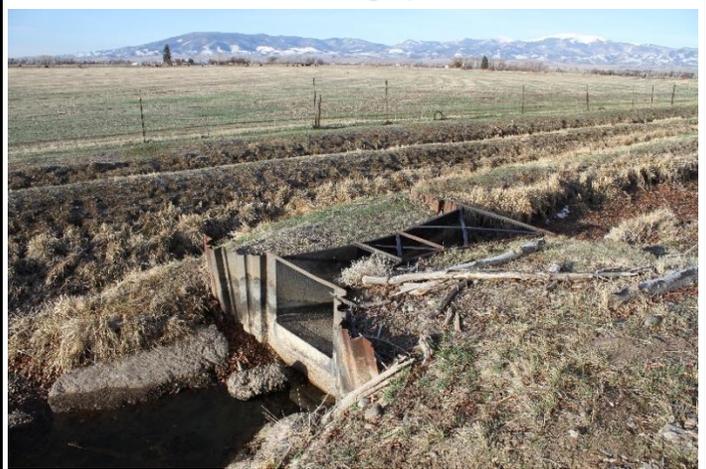
Flume looking upstream

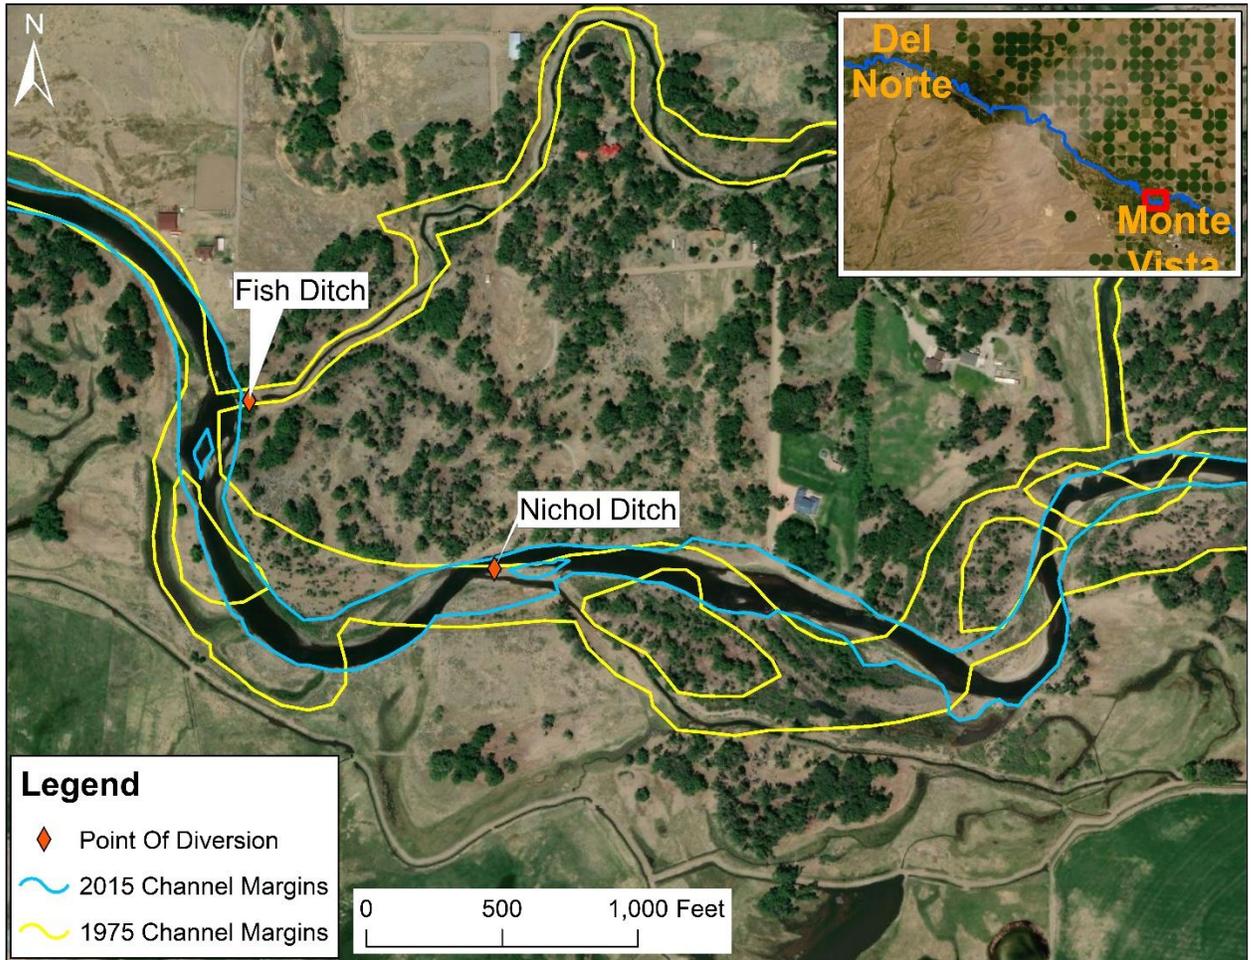
Nichol Ditch point of diversion and headgate location with 1975 and 2015 channel margins overlaid. illustrating channel migration away from the point of diversion
