RIO GRANDE DIVERSION INFRASTRUCTURE INVENTORY

Structure Name: NORTH SIDE DIVERSION

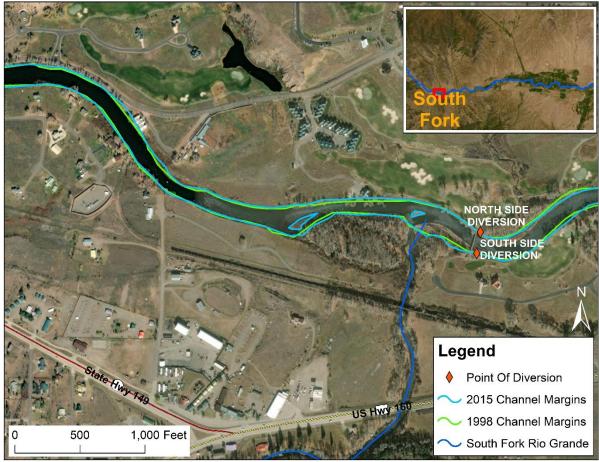
North and South Side Diversions with 1998 and 2015 channel margins overlaid.

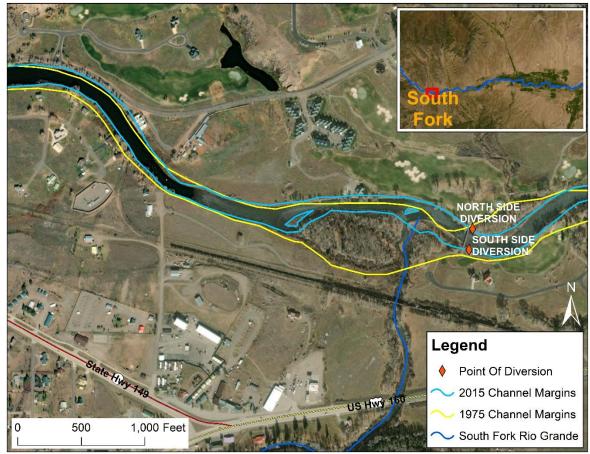
North and South Side Diversions with 1975 and 2015 channel margins overlaid.

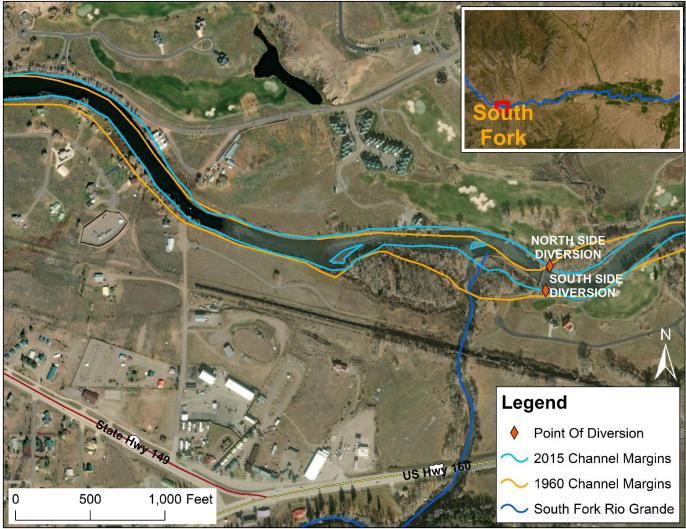
North and South Side Diversions with channel margins from 1960 and 2015 overlaid.
