## RIO GRANDE DIVERSION INFRASTRUCTURE INVENTORY

Structure Name: OFF D
Reported By: Daniel Boyes
<b>Date:</b> April 9, 2019
Headgate Latitude Longitude Location: 37.67933333 -106.31195
Headgate Type: Manually operated 3' wide steel slide gate
Headgate A ☑ Diversion and A □ River Miles from North Condition: B □ Other Condition: B ☑ Channel Rio Grande Terminus (Point of Diversion):  F □ F □ 4.15 mi
Repair(s) or Improvement(s) Completed Since 2006: The headgate was replaced in 2017.
Structure Description: Channel migration analysis shows the river is stable in the area immediately surrounding this structure. A concrete and rock diversion dam spans the river channel just downstream of the structure, directing water to a short feeder channel and the headgate, which sits along the south bank of the Rio Grande. The diversion functions moderately well but has washed out during previous high flow events and is a maintenance need for water users. A wire fence serves as a trash rack at the entrance of the feeder channel.  Repair(s) or Improvement(s) Currently Needed: Given the diversion dam maintenance need, the SMP Technical Advisory Team (TAT) recommends improving or replacing the diversio

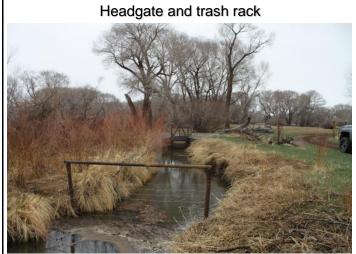
Headgate looking downstream
