RIO GRANDE DIVERSION INFRASTRUCTURE INVENTORY

Structure Name: PACE D

Date: April 1, 2019

PACE DITCH

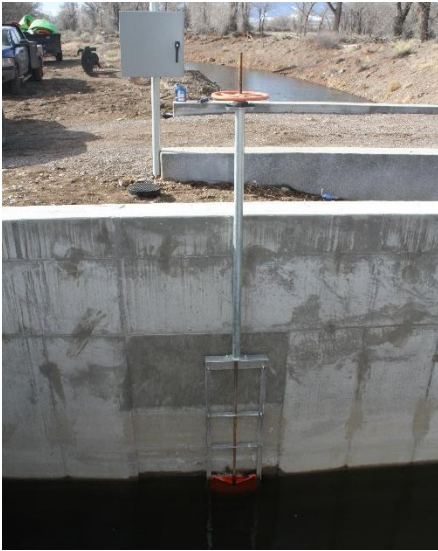
Headgate Condition:	A <input checked="" type="checkbox"/>	Diversion and Other Condition:	A <input type="checkbox"/>	River Miles from New Mexico State Line (Point of Diversion):	Structure Submerged:	Yes <input type="checkbox"/>
	B <input type="checkbox"/>		B <input type="checkbox"/>	89.38 mi	No <input checked="" type="checkbox"/>	
	C <input type="checkbox"/>		C <input checked="" type="checkbox"/>			
	D <input type="checkbox"/>		D <input type="checkbox"/>			
	F <input type="checkbox"/>		F <input type="checkbox"/>

Headgate looking downstream

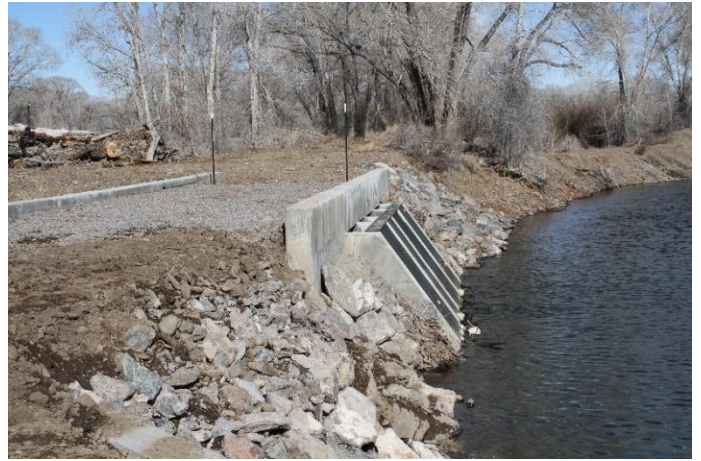
Trash rack looking upstream

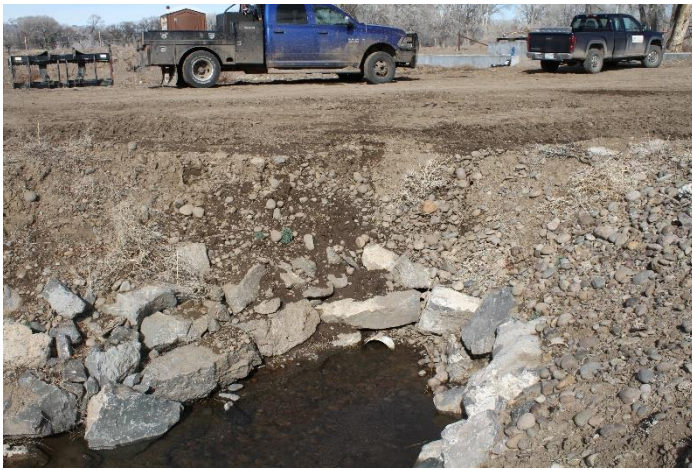
Headgate outlet

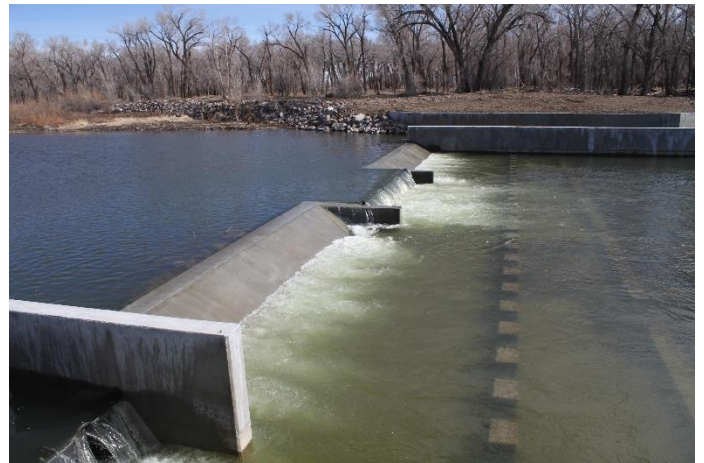
Repair(s) or Improvement(s) Completed Since 2006: As part of the Five Ditches Project, the headgate and diversion dam were replaced in partnership with the NRCS, RGHRP, and the ditch company. The headgate and trash rack were completed Spring 2018, and the diversion dam structure was completed Spring 2019. They now function well.

Diversion dam

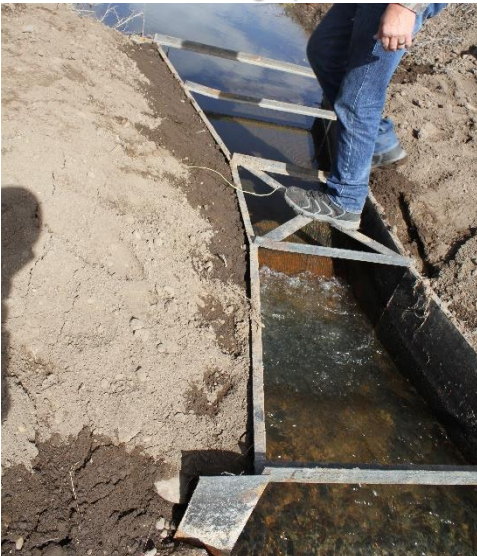
Repair(s) or Improvement(s) Currently Needed: The ditch's flume can get submerged during high flow. The SMP Technical Advisory Team (TAT) recommends lifting and resetting the flume. Although this may not be possible, if the ditch upstream of flume had more elevation change, the flume would function significantly better.

Flume looking upstream

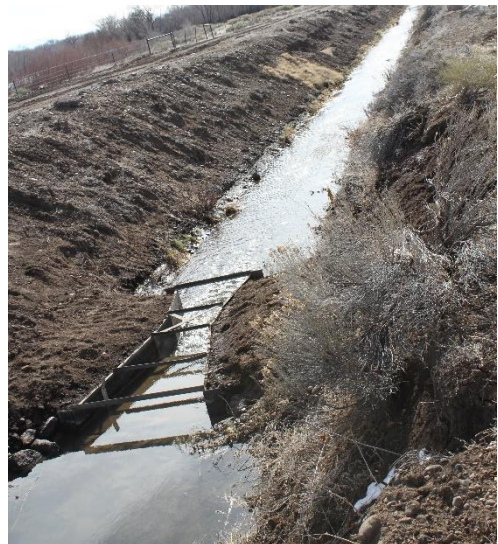
Flume looking downstream

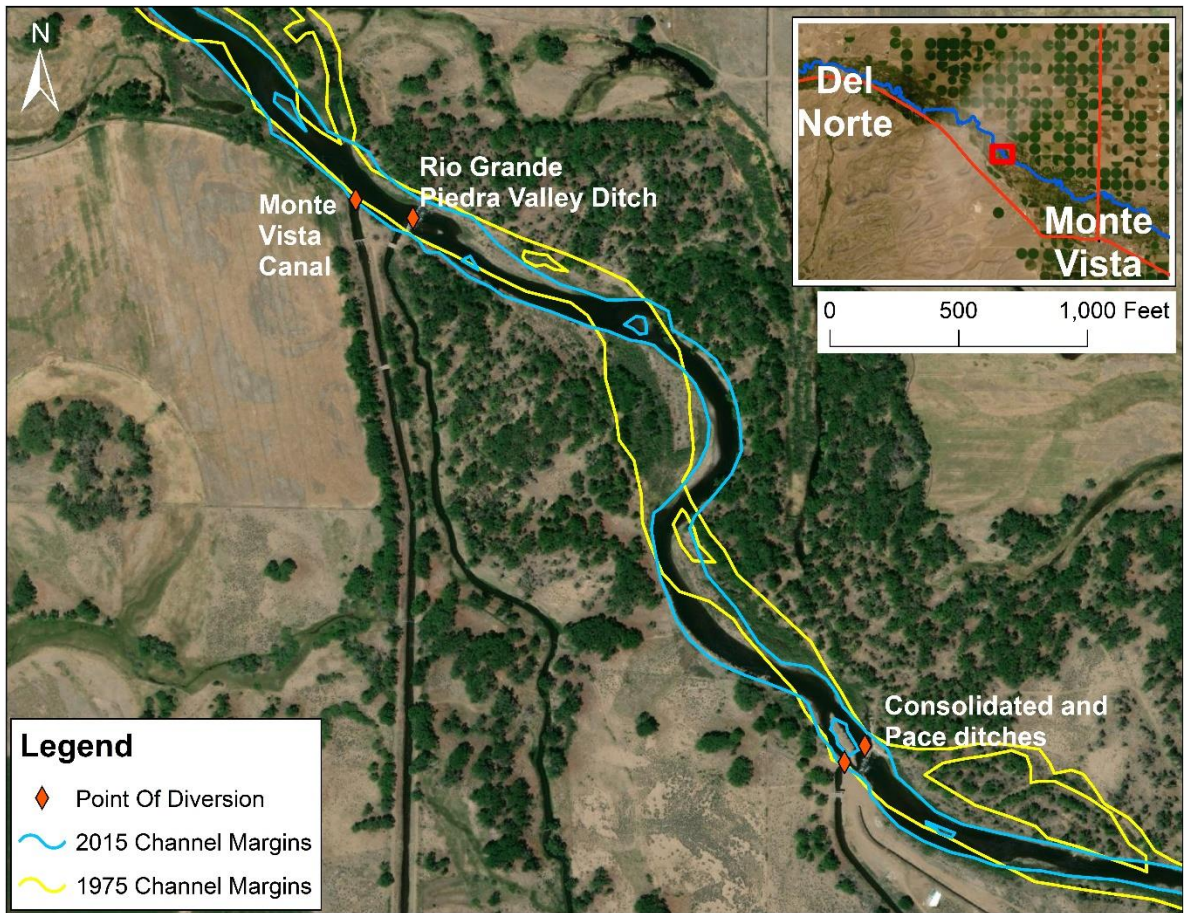
Structure Description: This ditch shares a diversion dam and headworks with the Consolidated Ditch. Within the last 35 years, the river has migrated significantly in this area, especially upstream of the diversion dam. The two meanders upstream of the diversion have been growing and changing the orientation of the river where it meets the diversion dam. A brand new large concrete diversion dam spans the river and directs water to the headgate. On the south bank of the river, a radial sluice gate was installed that can be adjusted using an air bladder. On the north side of the diversion, a large fish ladder was installed. In the center of the diversion sits an additional adjustable Obermeyer gate. A trash rack is at the entrance to the ditch, with the headgates located just below. This structure allows for boat and fish passage and, after construction was completed, bank and riparian habitat was restored using rock structures and riparian vegetation plantings. This structure serves 8 ditches, including Marajo Ditch, John Anderson Ditch, Star Ditch, Rio Grande San Luis Ditch, Rio Grande Lariat Ditch, Anderson Ditch, Atencio Ditch, and Horner Ydren Ditch.

Consolidated Ditch diversion dam with 1975 and 2015 channel margins overlaid. This map also shows the gravel bar upstream of the diversion (outlined in blue).

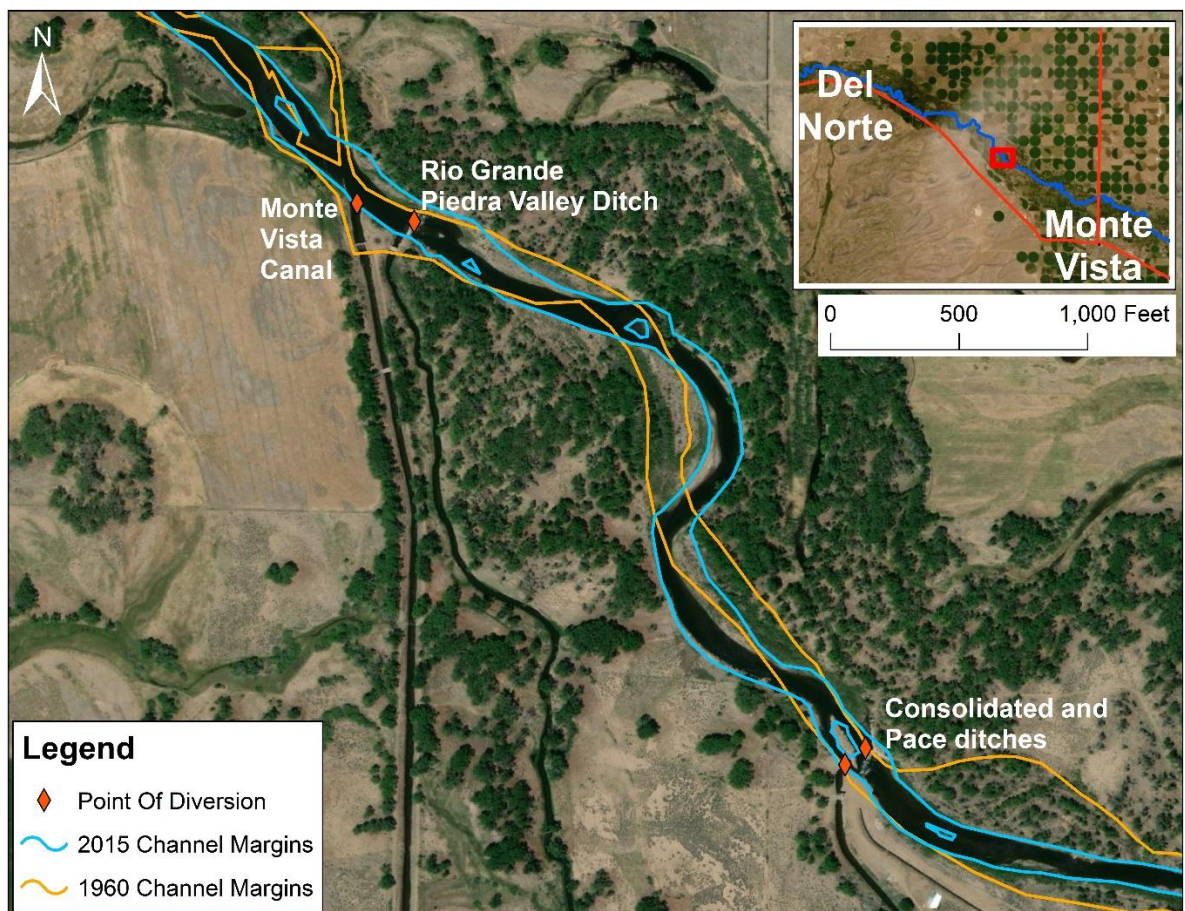
Consolidated Ditch diversion dam with 1960 and 2015 channel margins overlaid
