RIO GRANDE DIVERSION INFRASTRUCTURE INVENTORY

Structure Name: PARK GREEN D

PARK GREEN DITCH

Rio Grande Stream
Management Plan

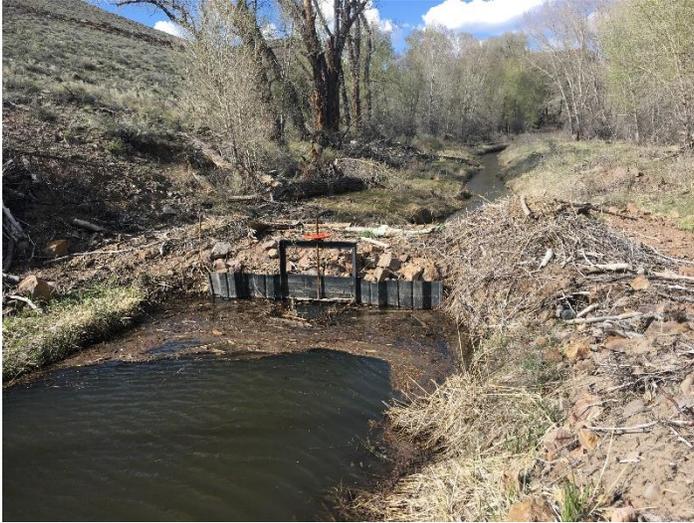
Headgate looking downstream

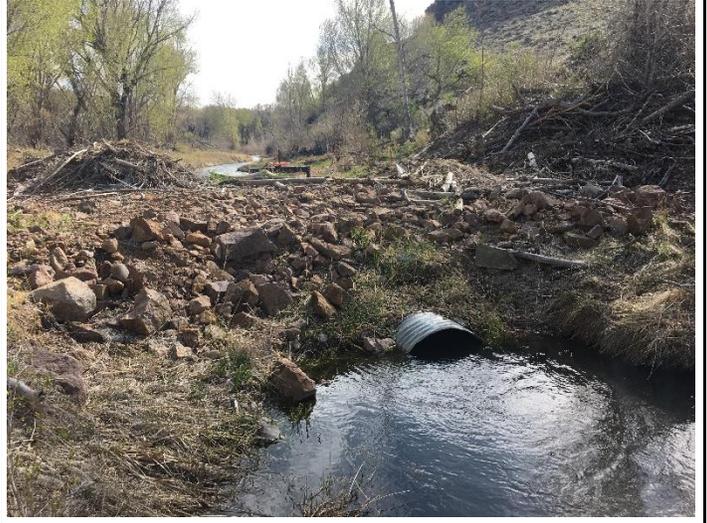
Headgate outlet

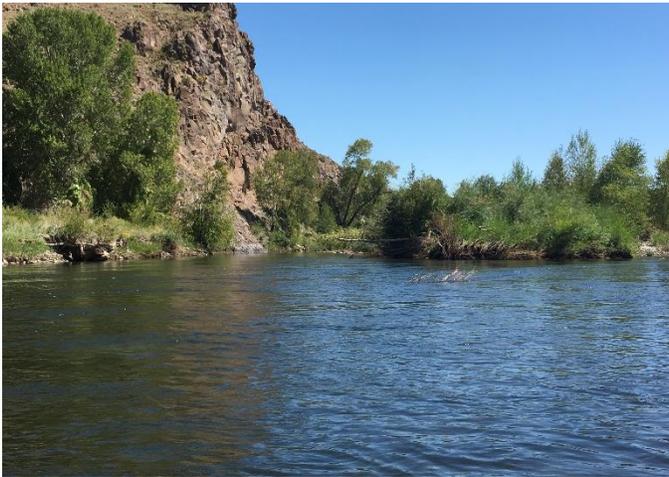
Structure Description: A small feeder channel on the north bank of the Rio Grande diverts water to the headgate. The feeder channel is approximately 0.2 miles long. There is no formal diversion dam, but the point of diversion is located at the apex of a meander and flows naturally enter the feeder channel. The feeder channel flows between a gravel bar to the south and a bedrock feature to the north. Due to its location, this structure experiences debris and sediment accumulation which has resulted in significantly reduced capacity. This ditch has difficulty diverting during low flows due to the lack of a diversion and during high flows due to limited feeder channel capacity.

Diversion and feeder channel entrance

Repair(s) or Improvement(s) Currently Needed: The SMP Technical Advisory Team (TAT) recommends installing a small but improved diversion dam and, because diversion relocation would be difficult, continued maintenance to remove debris and sediment in the feeder channel. A new diversion would allow the ditch to access water during low flows and sediment removal from the feeder channel would allow this structure to function at its full capacity.

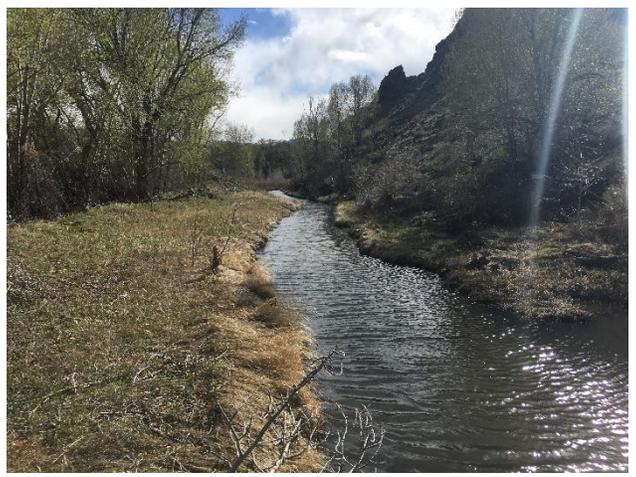
Feeder ditch looking upstream

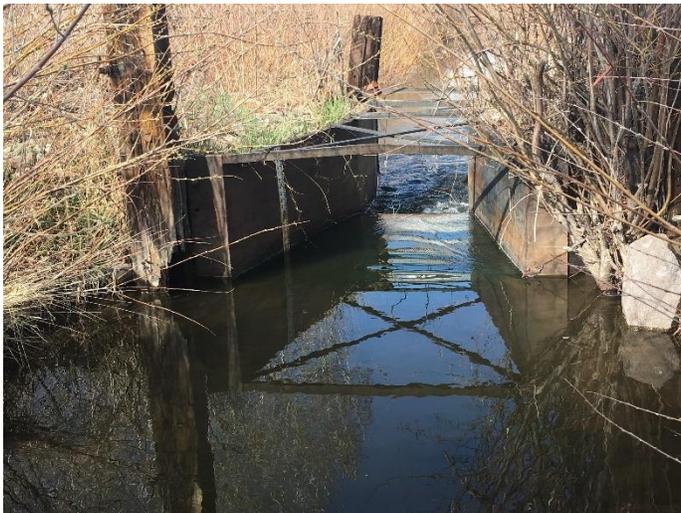
Flume looking downstream

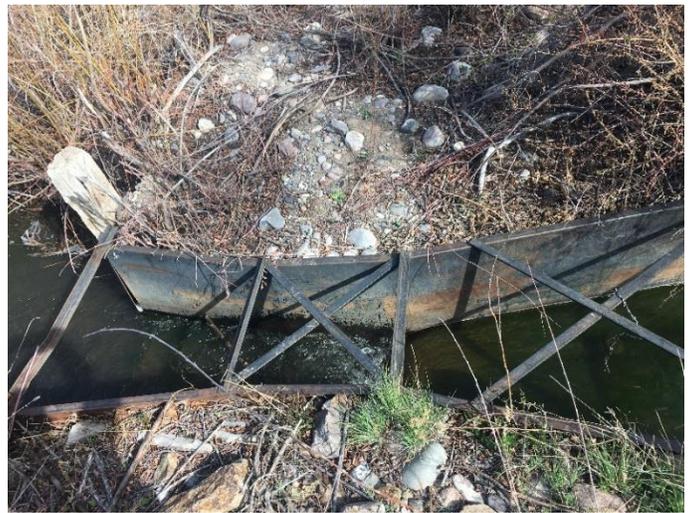
Zoomed image of flume

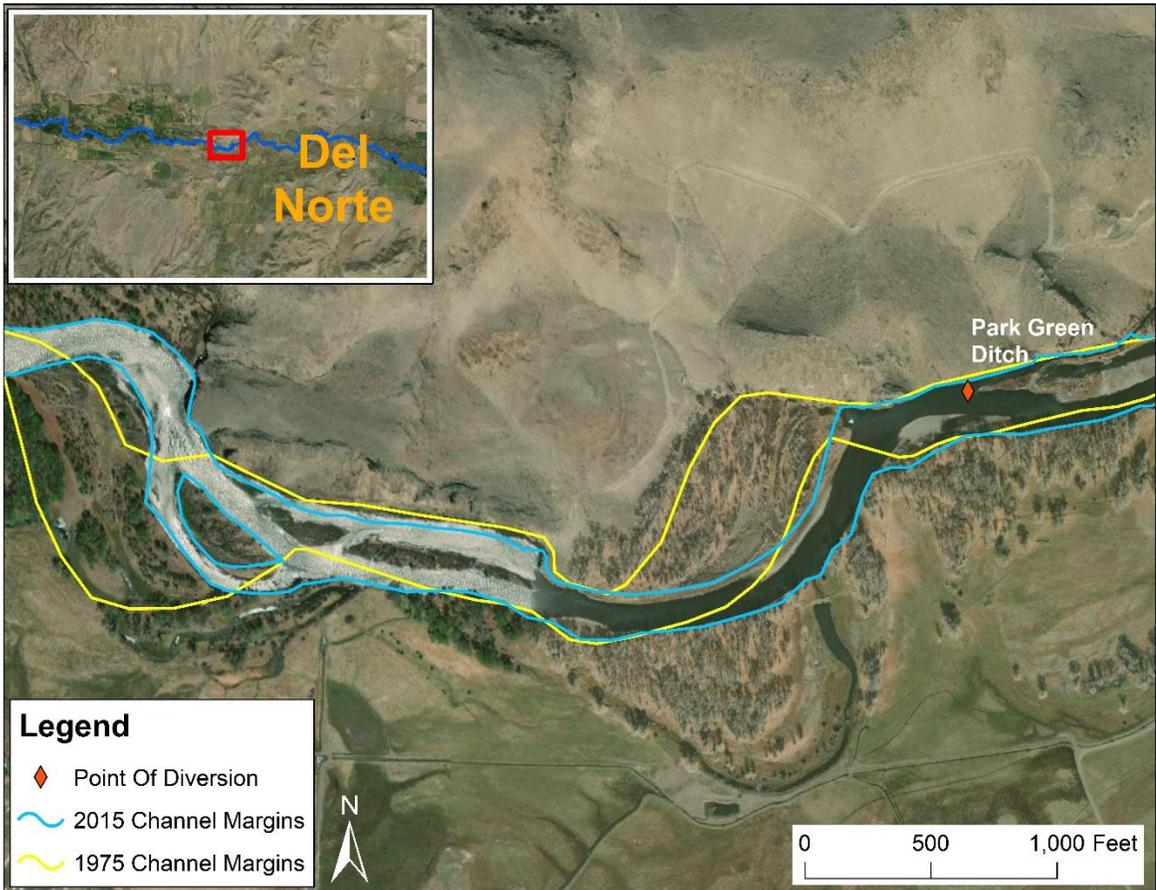
Point of diversion and headgate with 1975 to 2015 channel margins overlaid

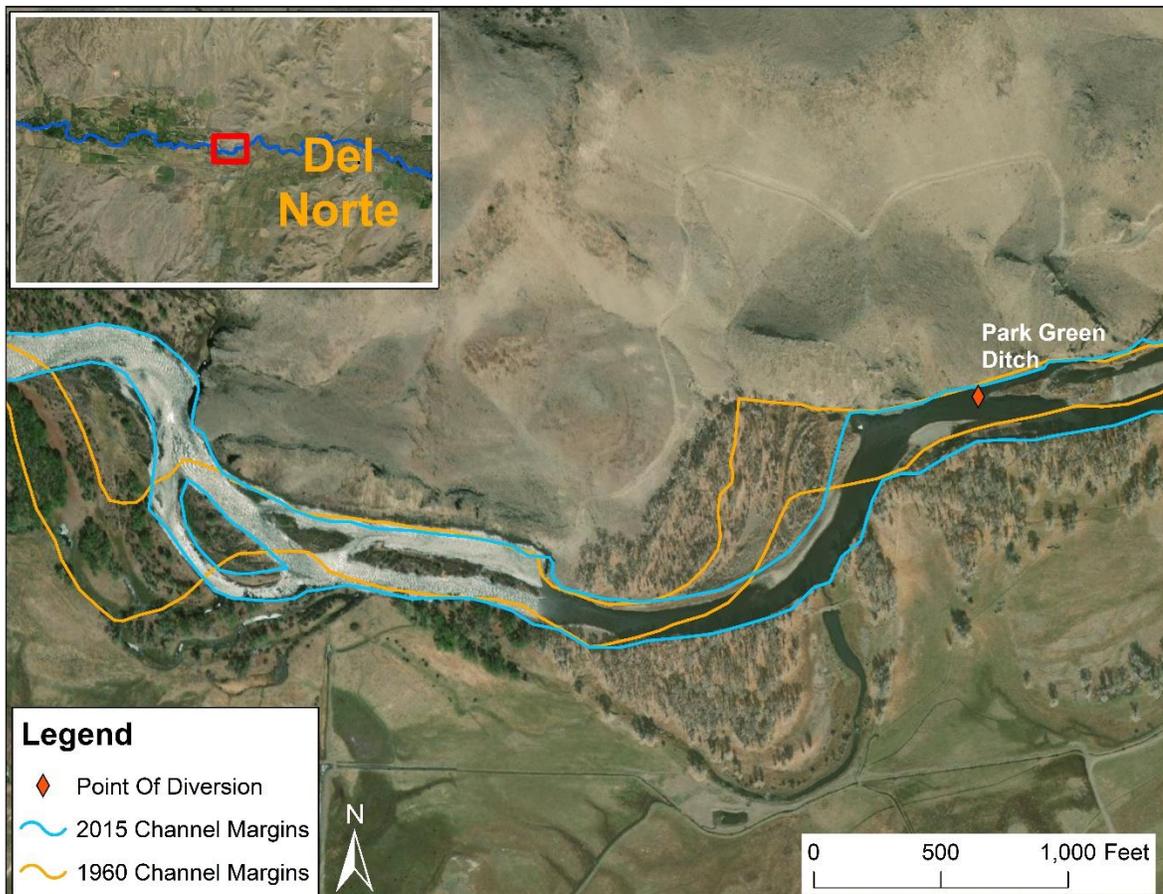
Point of diversion and headgate with 1960 to 2015 channel margins overlaid
