RIO GRANDE DIVERSION INFRASTRUCTURE INVENTORY

Structure Name: PFEIFFER D

PFEIFFER DITCH

Rio Grande Stream Management Plan

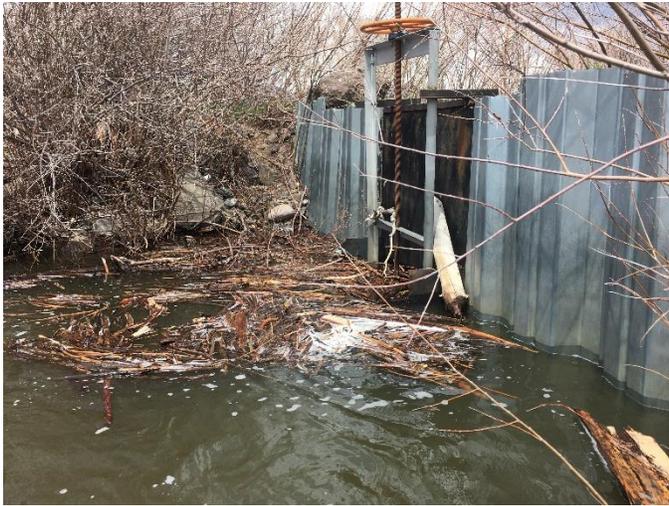
River headgate

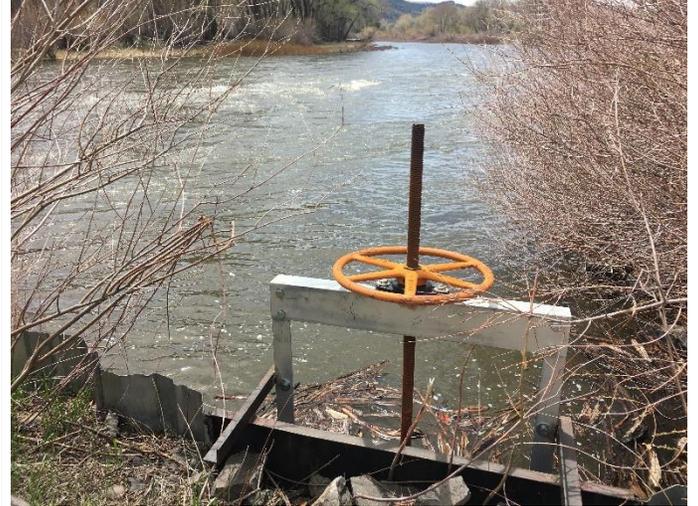
River headgate and diversion dam

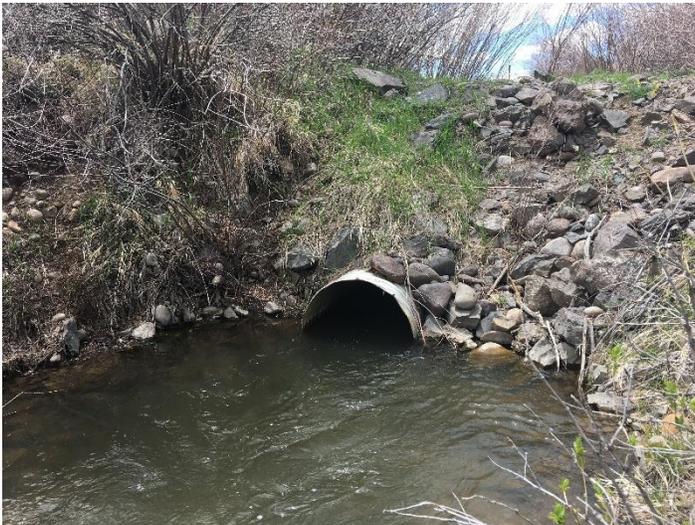
River headgate outlet

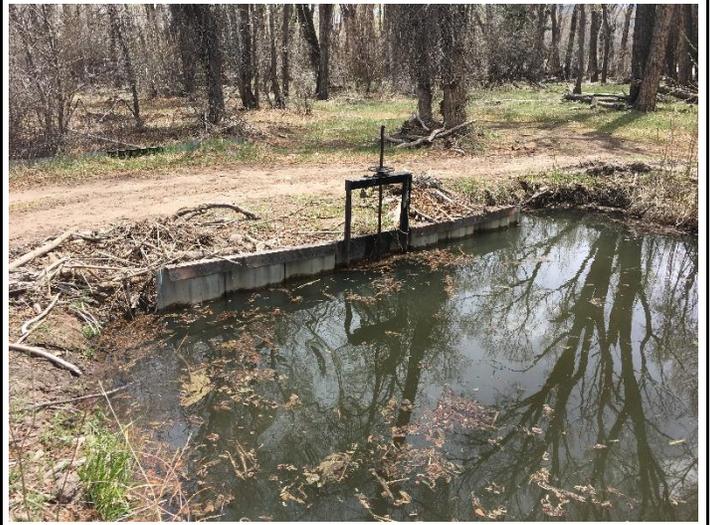
Repair(s) or Improvement(s) Currently Needed: The main issues facing this structure are sedimentation in the feeder channel, woody debris in the feeder channel and at the main headgate, and, to a lesser degree, difficulty diverting the ditch's water rights during low flow conditions. The SMP Technical Advisory Team (TAT) recommends mitigating sedimentation, installing a trash rack at the headgate, and considering the installation of a diversion dam. A sluice gate at the river headgate would reduce sedimentation and a trash rack at the main headgate would prevent debris accumulation. Although the ditch only has difficulty diverting at extremely low flows, the construction of a small diversion would allow the ditch to divert at all flows.

Main headgate

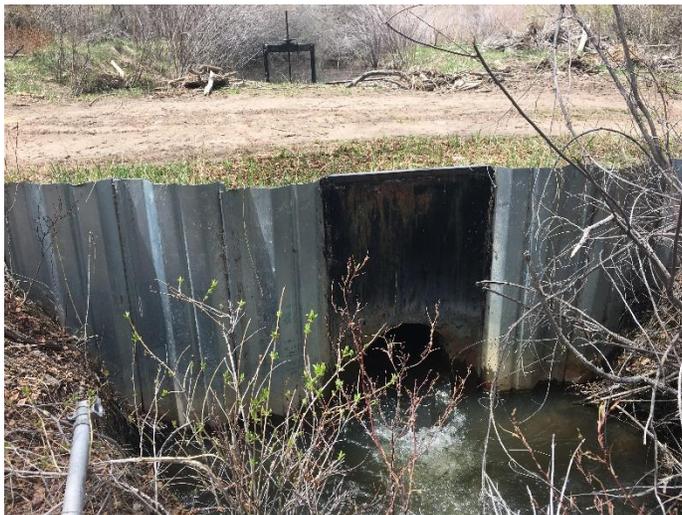
Main headgate outlet

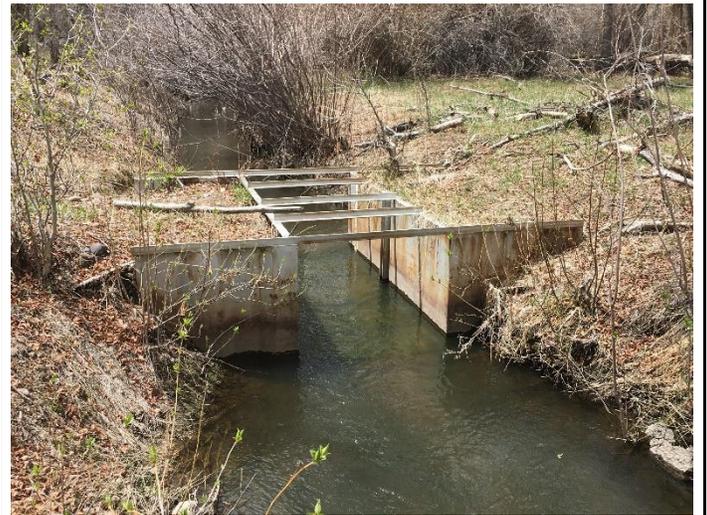
Flume looking upstream
