RIO GRANDE DIVERSION INFRASTRUCTURE INVENTORY

Structure Name: RABER D

Date: April 9, 2019

RABER DITCH

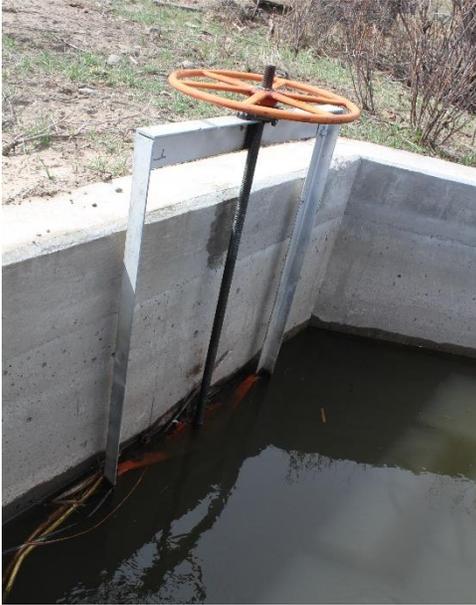
Headgate looking downstream

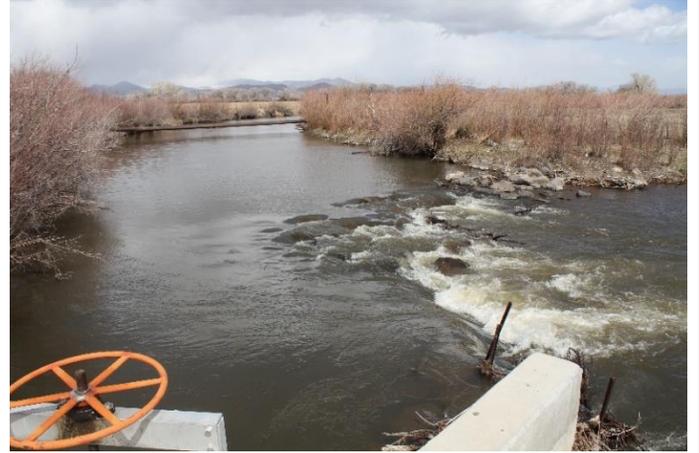
Headgate and diversion dam

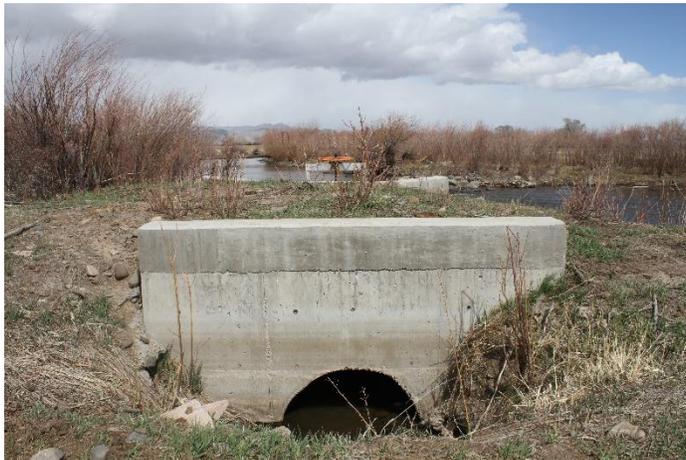
Headgate outlet

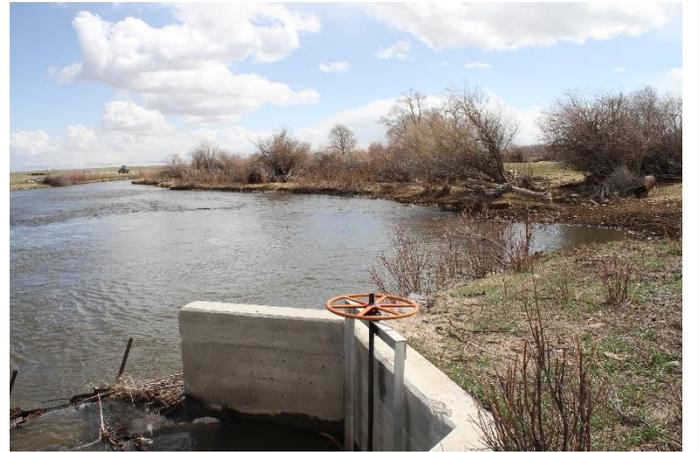
Headgate and channel looking downstream

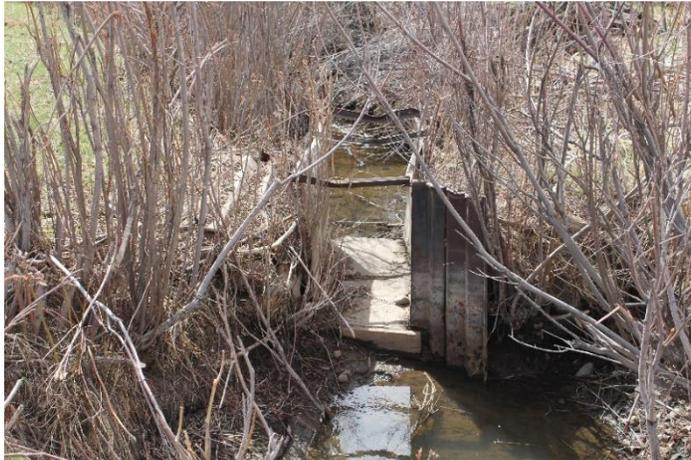
Repair(s) or Improvement(s) Currently Needed: The diversion dam functions well and no immediate need for improvement was identified. The flume is aging and the SMP Technical Advisory Team (TAT) recommends replacing it in the near future.

Flume looking downstream

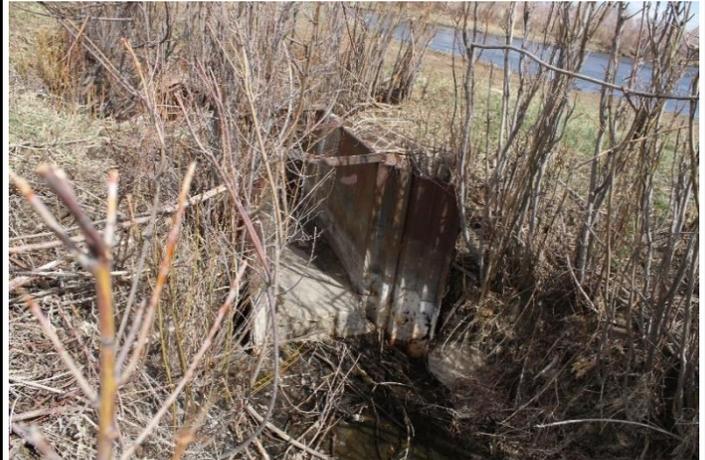
Flume looking upstream
