## RIO GRANDE DIVERSION INFRASTRUCTURE INVENTORY

me: RIVIERE ESTA		ATION PLAN	
Reported By:	: Daniel Boyes			
Date: April 7,	2019			
Headgate Location:	<b>Latitude</b> 37.67625	<b>Longitude</b> -106.62055		
Headgate Ty	rpe: Manually opera	ated 1.5' wide stee	el slide gate	
Headgate Condition:	A Diversion B Other Co C D D D F D	n and A □ condition: B ⋈ C □ D □ F □	River Miles from New Mexico State Line (Point of Diversion): 119.63 mi	Structure Yes ⊠ Submerged: No □
to the headga front of the he assess chann	te. A log trash boor adgate. The boom el migration indicat	n across the feed appears to be fun e the channel has	dam directs water to a short er channel prevents debrist actioning well. Historic aerials remained relatively stable ers water to two ponds ins	from accumulating in al photographs used to since 1960 (see maps
	mprovement(s) Contact the contact that t		There were no major issu	es identified at this
Comments:	This structure opera	ites under augme	ntation plan 2002037.

RIVIERE ESTATES AUGMENTATION PLAN

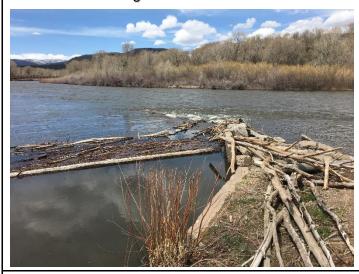
Flume looking downstream

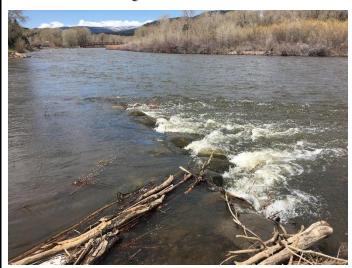
Flume looking upstream

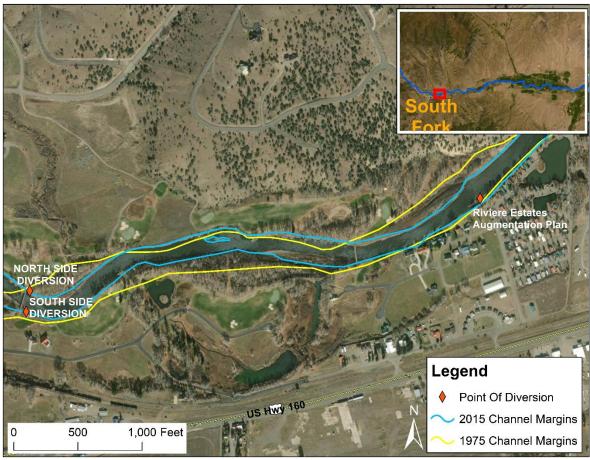
Map of headgate location with 1975 and 2015 channel margins overlaid.

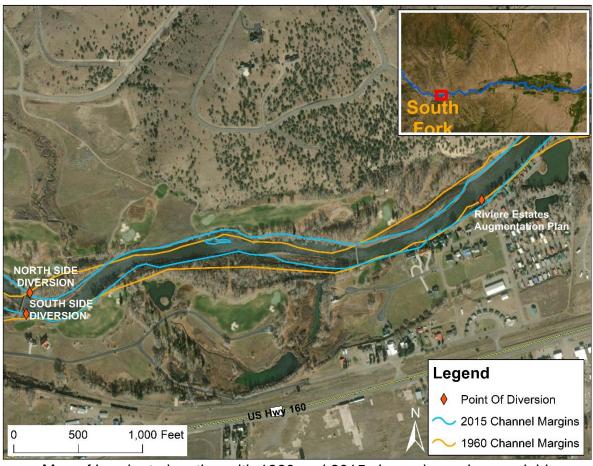
Map of headgate location with 1960 and 2015 channel margins overlaid.
