# RIO GRANDE DIVERSION INFRASTRUCTURE INVENTORY

**Structure Name:** SAN JOSE OR LUCERO D

**Reported By:** Daniel Boyes

**Date:** April 1, 2019

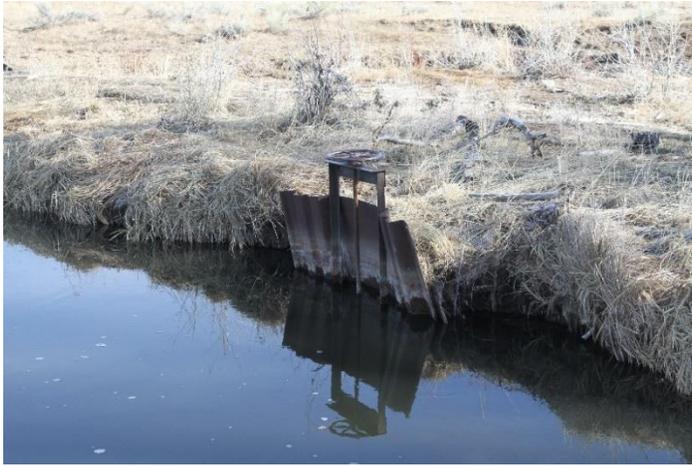
Headgate looking downstream

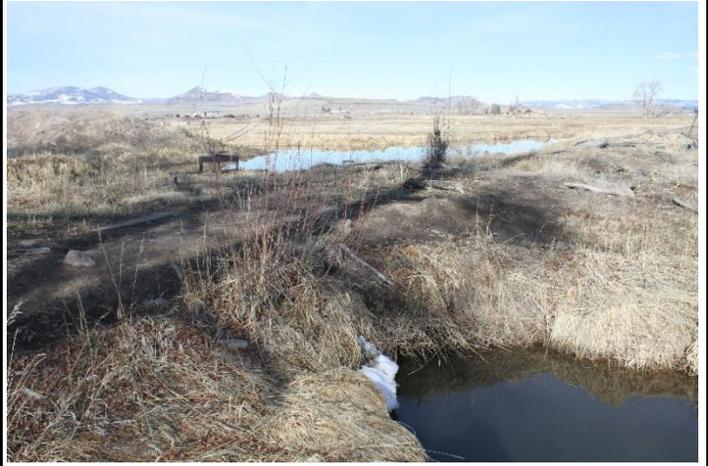
Headgate outlet

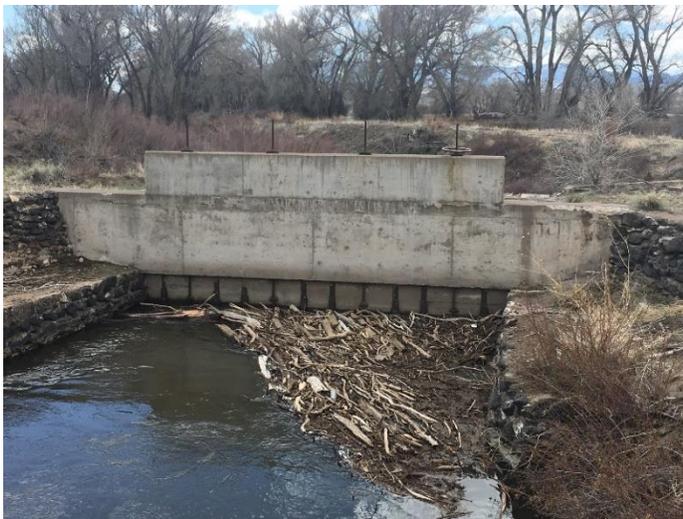
River headgate

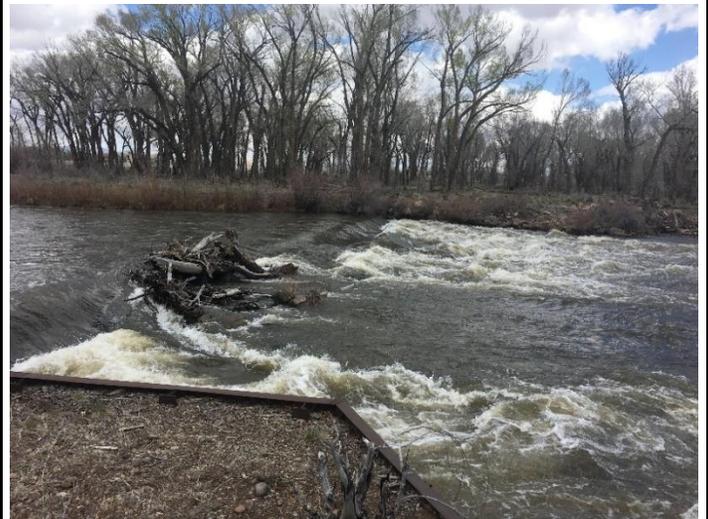
Diversion dam on Rio Grande

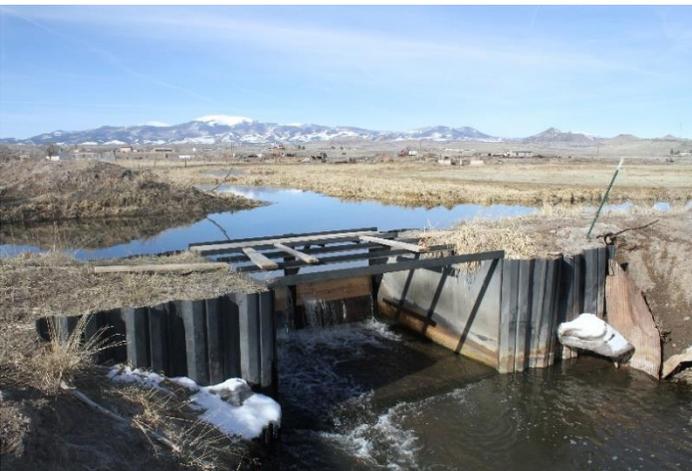
Return flow structure on feeder ditch

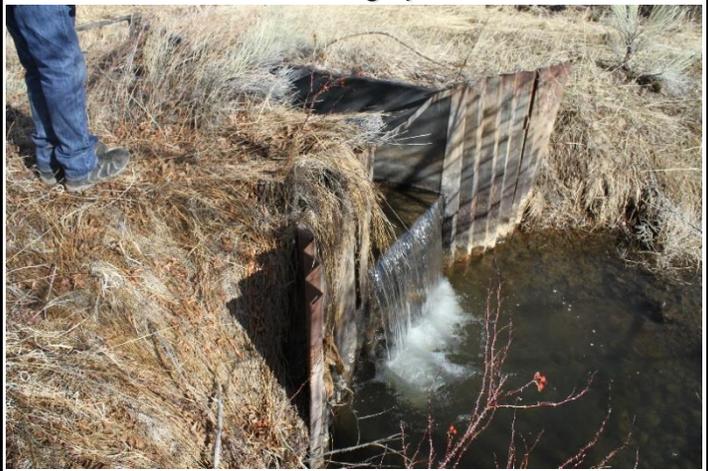
Flume looking upstream

**Repair(s) or Improvement(s) Currently Needed:** For a description and recommendations related to the diversion, refer to the Monte Vista Canal as they share a diversion. The Rio Grande Piedra Valley Ditch main headgate serves as the diversion dam for this structure, located approximately 1.1 miles down the feeder channel. The main headgate functions well. The flume has heaved and downstream erosion is occurring. The SMP Technical Advisory Team (TAT) recommends flume replacement to maintain long-term measurement accuracy and efficiency.
