RIO GRANDE DIVERSION INFRASTRUCTURE INVENTORY

Structure Name: SAN JUAN D

Date: May 7, 2019

SAN JUAN DITCH

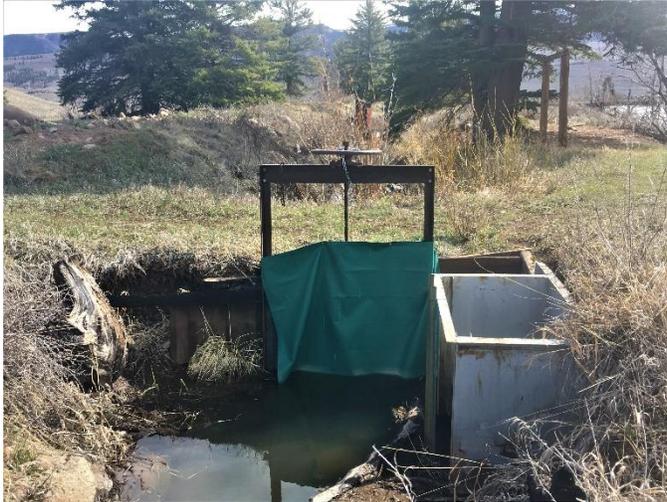
Headgate looking downstream

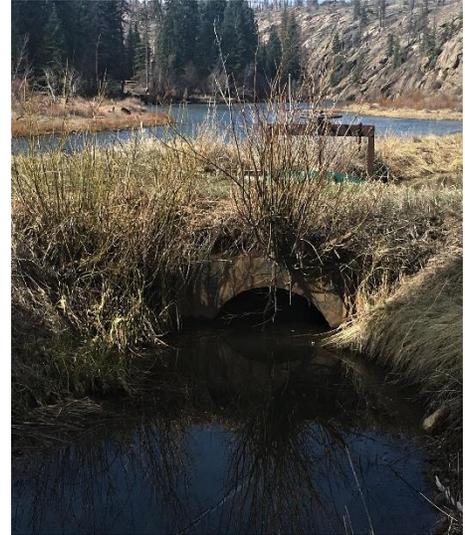
Headgate outlet

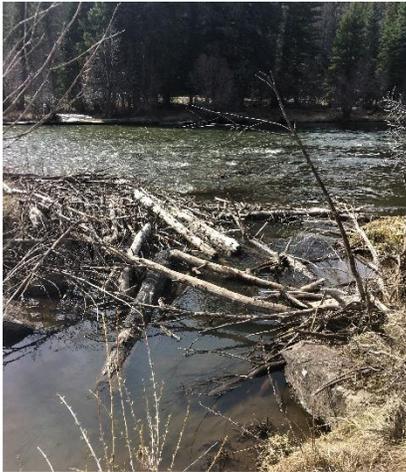
Diversion dam and feeder ditch

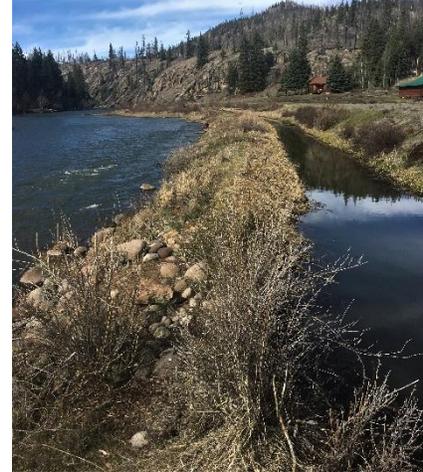
Feeder ditch looking upstream

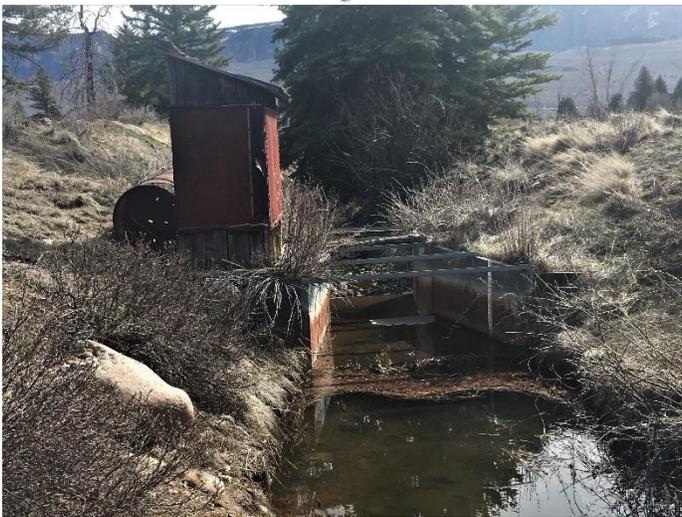
Repair(s) or Improvement(s) Currently Needed: No major issues were identified at this structure, however the flume is tilted and could be reset or replaced to improve measurement accuracy.

Flume looking downstream

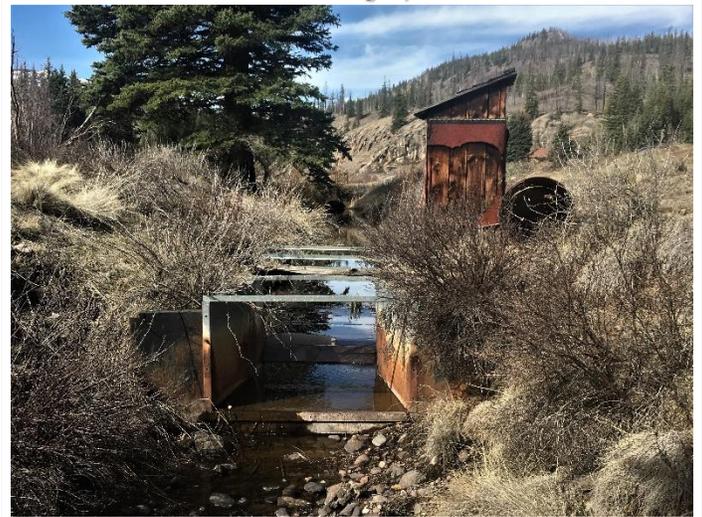
Flume looking upstream
