RIO GRANDE DIVERSION INFRASTRUCTURE INVENTORY

Structure Name: SCHUCH SCHMIDT D

Date: April 9, 2019

SCHUCH SCHMIDT DITCH

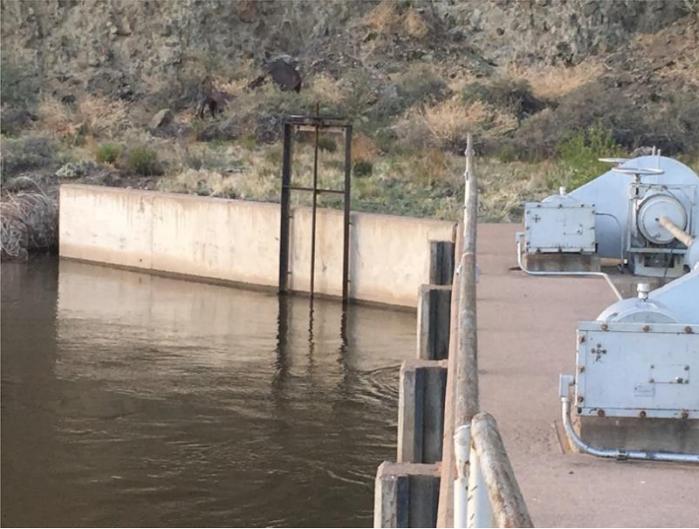
Repair(s) or Improvement(s) Currently Needed: The diversion dam functions well for this ditch, but the headgate leaks and the SMP Technical Advisory Team (TAT) recommends headgate repair.

Headgate looking downstream

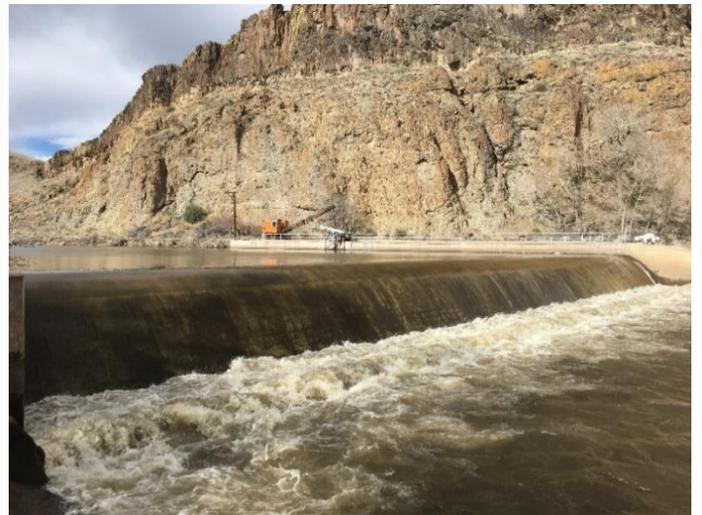
Diversion dam

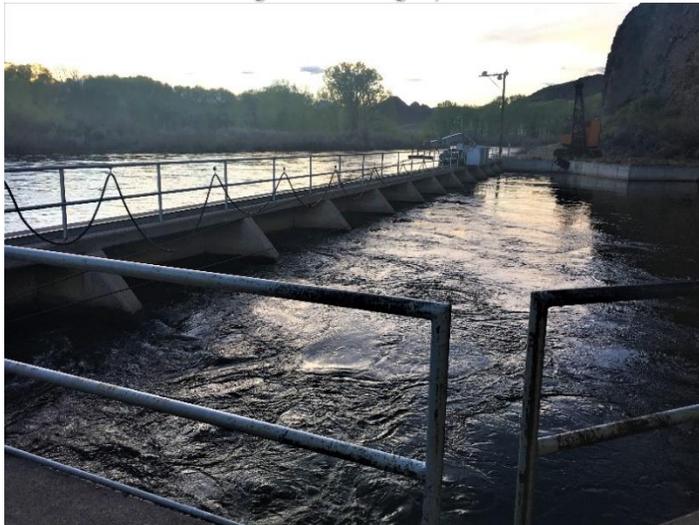
River headgate looking upstream

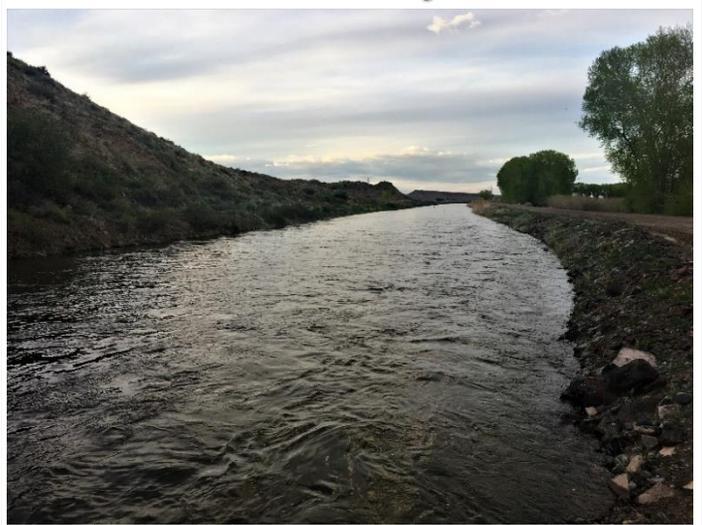
Rio Grande Canal looking downstream

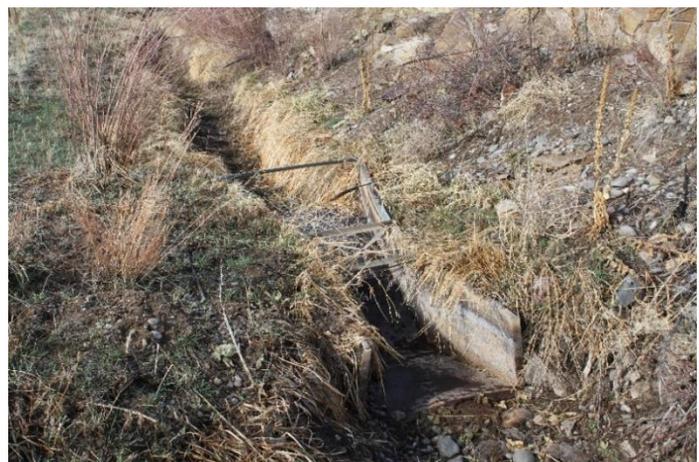
Flume looking upstream

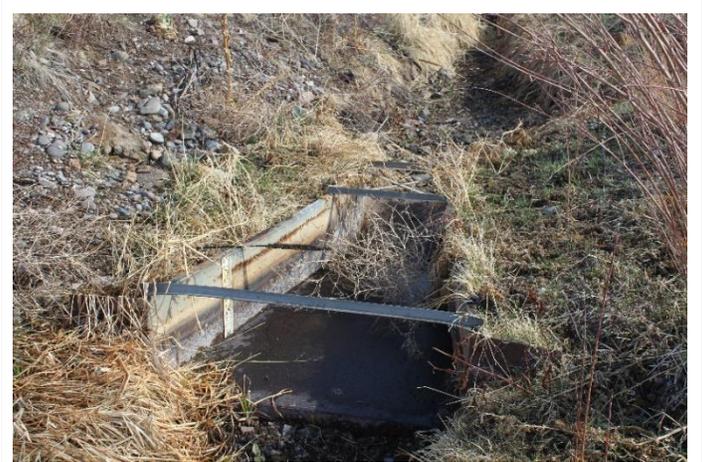
Flume looking downstream

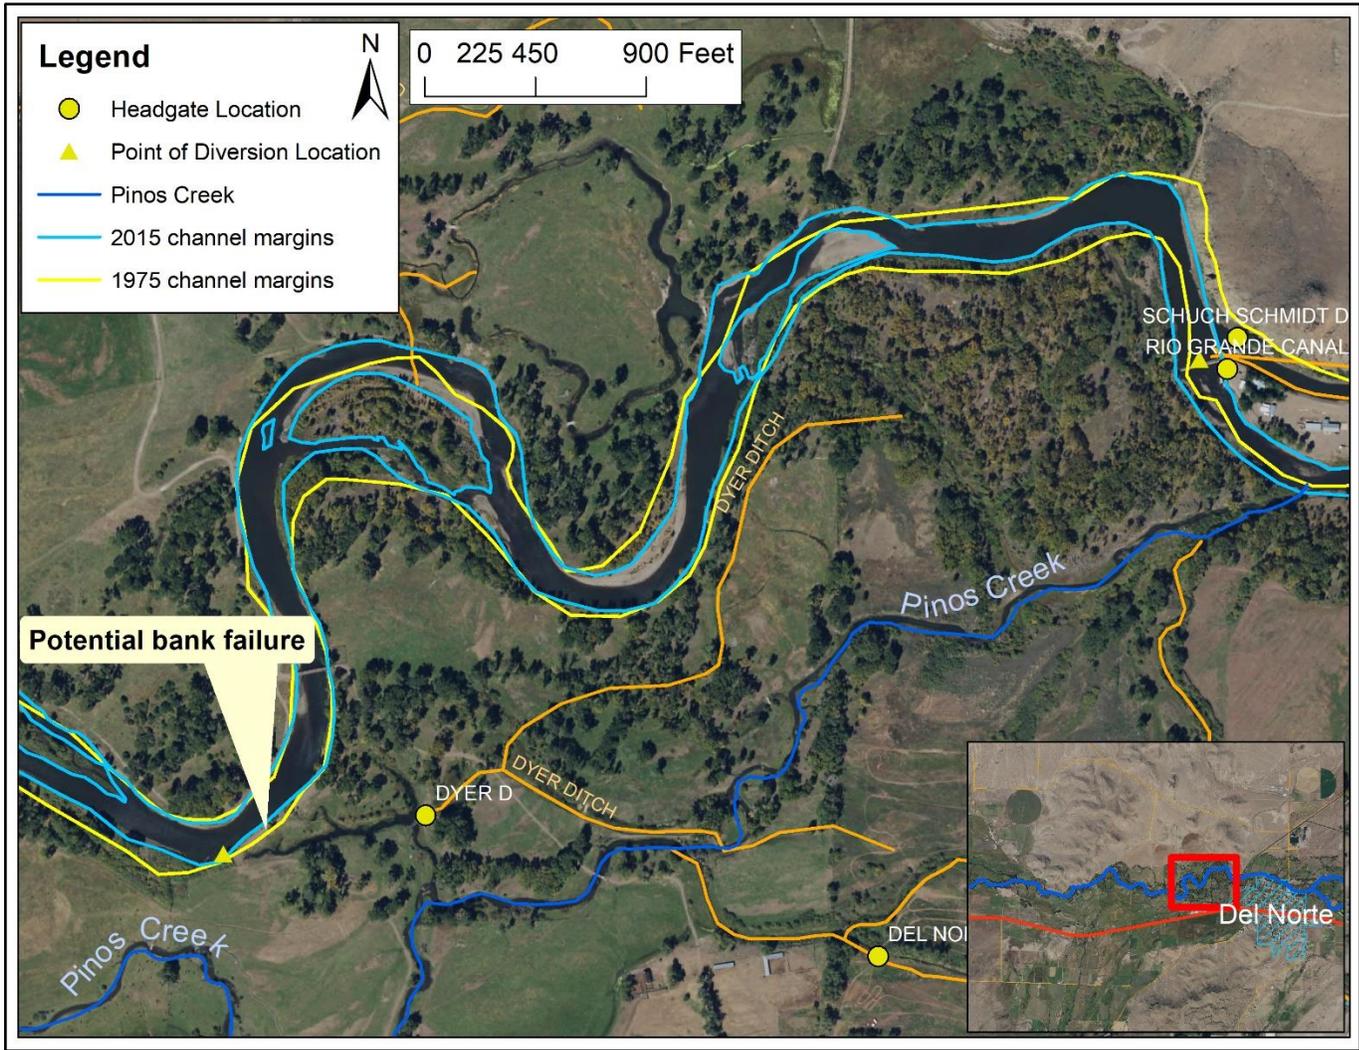
Structure Description: This structure shares a diversion with the Rio Grande Canal. The structure utilizes the same diversion dam and the headgate is located on the headwall of the Rio Grande Canal diversion structure. Water drains through a corrugated metal pipe underneath the hill to the north, and reaches the ditch approximately 0.25 miles northeast. The diversion dam functions well for this ditch, but the headgate leaks. The channel is very stable in the area immediately surrounding this structure's diversion, in part due to the bedrock control on the north bank of the river. However, approximately 1.5 miles upstream of the Rio Grande Canal diversion, near the Dyer Ditch diversion, there is potential for the river to jump the south bank and form a new channel, following Dyer Ditch and the Pinos Creek channel (see map below). If this occurs, the Rio Grande Canal would be bypassed and could pose a serious flooding risk to the Town of Del Norte.

Map showing potential bank failure and risk to Rio Grande Canal
