# RIO GRANDE DIVERSION INFRASTRUCTURE INVENTORY

**Structure Name:** SILVA D

**Date:** April 9, 2019

Rio Grande Stream Management Plan

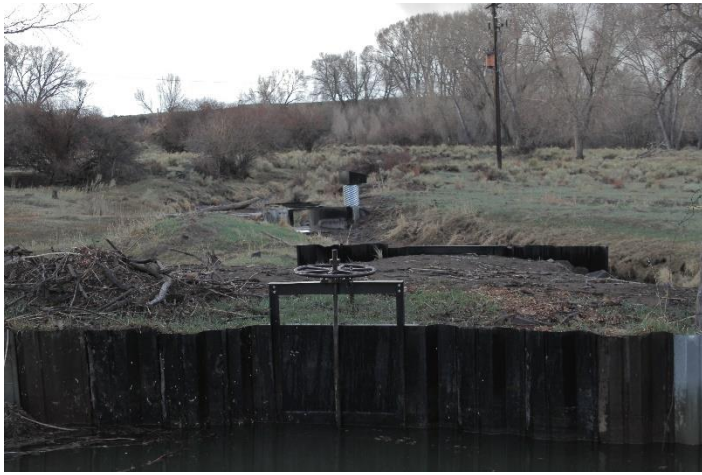
Headgate looking downstream

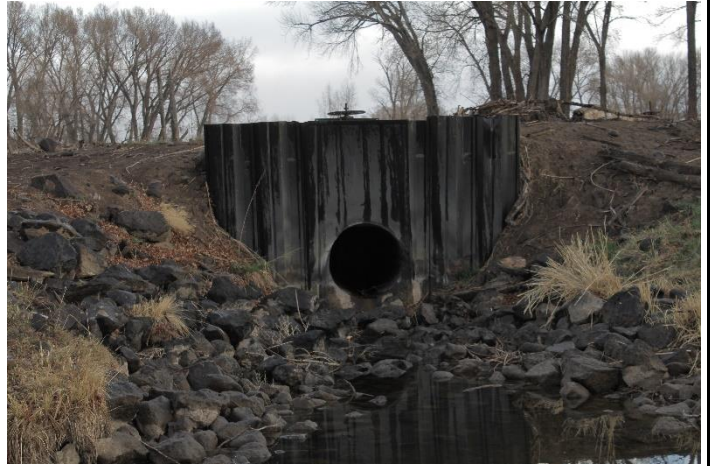
Headgate outlet

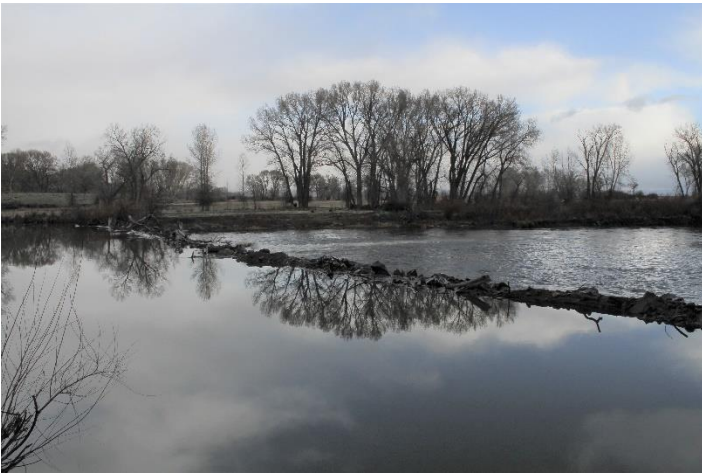
**Structure Description:** This ditch holds the #1 priority water right on the Rio Grande. The ditch shares a diversion dam and short feeder channel with the Atencio Ditch 2. The diversion dam is a stacked rock structure, which was recently supplemented with additional rock. Despite recent improvements, this diversion accumulates woody debris and sediment and is a significant maintenance challenge for water users. It is a hazard for recreational boaters and can also form a barrier to fish passage during low flow conditions. Water is directed to the headgate, located down a short feeder channel off the south bank of the Rio Grande. The headgate and flume were recently replaced and both function well. The channel both upstream and downstream of the diversion experiences lateral migration. Meanders have continued to grow over the last 40 years (see map in report card). However, migration at the diversion dam is limited due to bedrock control. A secondary channel begins approximately 0.9 miles upstream of the diversion and flows around the structure.

Diversion dam looking downstream

**Repair(s) or Improvement(s) Currently Needed:** Given the issues identified, the SMP Technical Advisory Team (TAT) recommends replacing the diversion dam. A new diversion could be designed to increase diversion and irrigation efficiencies, reduce maintenance, create fish and boat passage, and improve sediment and debris transport.

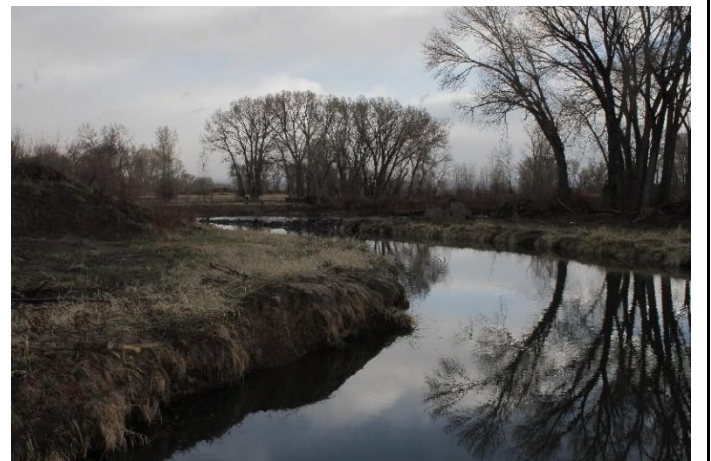
Feeder ditch (also serves Atencio Ditch #2)

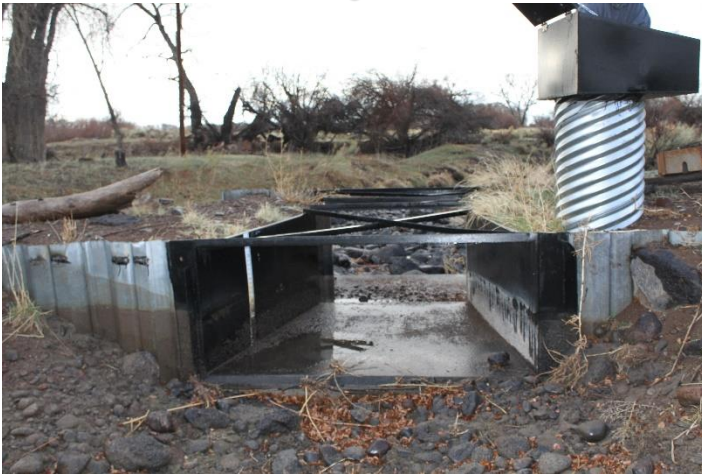
**Repair(s) or Improvement(s) Completed Since 2006:** The headgate was recently improved with new and extended wing walls. The flume was recently replaced and functions well.

Flume looking downstream

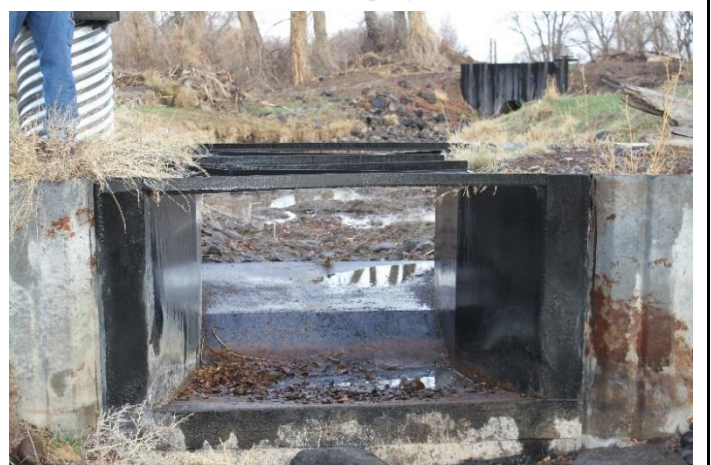
Flume looking upstream

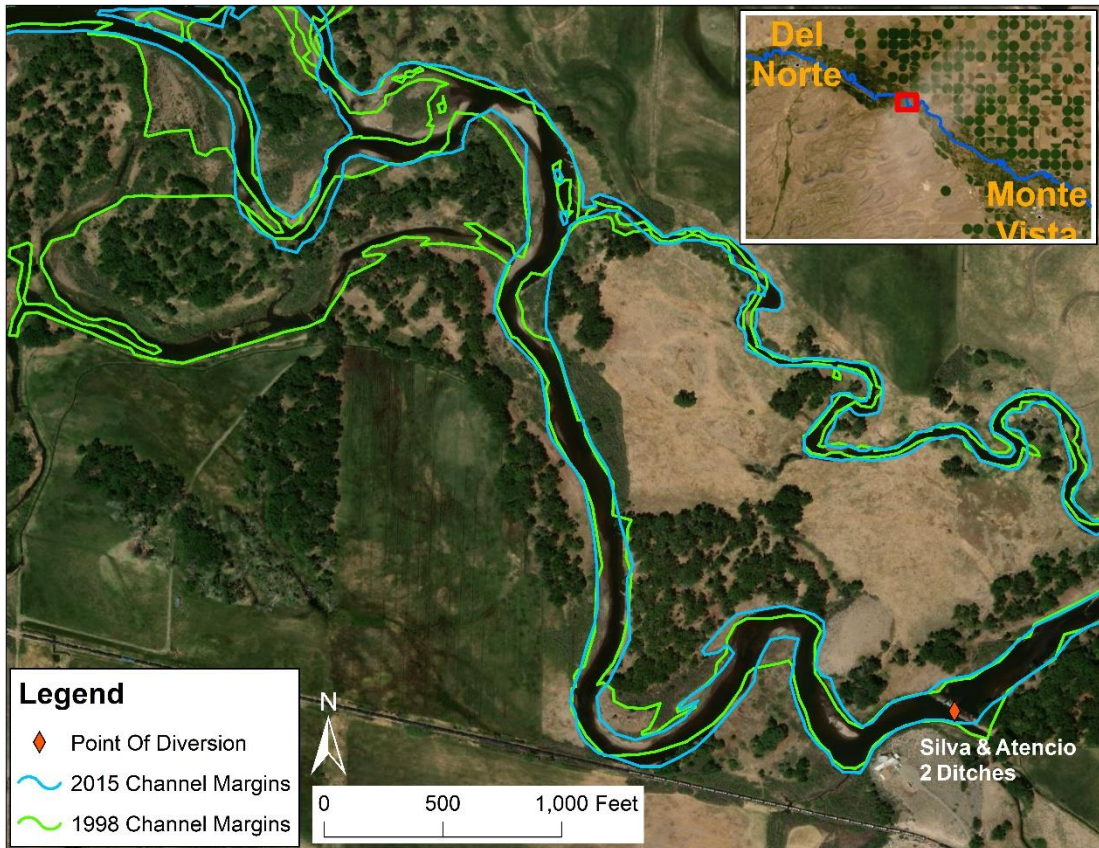
Silva Ditch point of diversion with 1998 and 2015 channel margins overlaid

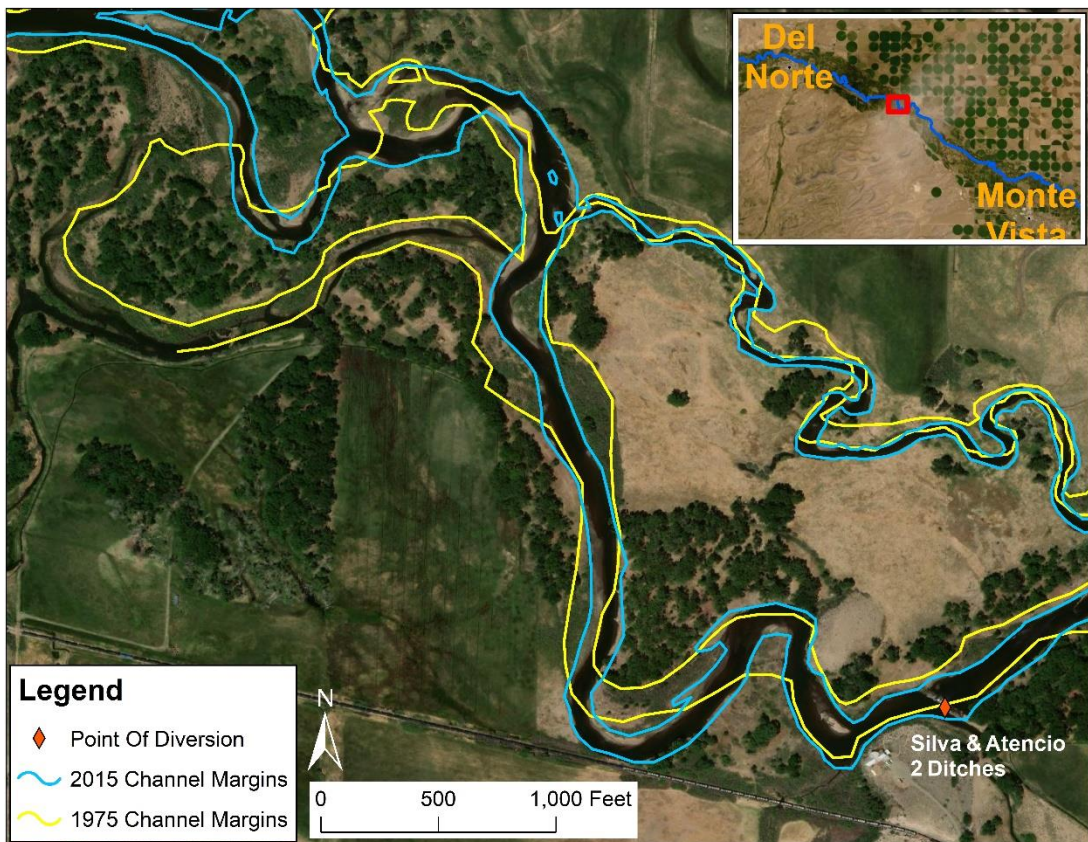
Silva Ditch point of diversion with 1975 and 2015 channel margins overlaid

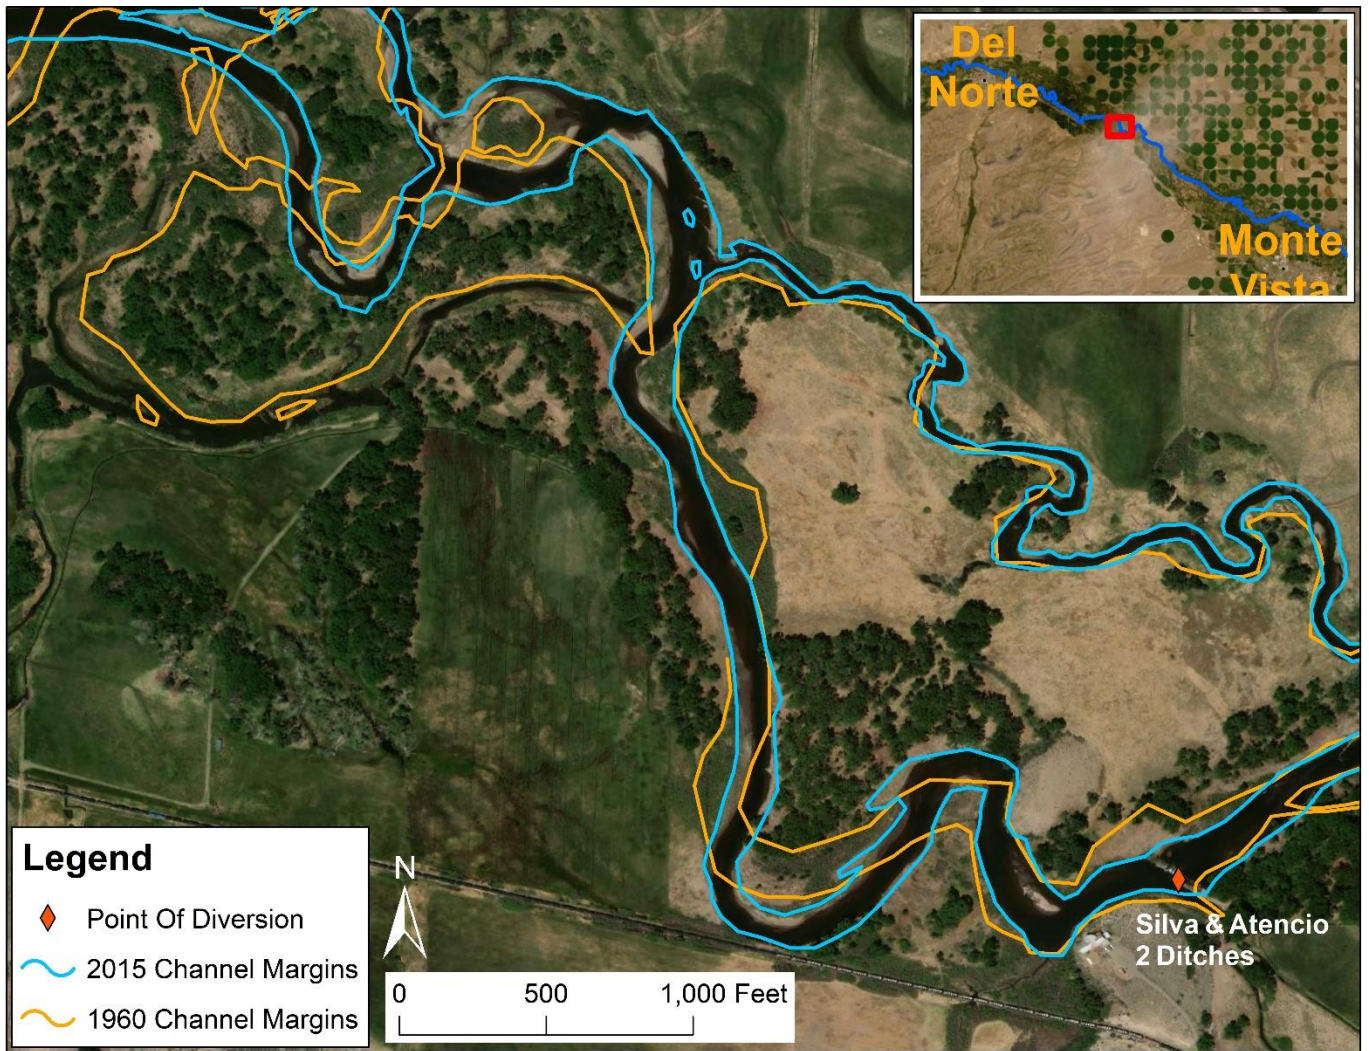
Silva Ditch point of diversion with 1960 and 2015 channel margins overlaid.
