## RIO GRANDE DIVERSION INFRASTRUCTURE INVENTORY

Structure Na	me: SOU	TH FORK HI	GHLIN	IE D		
Reported By	: Daniel E	Boyes				
Date: May 7,	2019					
Headgate Location:				<b>itude</b> 64203333	3	
Headgate Ty	<b>/pe:</b> Man	ually operated	d steel	slide gate	•	
Headgate Condition:	A □ B ⋈ C □ D □ F □	Diversion a Other Cond		A □ B □ C □ D ⋈ F □	River Miles from Rio Grande Confluence (Point of Diversion): 0.86 mi	Structure Yes ⊠ Submerged: No □
overall. A con	escription acrete dive	: This structuersion dam space head pres	re is lo cans the	cated on e river an	the South Fork Rio Gran d has semi-permanent m	de and functions effectively netal posts which support ocated on the east side of
Repair(s) or need to be re					he flume currently meas mage.	ures accurately but may
Comments:	This ditch	includes prio	rities 1	06, 184, 2	292, 307, 352, and 1916-	58.
Notes:

SOUTH FORK HIGHLINE DITCH
PHOTO LOG

Rio Grande Stream Management Plan

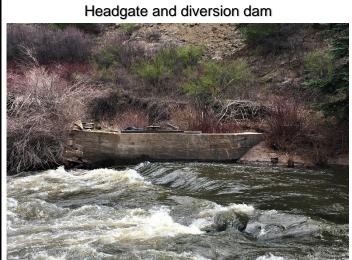
Headgate looking downstream

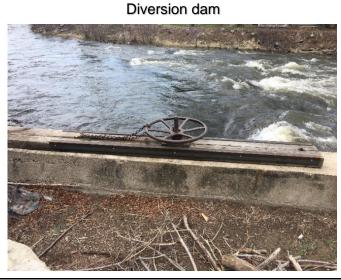
Headgate outlet
