## RIO GRANDE DIVERSION INFRASTRUCTURE INVENTORY

## Structure Name: SOUTH SIDE DIVERSION

Date: May 7, 2019

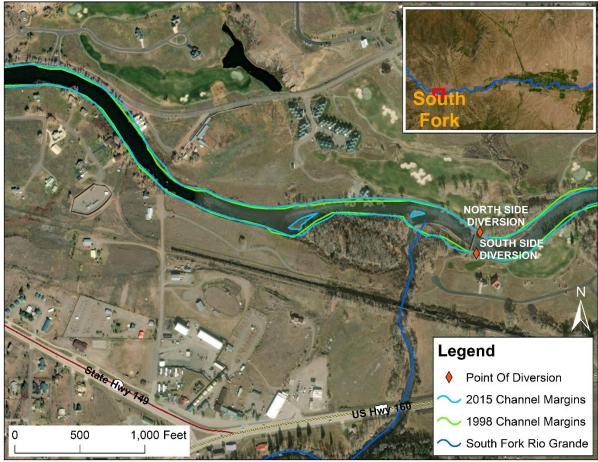
North and South Side Diversions with 1998 and 2015 channel margins overlaid.

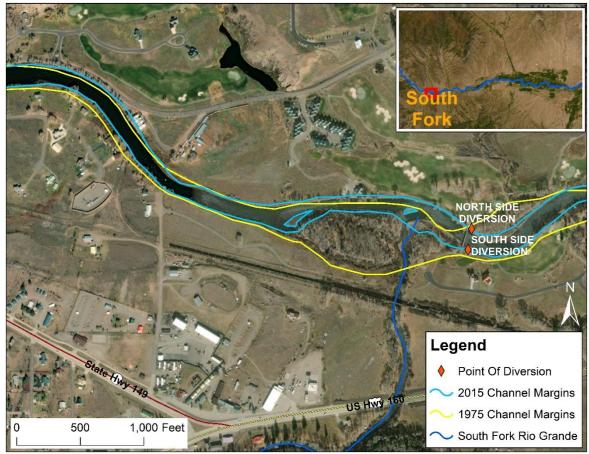
North and South Side Diversions with 1975 and 2015 channel margins overlaid.

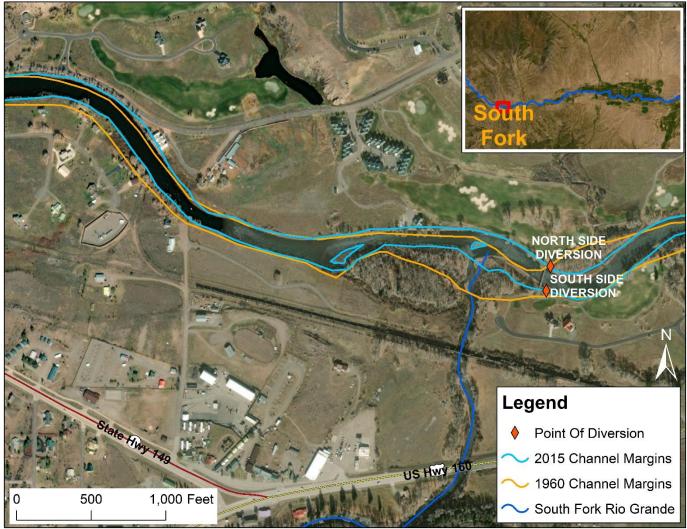
North and South Side Diversions with channel margins from 1960 and 2015 overlaid.
