# RIO GRANDE DIVERSION INFRASTRUCTURE INVENTORY

**Structure Name:** STAR D

STAR DITCH

PHOTO LOG

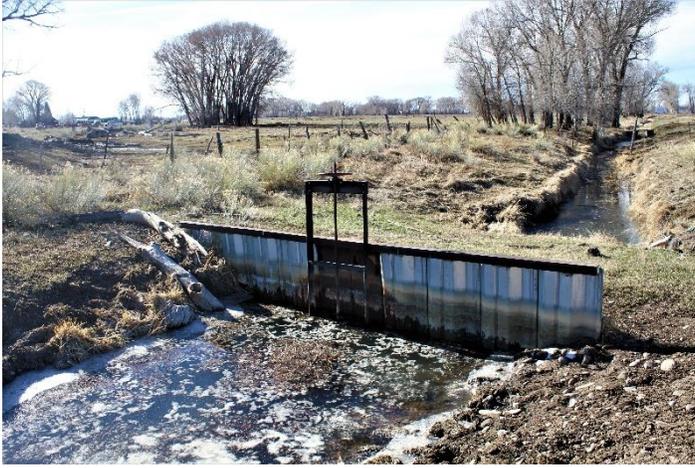
Headgate looking downstream

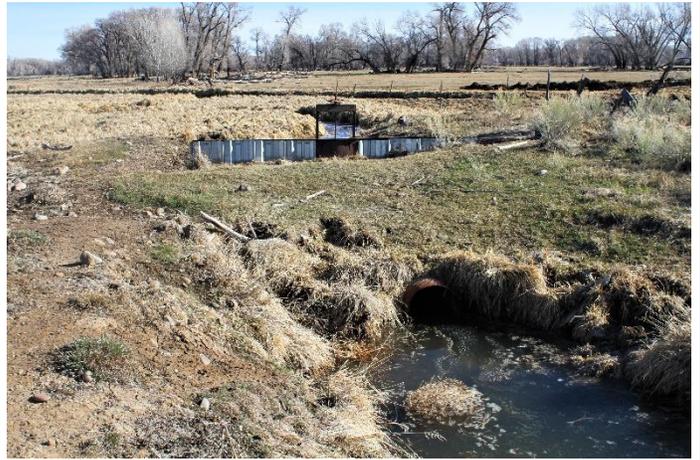
Headgate outlet

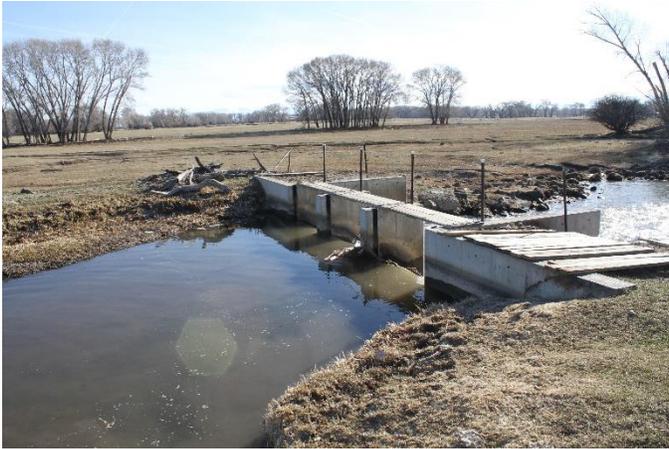
Consolidated Slough Weir

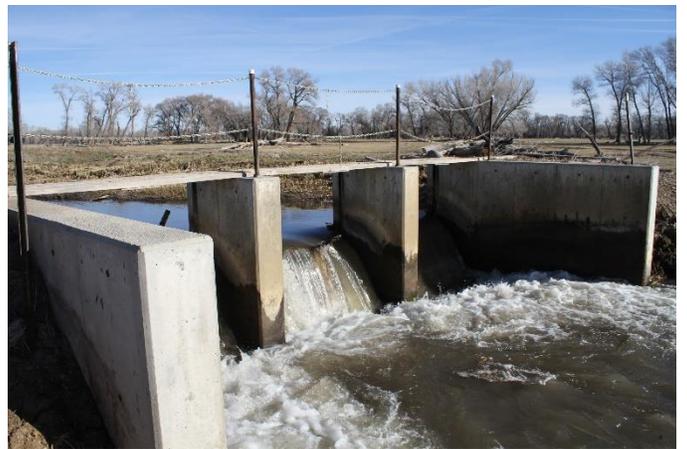
Consolidated Slough Weir looking upstream

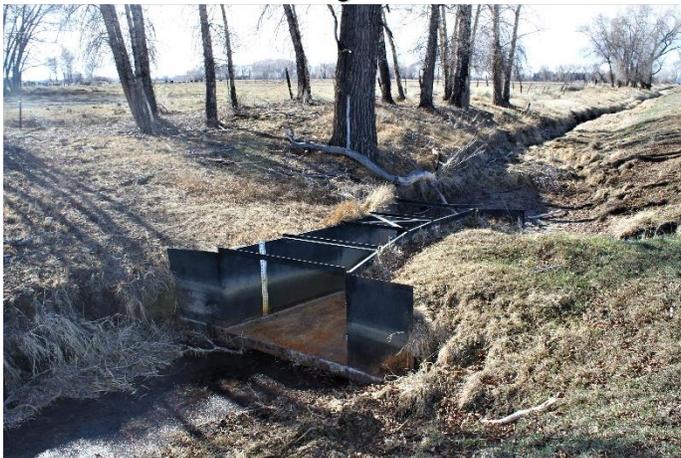
**Structure Description:** Water is diverted off the Rio Grande via the Consolidated Slough Ditch diversion located on the south bank of the river. The Consolidated Slough delivers water to the feeder channel, which transports water approximately 3.1 miles to the Star Ditch headgate. The headgate is just upstream of the Atencio Ditch, Anderson Ditch, Rio Grande Lariat Ditch, and Rio Grande San Luis Ditch. The Consolidated Slough Weir creates enough head pressure in the Consolidated Slough to deliver water to a short feeder channel and the Star Ditch headgate. The headgate functions well and does not leak. The Parshall flume is slightly tilted and eroding on its downstream side.

Flume looking downstream

**Repair(s) or Improvement(s) Currently Needed:** The SMP Technical Advisory Team (TAT) recommends resetting the flume to maintain long-term measurement accuracy.

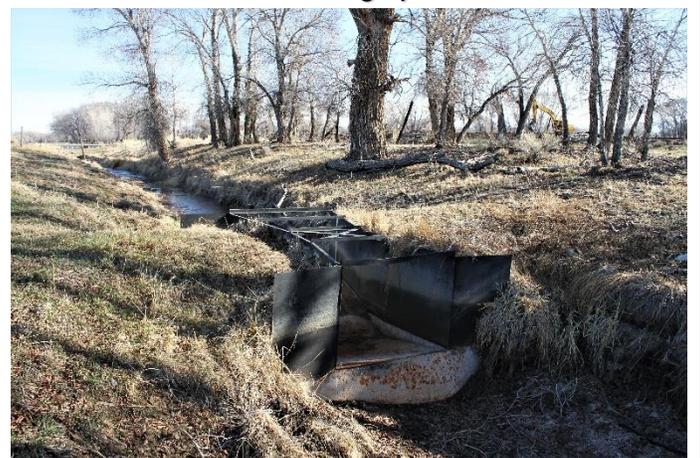
Flume looking upstream

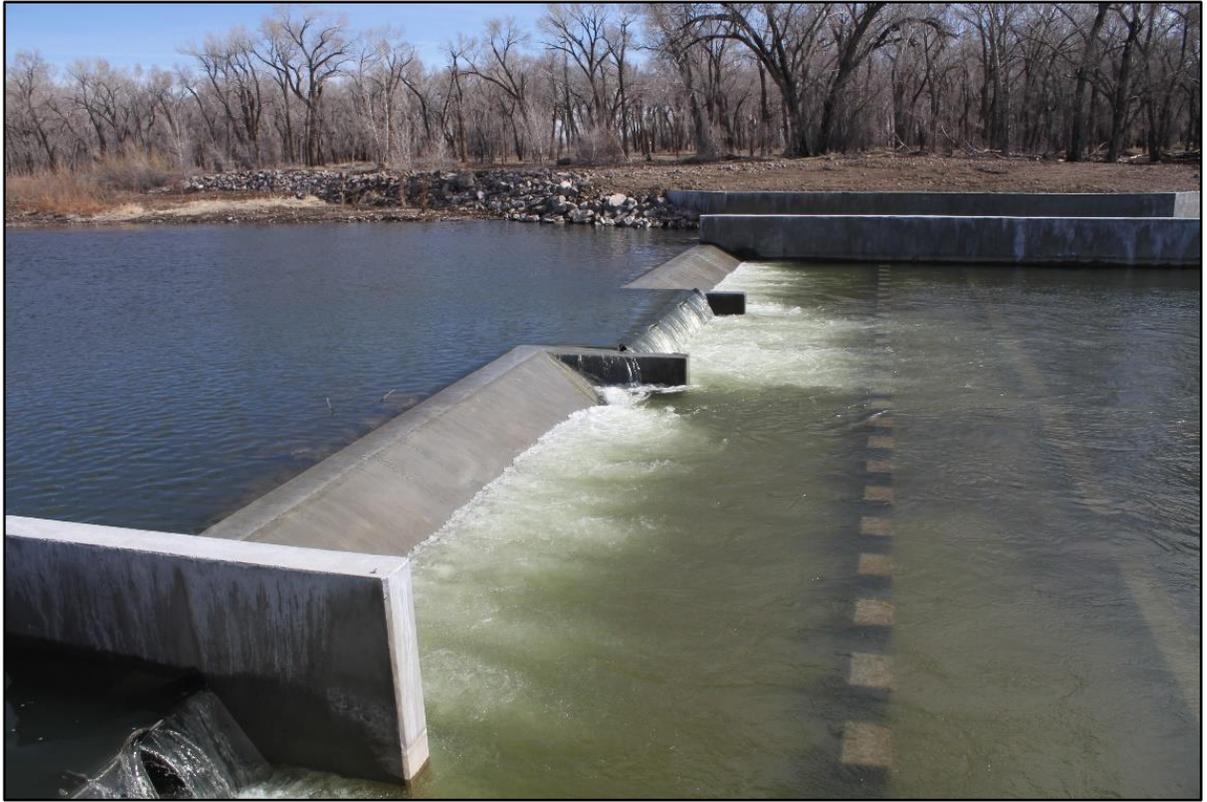
New diversion dam servicing the Consolidated Slough and associated ditches.
