RIO GRANDE DIVERSION INFRASTRUCTURE INVENTORY

Structure Name: WEISS D

WEISS DITCH

**Rio Grande Stream
Management Plan**

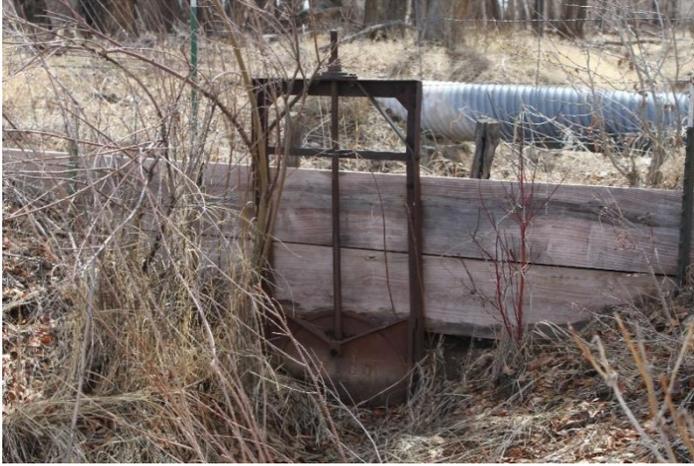
Headgate looking downstream

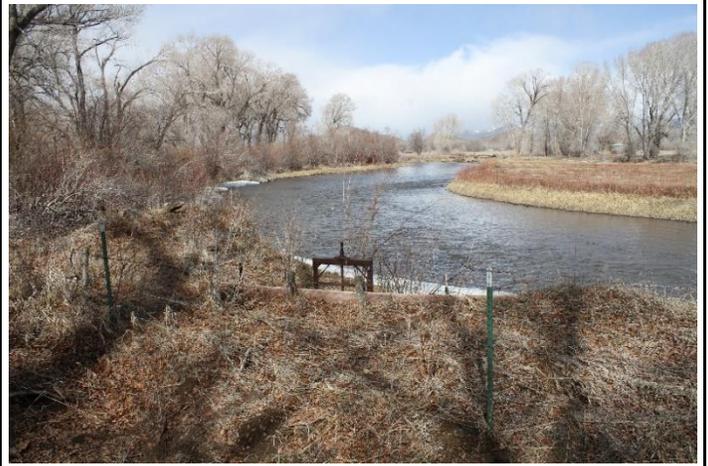
Headgate looking upstream

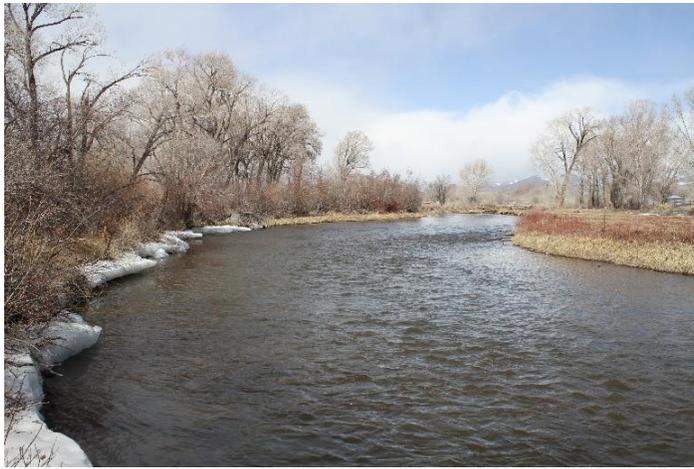
Rio Grande looking upstream

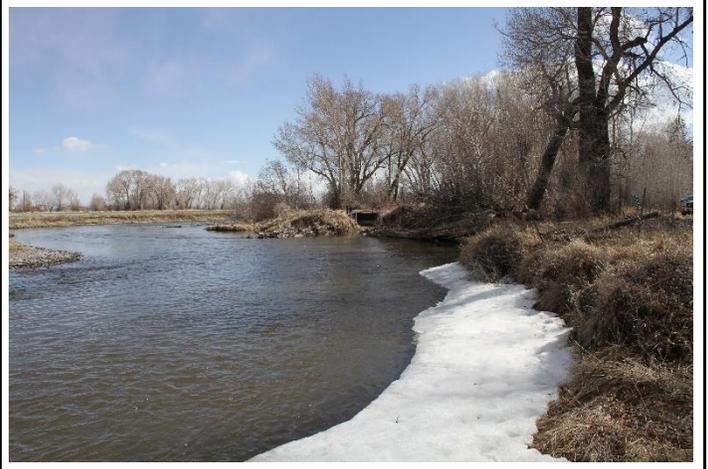
North channel Rio Grande looking downstream

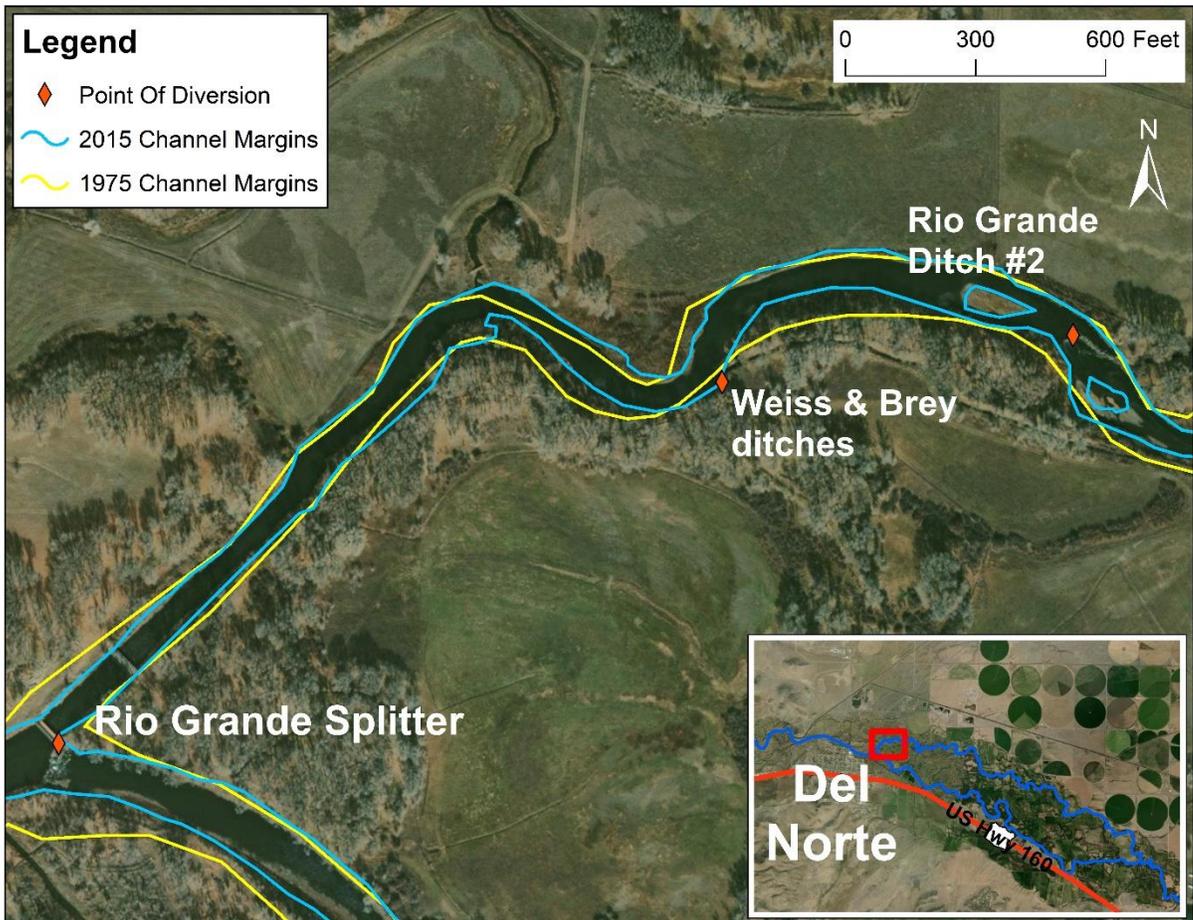
Aerial view of the Weiss Ditch headgate and diversion location with 1975 and 2015 channel margins overlaid.
