RIO GRANDE DIVERSION INFRASTRUCTURE INVENTORY

Structure Name: RIO GRANDE PIEDRA VALLEY D

Date: April 1, 2019

Rio Grande Stream
Management Plan

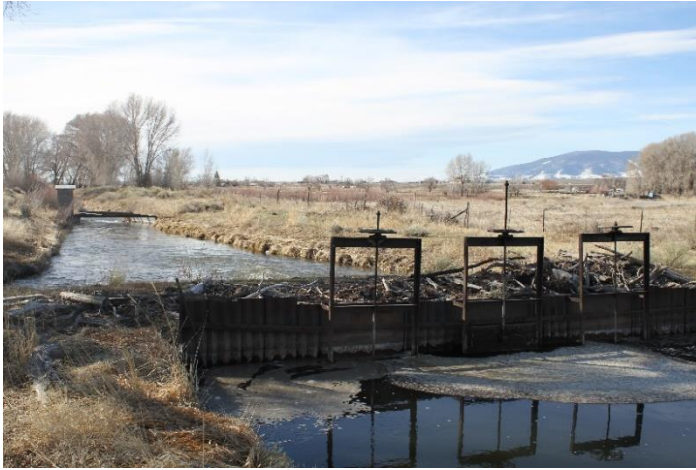
Main headgate looking downstream

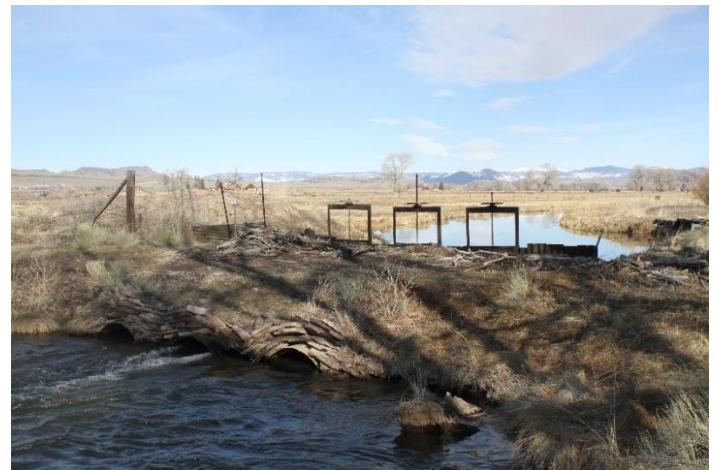
Main headgate outlet

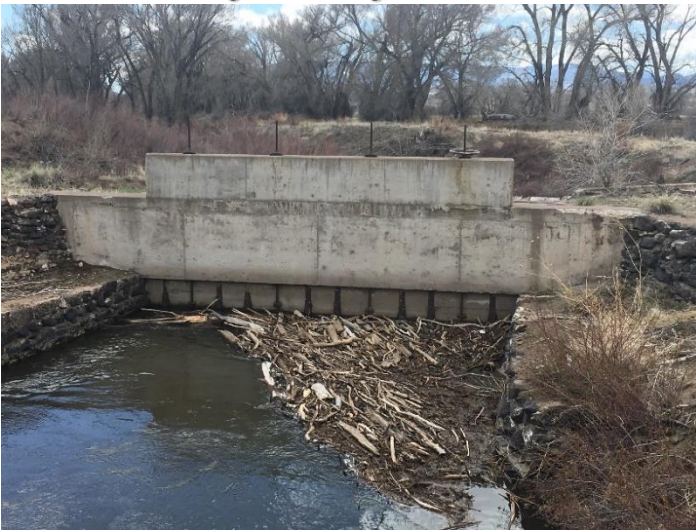
River headgate looking downstream

Repair(s) or Improvement(s) Currently Needed: To mitigate the issues described above, the SMP Technical Advisory Team (TAT) recommends installation of an improved trash rack and, as noted above, this ditch's headgate could be combined with that of the Monte Vista Canal to increase efficiency and decrease maintenance

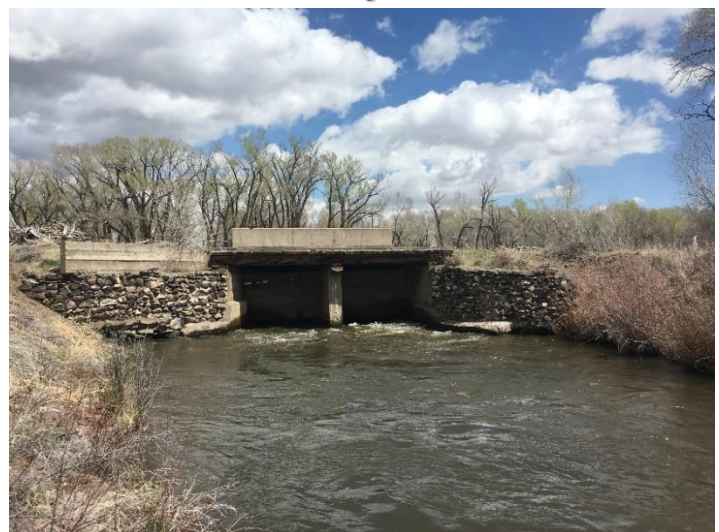
River headgate outlet

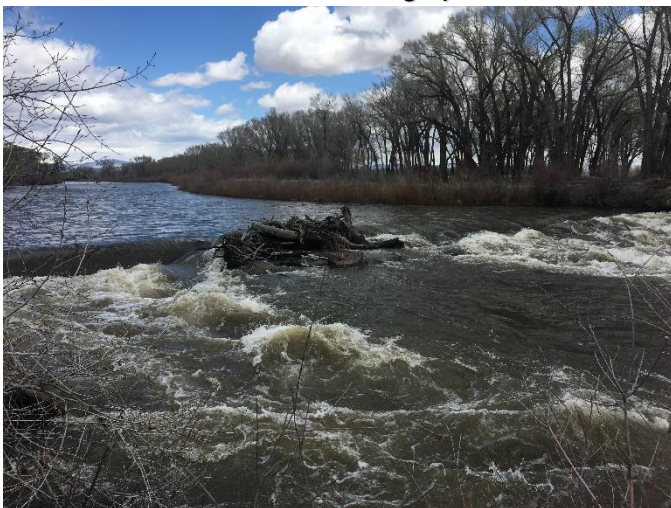
Diversion dam looking upstream

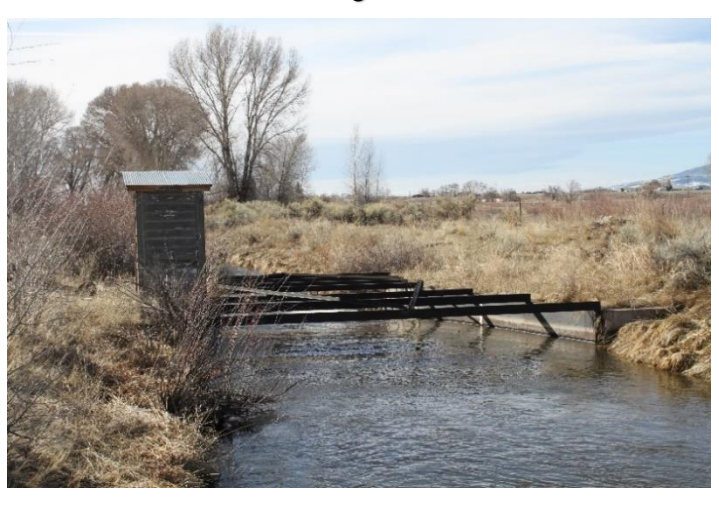
Flume looking downstream
