RIO GRANDE DIVERSION INFRASTRUCTURE INVENTORY

Structure Name: CONSOLIDATED D

Reported By: Daniel Boyes

Date: April 1, 2019

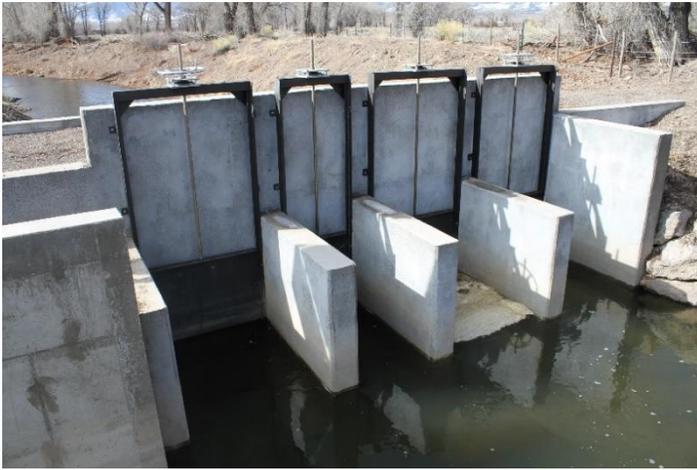
Headgate looking downstream

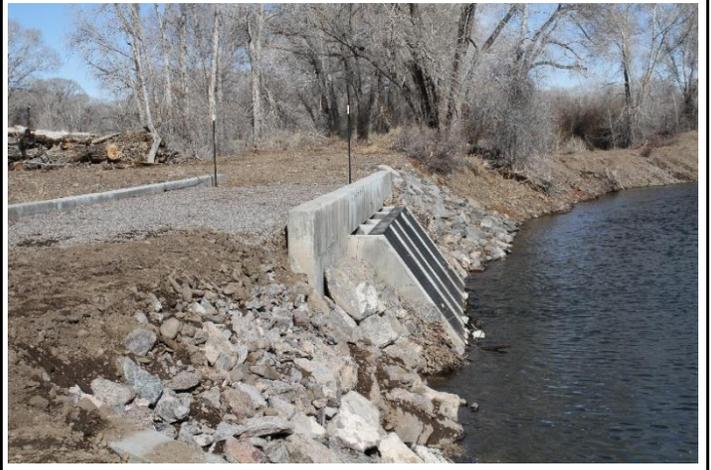
Trash rack in front of headgate

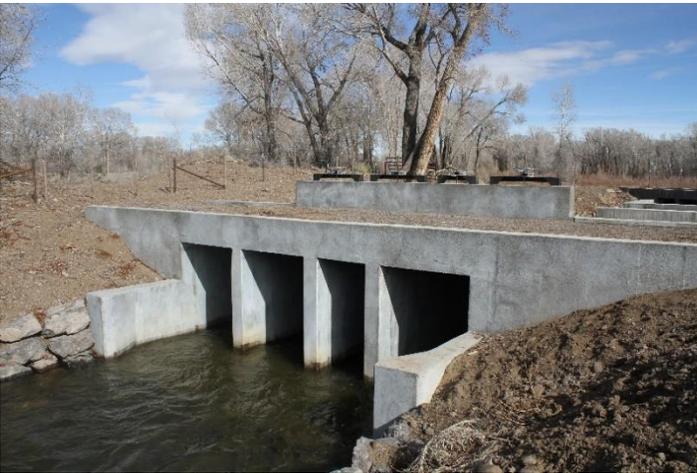
Headgate outlet

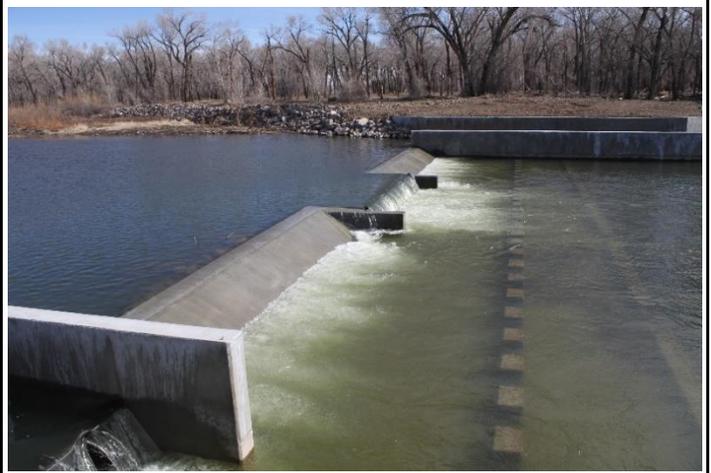
Diversion dam looking upstream

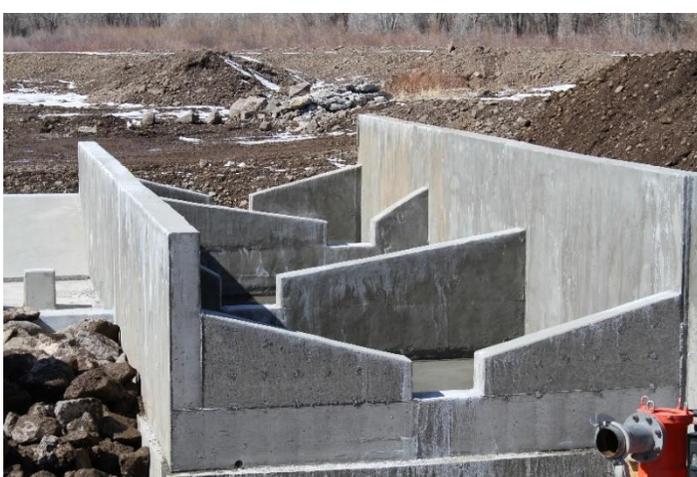
Fish ladder looking upstream

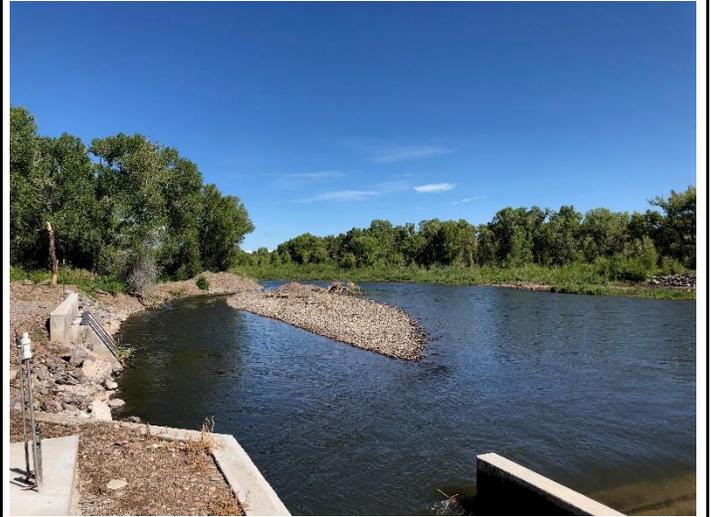
Gravel bar above diversion dam (summer 2019)

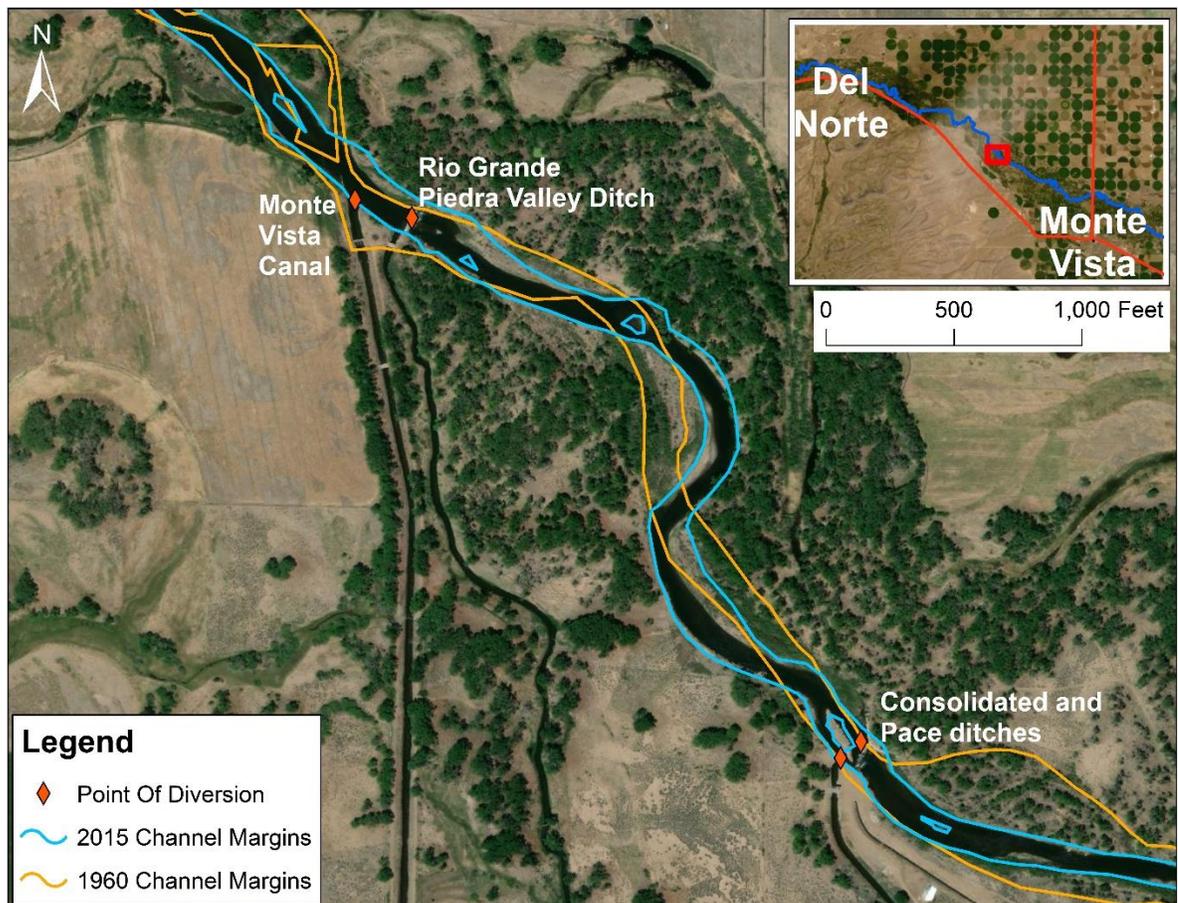
Consolidated Ditch diversion dam with 1960 and 2015 channel margins overlaid
