RIO GRANDE DIVERSION INFRASTRUCTURE INVENTORY

Structure Name: INDEPENDENT D

Date: April 10, 2019

INDEPENDENT DITCH

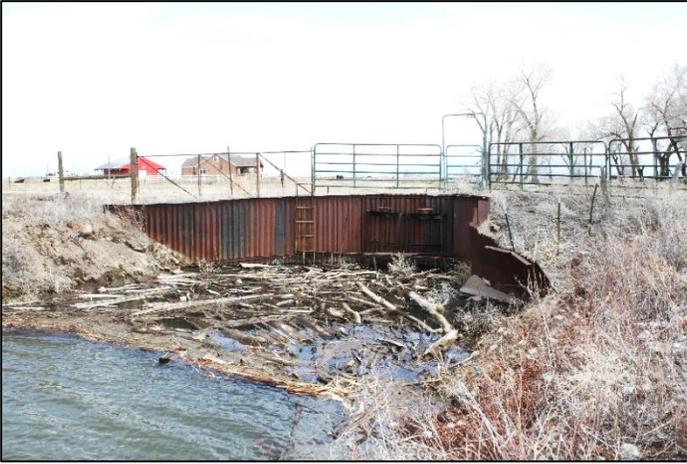
Headgate looking downstream

Repair(s) or Improvement(s) Currently Needed: The Technical Advisory Team (TAT) recommends installing a new trash rack in front of the structure's headgate. CPW recommends fish passage in this reach and the TAT also recommends creating safe boat passage and increasing sediment transport capacity at the diversion. Additionally, the TAT recommends bank stabilization upstream of the diversion. An improved trash rack in front of the headgate would mitigate debris accumulation and reduce ditch maintenance. If the diversion is replaced in the future, increasing its sediment transport capacity and creating boat passage would improve ditch function, enhance river health, and provide new recreational opportunities. Riparian revegetation and/or bank stabilization structures would increase bank stability and mitigate erosion and sediment input.

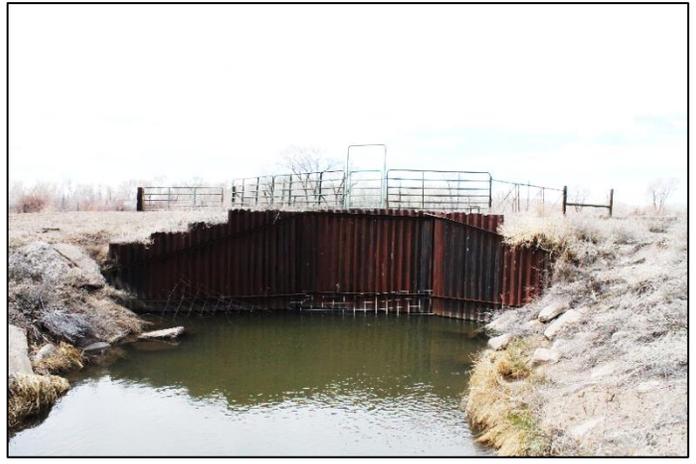
Headgate outlet

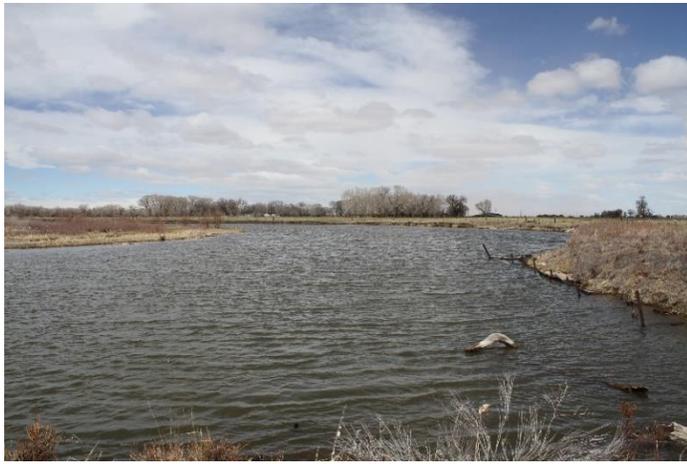
Rio Grande upstream of headgate

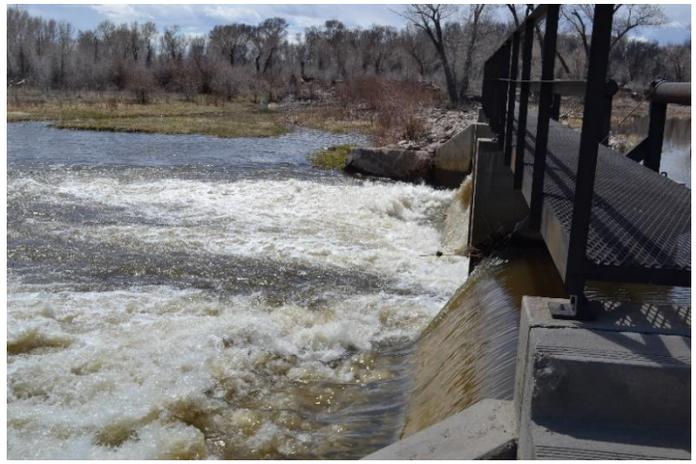
Diversion dam

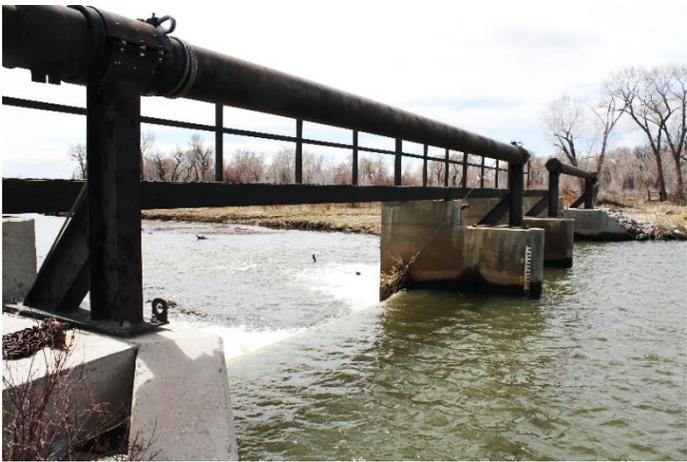
Diversion dam looking downstream

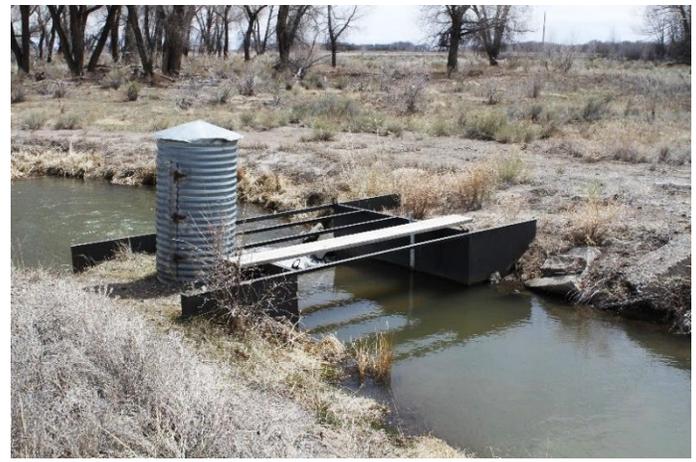
Rated box looking downstream

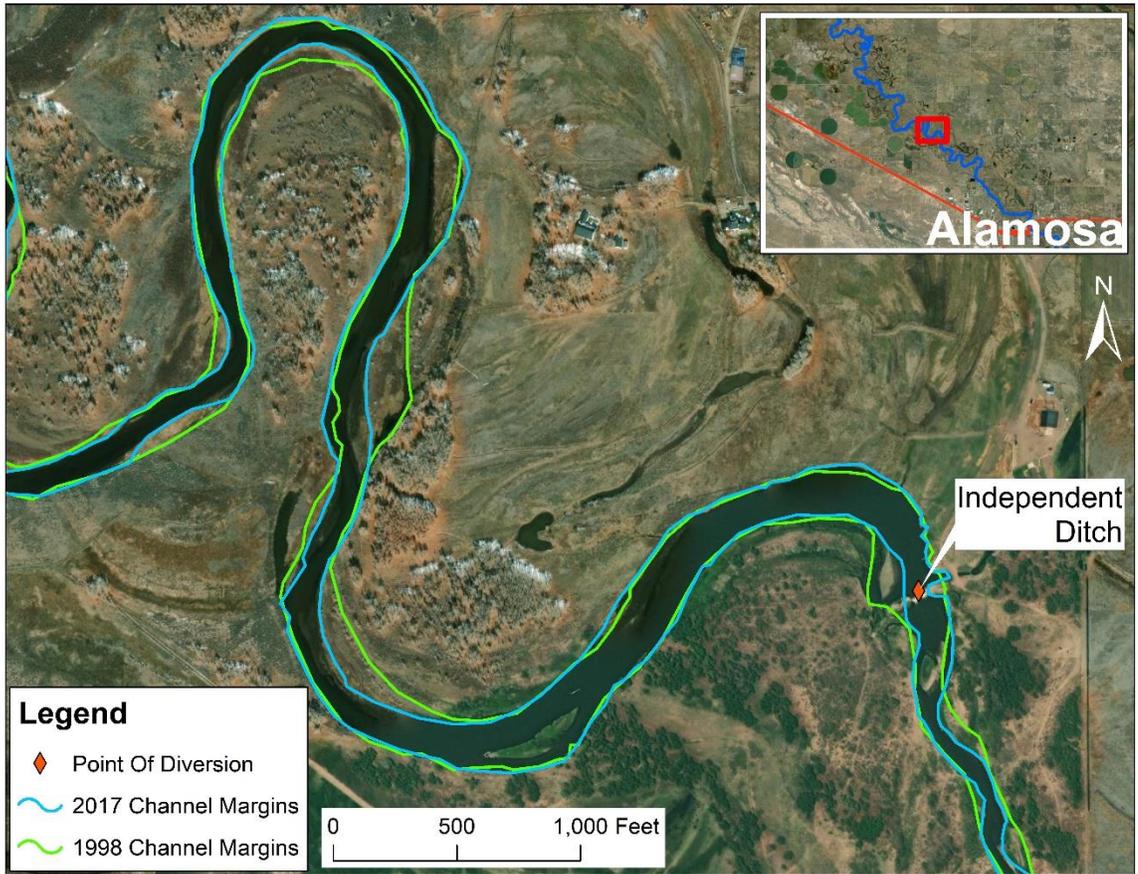
Headgate location with 1998 and 2017 channel margins overlaid

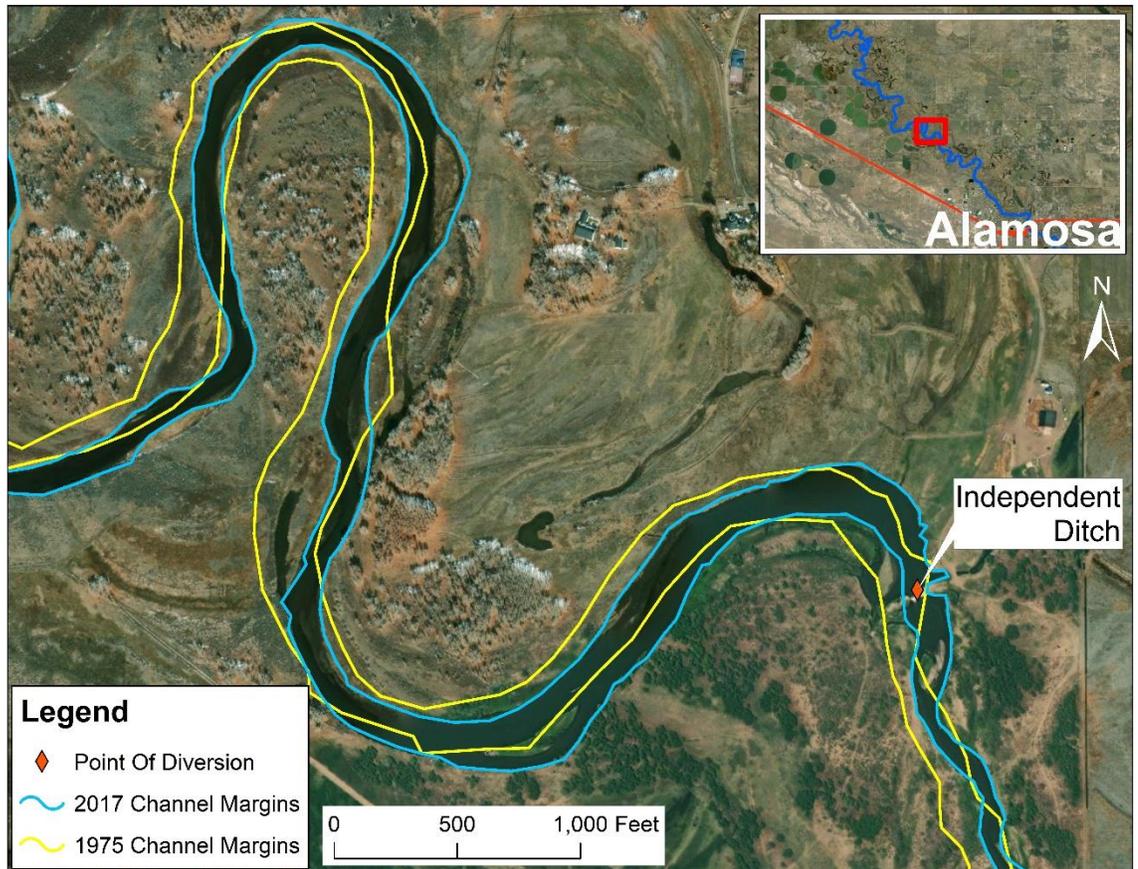
Headgate location with 1975 and 2017 channel margins overlaid
