# RIO GRANDE DIVERSION INFRASTRUCTURE INVENTORY

**Structure Name:** RIO GRANDE CANAL

**Date:** April 9, 2019

Rio Grande Stream Management Plan

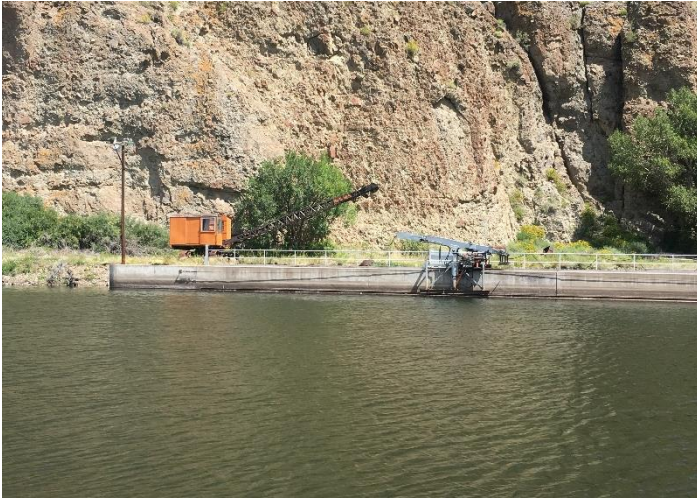
Headgate looking downstream

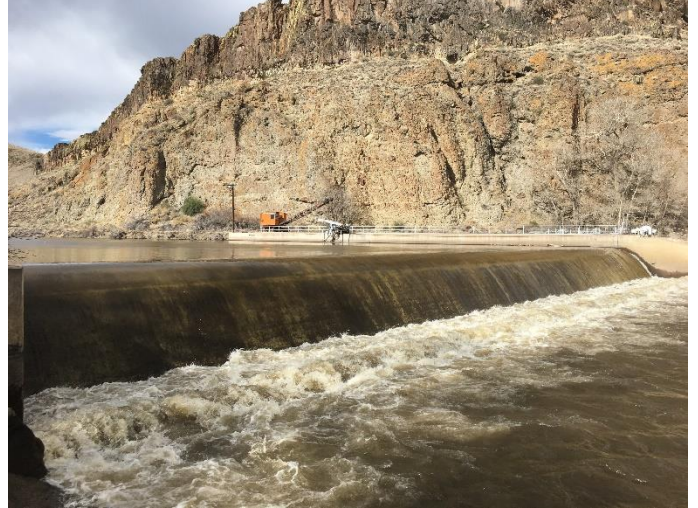
Headgate and diversion dam

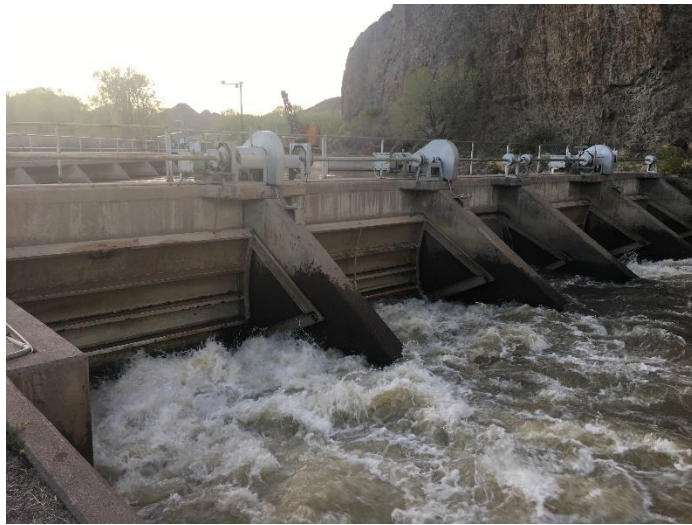
Headgate outlet

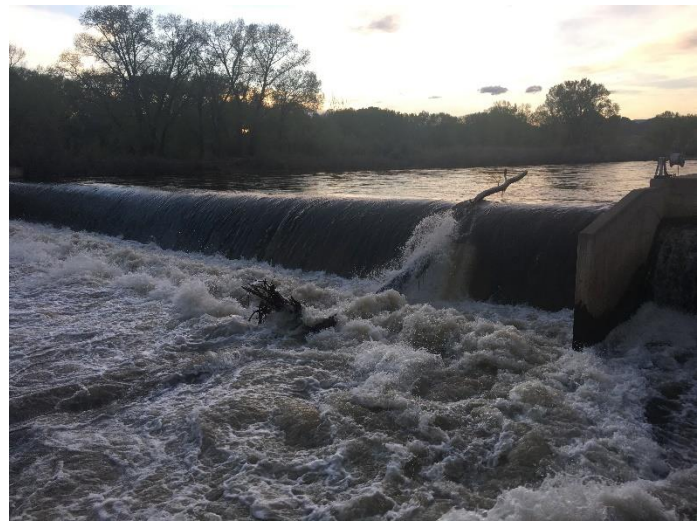
Diversion dam looking upstream

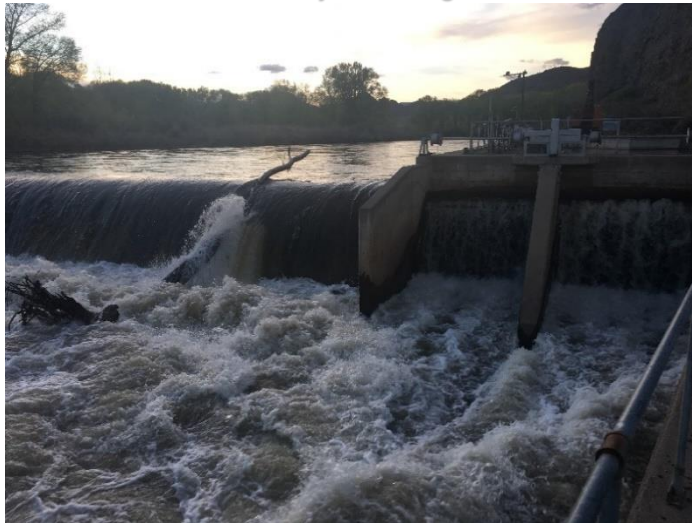
Radial adjustment gates

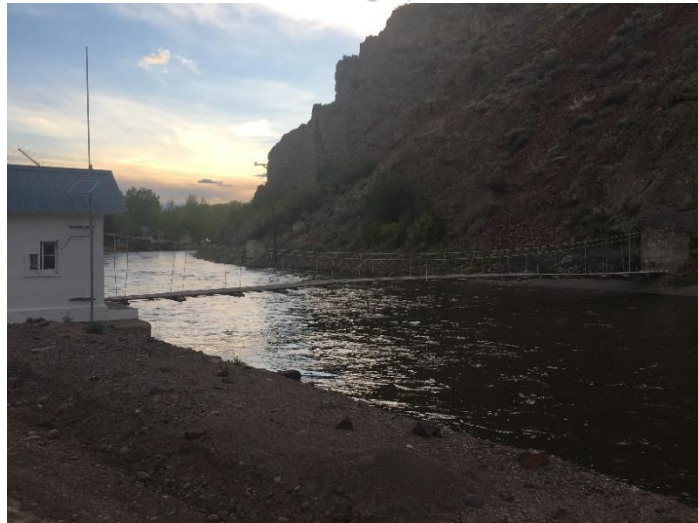
Flume looking upstream

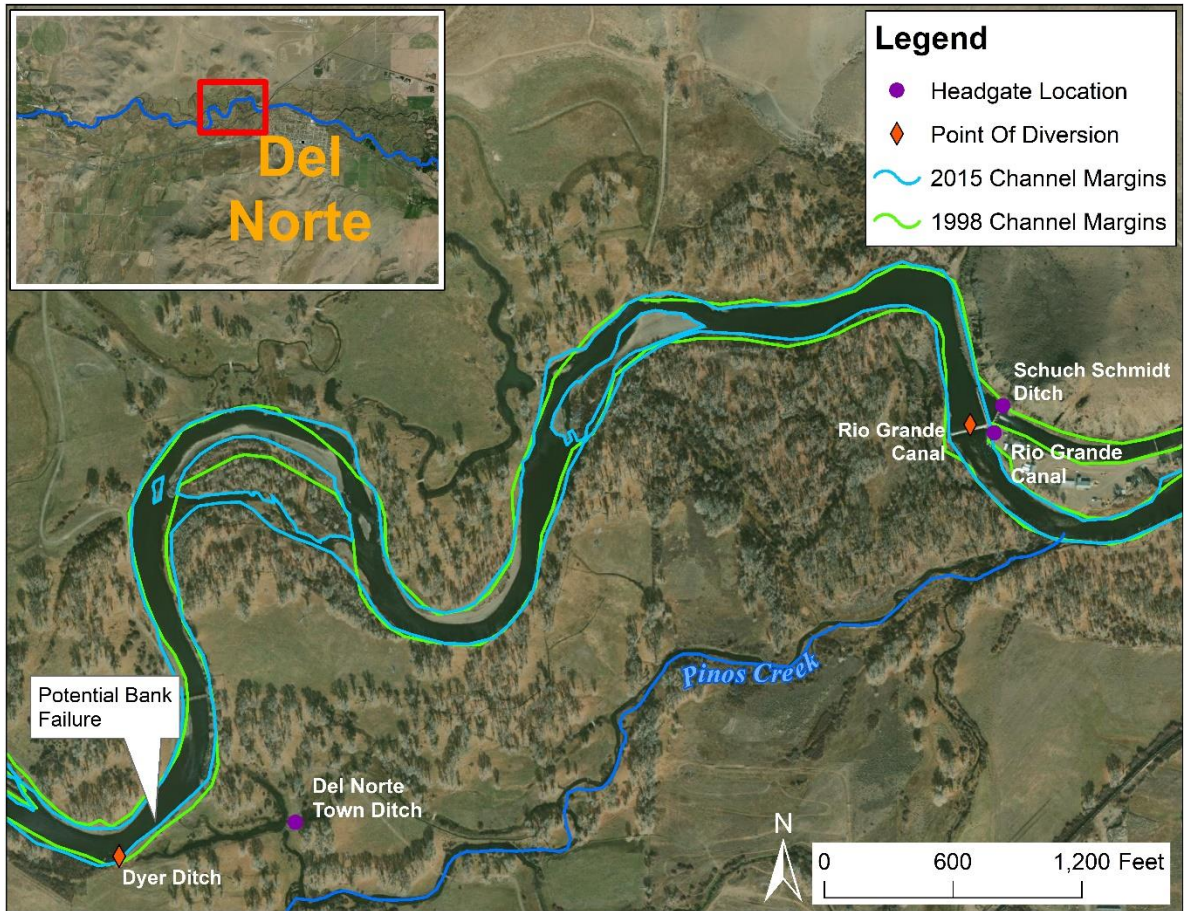
**Structure Description:** The channel is very stable in the area immediately surrounding this structure's diversion, in part due to the bedrock control on the north bank of the river. However, approximately 1.5 miles upstream of the Rio Grande Canal diversion, near the Dyer Ditch diversion, there is potential for the river to jump the south bank and form a new channel, following Dyer Ditch and the Pinos Creek channel (see map below). If this occurs, the Rio Grande Canal would be bypassed and could pose a serious flooding risk to the Town of Del Norte. The canal's diversion is a concrete dam that spans the entire river, directing water to the canal headgates. The headgates and canal are located on the north side of the river. A pair of sluice gates enables sediment to be flushed downstream. An additional set of adjustment gates (3) are located just downstream of the headgate. The diversion dam functions well for water users, but poses significant risks for recreational boaters. The diversion dam creates a roughly 10-foot change in the river's water surface elevation. At some flows, this forms a hydraulic jump, which is very dangerous and can entrain, or trap, objects for long periods of time. To make this structure safe for recreational boaters, the diversion dam would need to be modified for safe boat passage. However, as noted in the 2018 Rio Grande Fish Management Plan, this channel-wide diversion serves a critical role as a barrier to nonnative fish species movement upstream. The only designated Gold Medal fishery in the Rio Grande Basin spans approximately 17 miles from South Fork downstream to this structure. If the structure is ever modified, it is critically important that it remains a fish barrier to prevent nonnative predators found downstream from moving upstream into the high-quality trout fisheries.

Map showing potential bank failure and risk to Rio Grande Canal.

**Repair(s) or Improvement(s) Currently Needed:** The SMP Technical Advisory Team (TAT) does not recommend any immediate improvements, however if the diversion is modified in the future, the TAT recommends incorporating boat passage, if possible, and maintain the existing fish barrier.

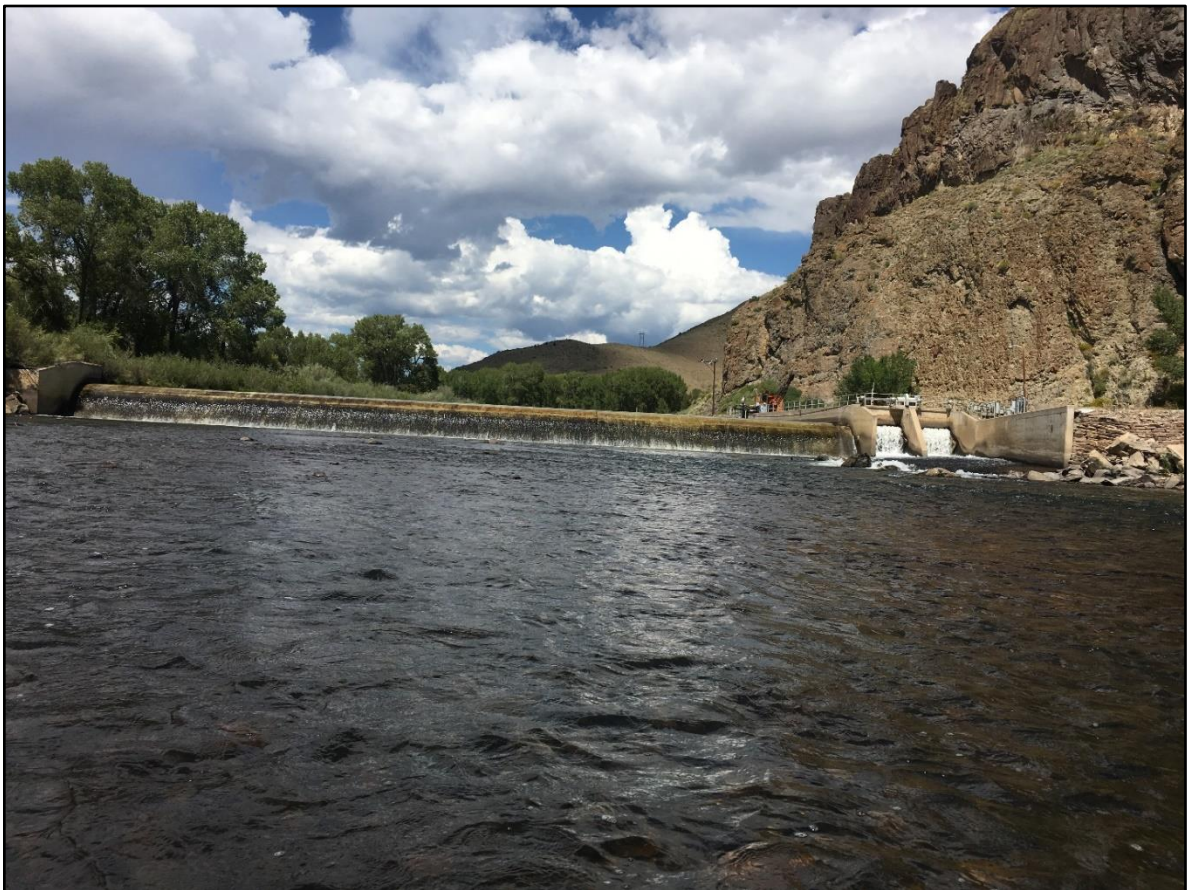
Rio Grande Canal diversion dam looking upstream
