SAGUACHE CREEK DIVERSION INFRASTRUCTURE INVENTORY

Structure Name: ASHLEY PROFFIT D

ASHLEY PROFFIT DITCH

Saguache Creek Stream Management Plan

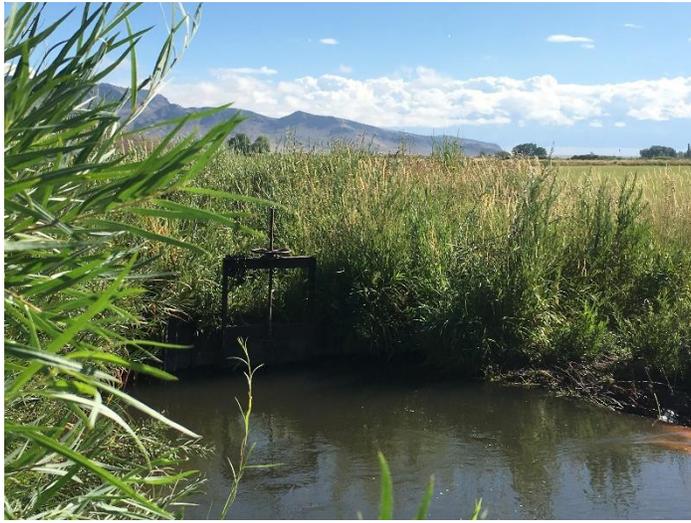
Headgate looking downstream

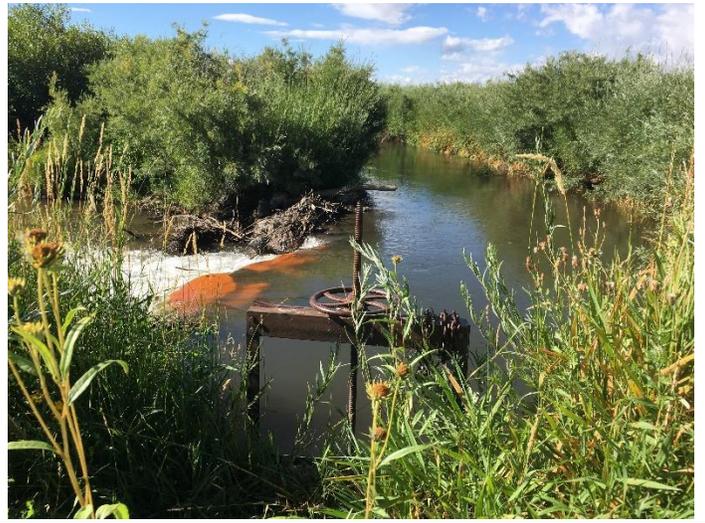
Headgate outlet

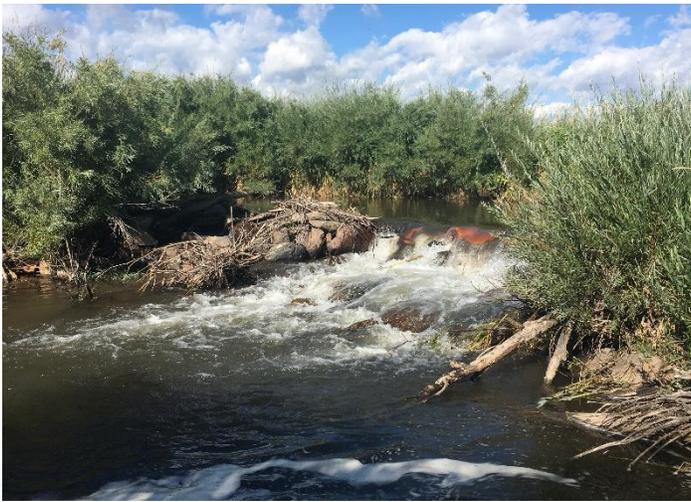
Structure Description: This structure is located on the outside of a tight meander. A stacked rock diversion dam directs water to the headgate, located on the north bank of the stream. The headgate functions effectively, however it cannot access its full decree at low flows due to leaks in the dam. The meander upstream of this structure could be cut off during a high flow event, which would cause the structure to be bypassed.

Diversion dam looking upstream

Repair(s) or Improvement(s) Currently Needed: Given these current issues, the SMP Technical Advisory Team (TAT) recommends improving the diversion dam with a structure designed to reduce maintenance and enable the ditch to divert at all flows. If the upstream meander is cut off, the TAT recommends relocating the point of diversion accordingly

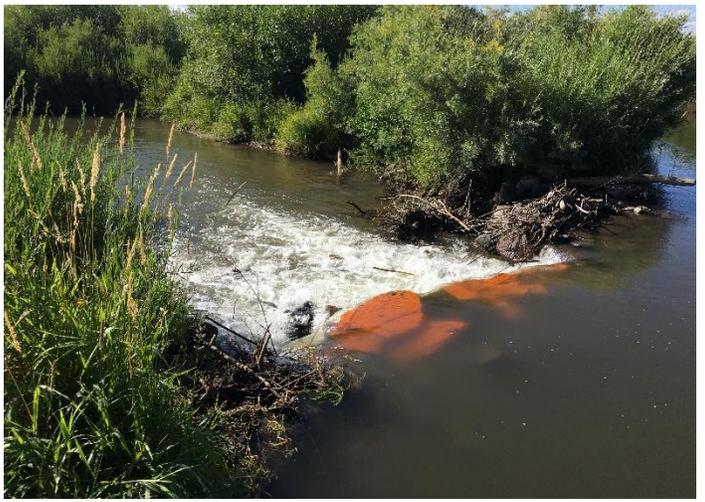
Diversion dam looking downstream

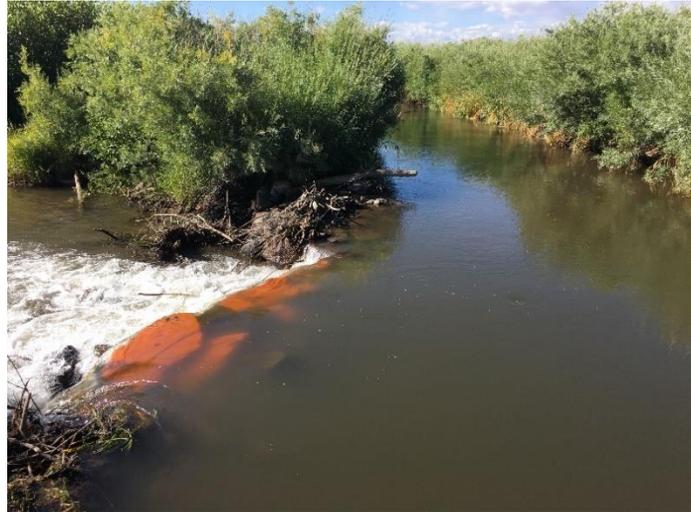
Channel looking upstream

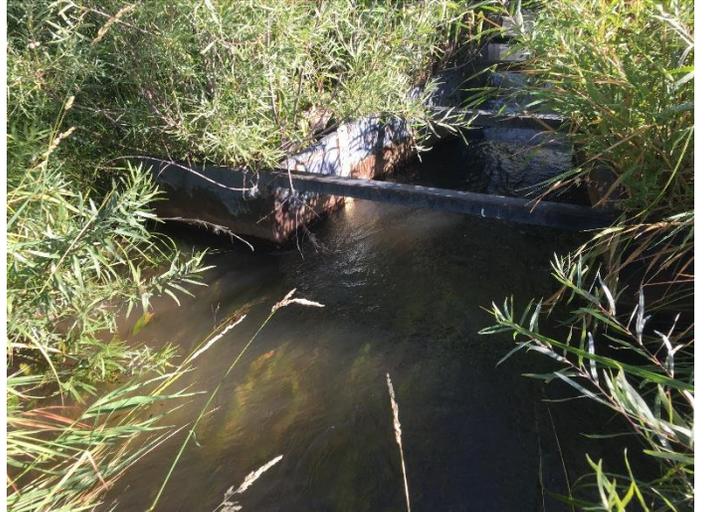
Flume looking downstream
