SAGUACHE CREEK DIVERSION INFRASTRUCTURE INVENTORY

BIG MEADOW DITCH

PHOTO LOG

Saguache Creek Stream Management Plan

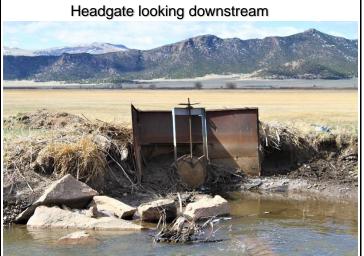
Headgate outlet

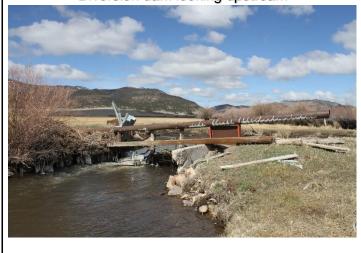
Flume looking downstream
