SAGUACHE CREEK DIVERSION INFRASTRUCTURE INVENTORY

Structure Name: BRAUN BROS D 1

Date: April 3, 2019

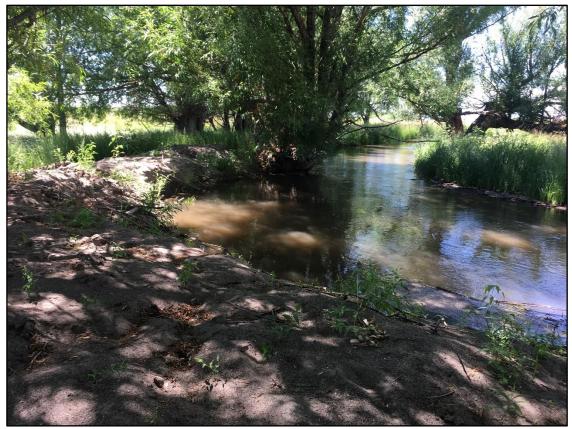
Structure Description: This structure is located just upstream of County Road X and Braun Bridge. The diversion dam is a check board structure with a recently installed catwalk. It is shared with the Nehls Company Ditch. The headgate, located on the north bank of the stream, functions moderately well but is hindered by sediment and woody debris accumulation. During 2019 spring runoff, the stream left the channel, flooding the adjacent field and leaving significantly less flow available for diversion. The bank was reinforced using compacted soil (see photos below).

Failed bank that was reinforced with compacted soil

Repair(s) or Improvement(s) Currently Needed: The SMP Technical Advisory Team (TAT) recommends riparian revegetation upstream of the diversion and installation of a sluice gate adjacent to the headgate. Revegetation would mitigate upstream erosion and flooding and a sluice gate would improve sediment transport.

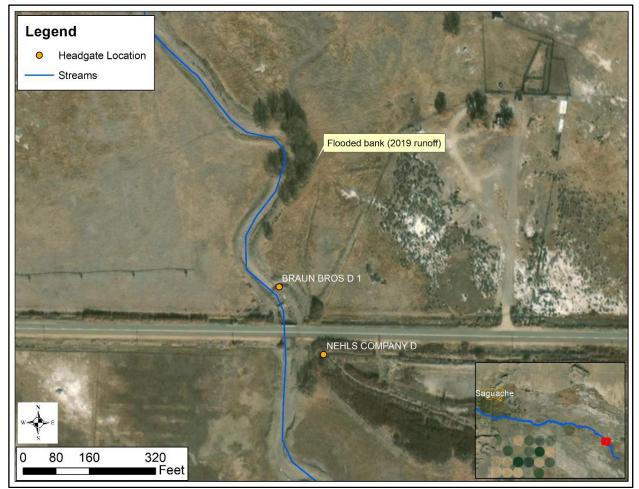
Braun Bros Ditch 1 headgate location and surrounding stream channel.
