SAGUACHE CREEK DIVERSION INFRASTRUCTURE INVENTORY

CARRUTHERS DITCH

Saguache Creek Stream Management Plan

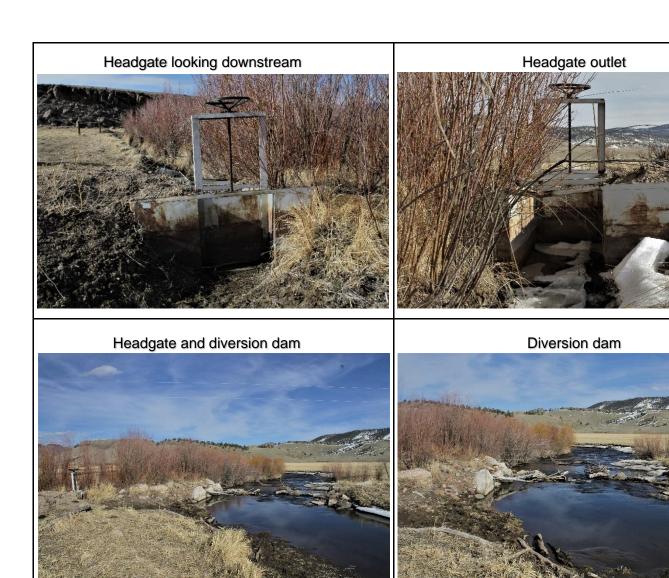
Structure Name: CARRUTHERS D				
Reported By: Daniel Boyes				
Date : April 4, 2019				
Headgate Location:	Latitude 38.118874	Longitude -106.473297		
Headgate Type: Manually operated 2' screw gate				
Headgate Condition:		on and A □ Condition: B □ C ⊠ D □ F □	Stream Miles from Saguache Creek Terminus (Point of Diversion): 69.0 mi	Structure Yes □ Submerged: No ⊠
Structure Description: A boulder diversion dam directs water to the headgate, which is located on the west bank of the stream. The diversion is located in the transition zone between two meanders. The headgate is tilted and is being eroded. The stream is disconnected from its floodplain in some areas of this reach.				
Repair(s) or Improvement(s) Currently Needed: The SMP Technical Advisory Team (TAT) recommends resetting the headgate and restoring the bank upstream of this structure. Headgate repair would improve efficiency and reduce maintenance. Bank stabilization and riparian revegetation would help protect the headgate, mitigate erosion, and reconnect the stream with its floodplain.

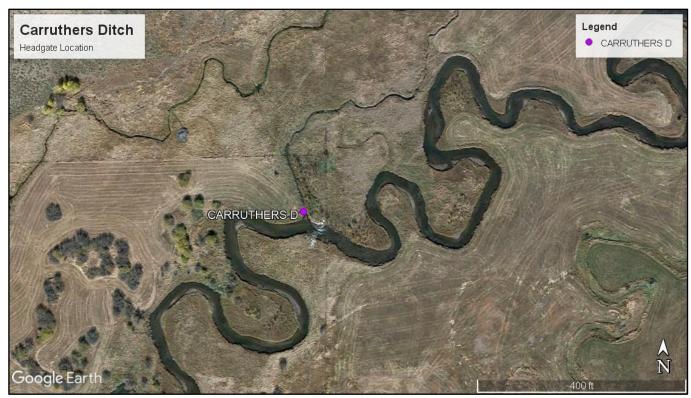
Carruthers Ditch headgate location. This image illustrates the high channel sinuosity in this reach
