SAGUACHE CREEK DIVERSION INFRASTRUCTURE INVENTORY

Structure Name: CHASE PEYTON D

Date: April 4, 2019

Saguache Creek Stream Management Plan

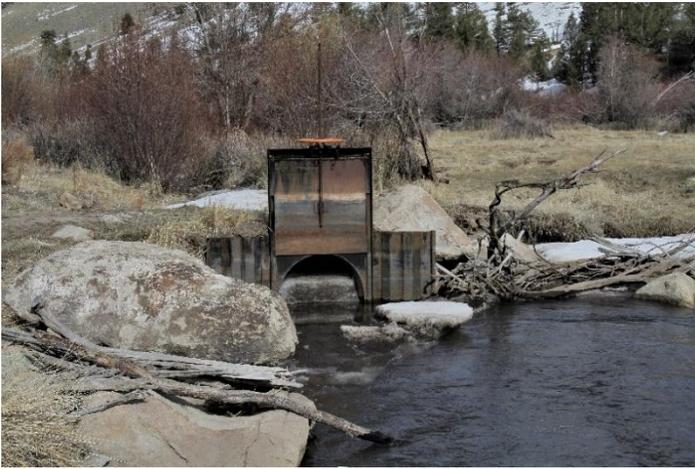
Headgate (pre-2019 runoff)

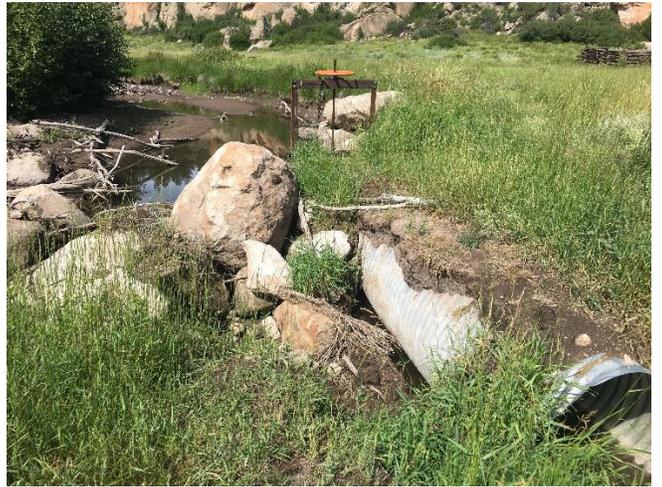
Headgate outlet (post-2019 runoff)

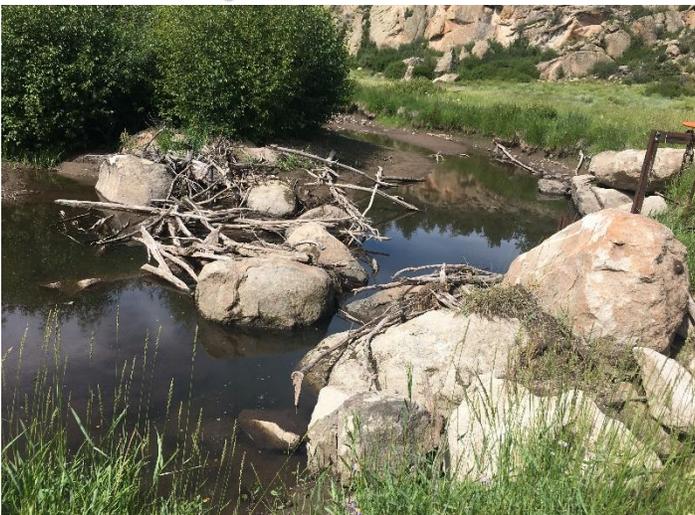
Headgate and diversion dam

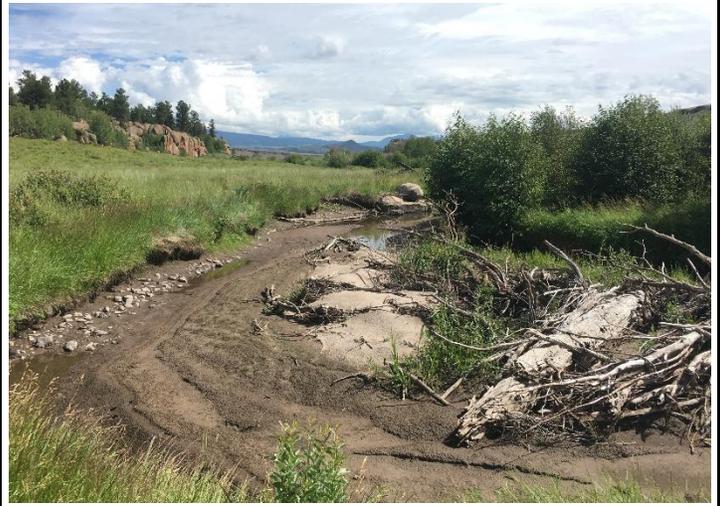
Dry channel looking downstream

Repair(s) or Improvement(s) Currently Needed: Given the issues identified at this structure, the SMP Technical Advisory Team (TAT) recommends the following possible long-term solutions to the recent meander cut off: 1) rebuild the stream bank that was breached to redirect flow to the original stream channel and to the headgate; 2) relocate the point of diversion to divert flows just downstream of the current point of diversion. If the point of diversion is relocated, the TAT recommends retaining the original diversion dam and headgate in the event the stream recaptures the original channel.

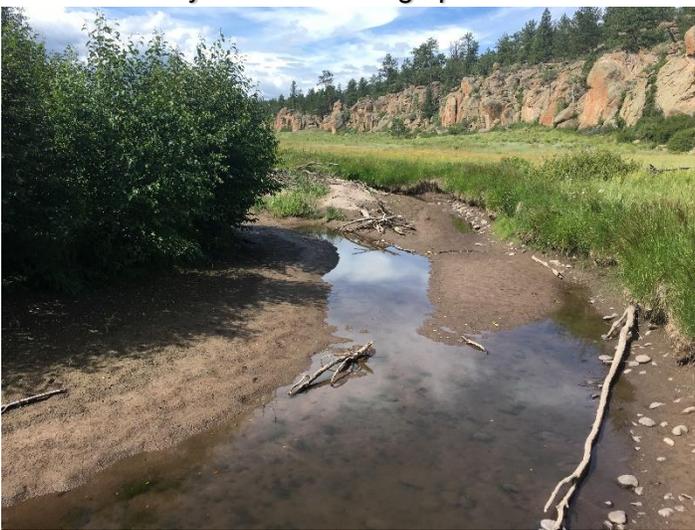
Dry channel looking upstream

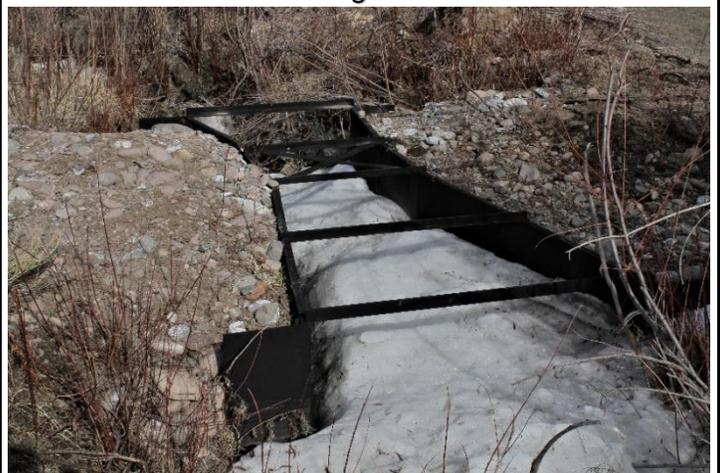
Flume looking downstream

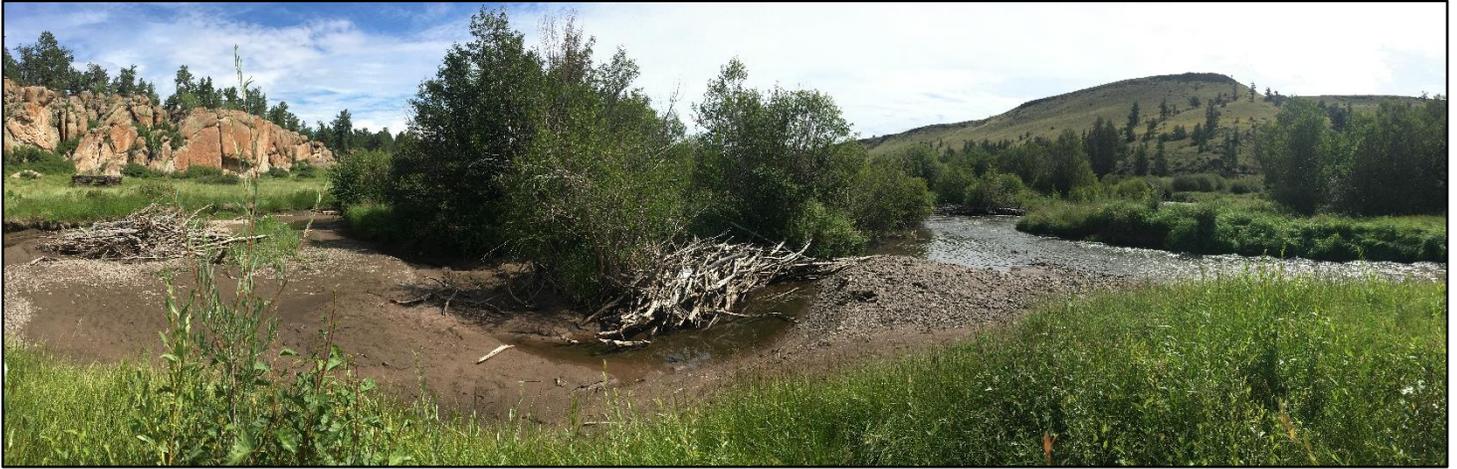
Dry meander, which was cut off during 2019 spring runoff.

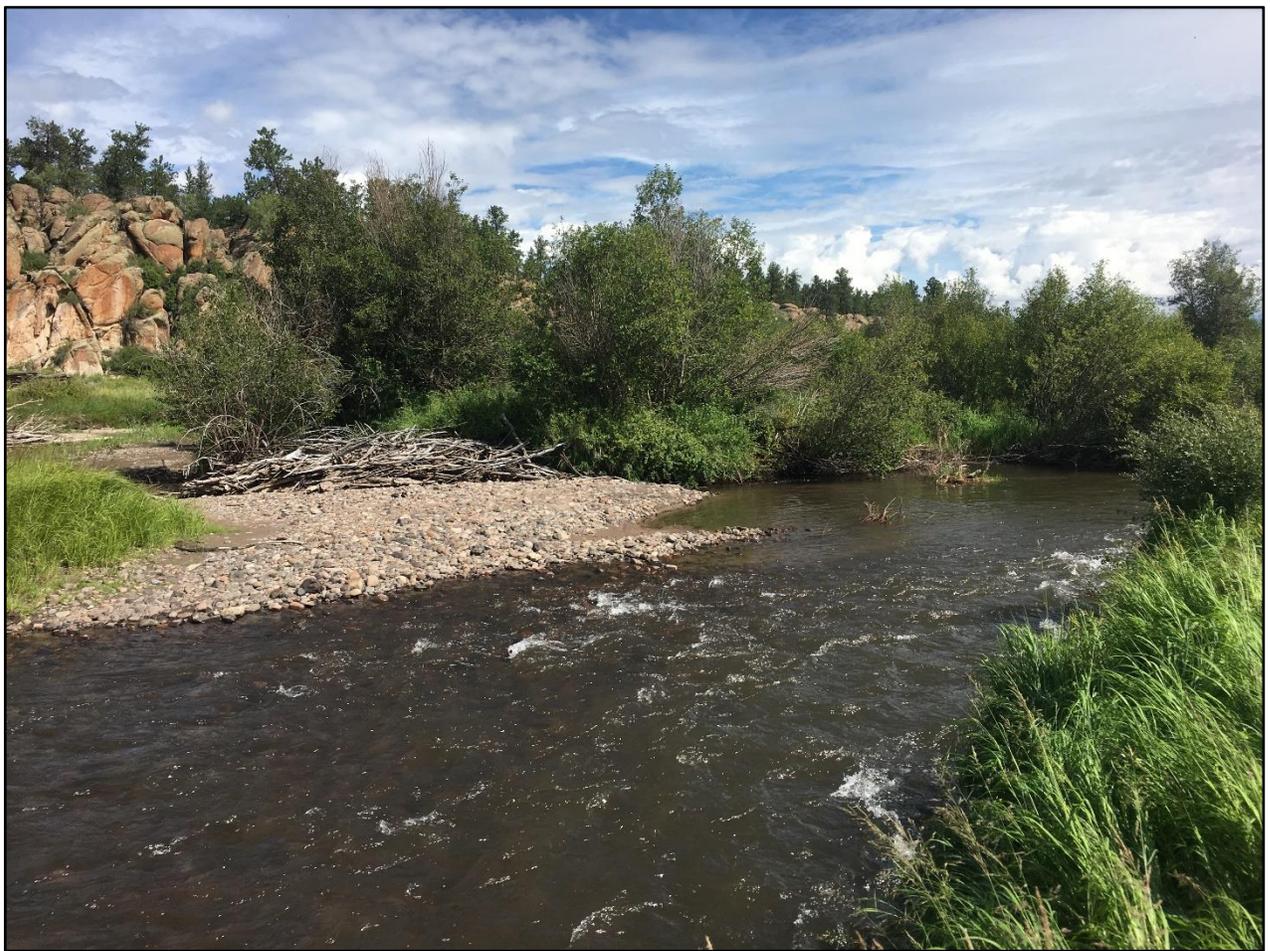
This photo, looking downstream, shows the meander (left) that was cut off during 2019 spring runoff.

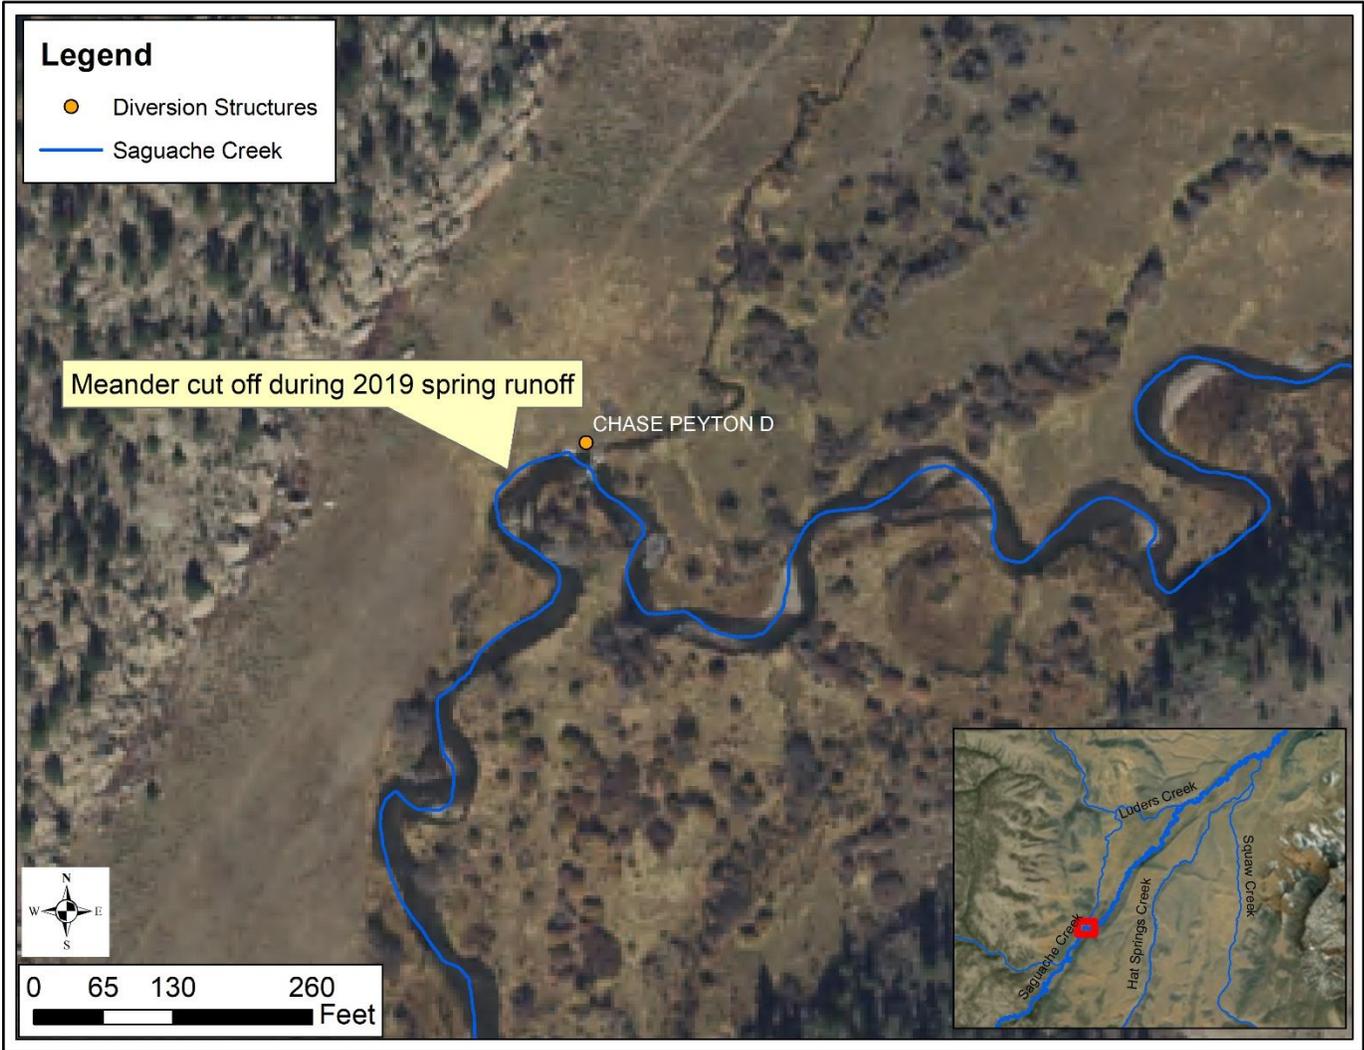
Point of diversion and meander that was cut off during 2019 spring runoff.
