SAGUACHE CREEK DIVERSION INFRASTRUCTURE INVENTORY

ELWES D1

Saguache Creek Stream Management Plan

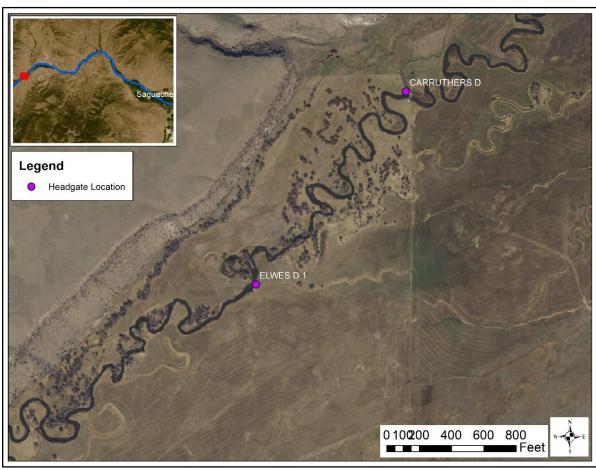
Elwes Ditch 1 headgate location relative to Carruthers Ditch.

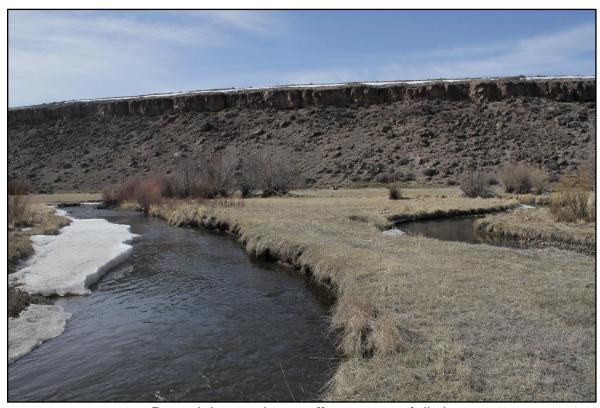
Potential meander cutoff upstream of ditch
