SAGUACHE CREEK DIVERSION INFRASTRUCTURE INVENTORY

Structure Name: FLORENCE D

Date: April 4, 2019

Saguache Creek Stream
Management Plan

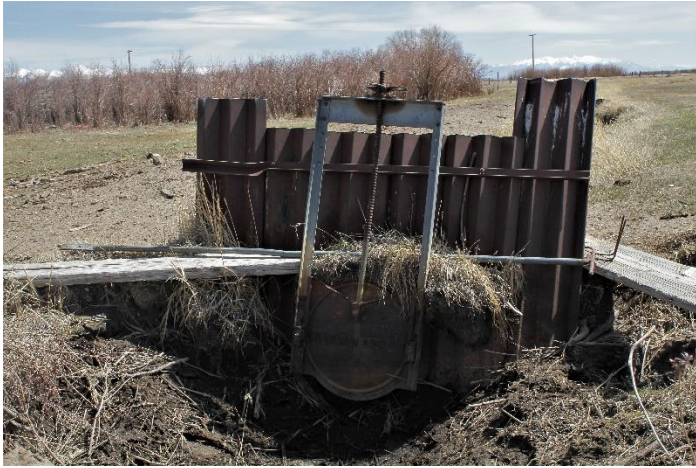
Structure Description: This diversion is located on a tight meander just upstream of County Rd 46. The diversion dam is a boulder structure that functions well but requires regular maintenance (i.e., moving boulders depending on flows). There is potential for bank erosion and/or failure on the north side of the diversion dam. The headgate, located on the south bank of the stream, leaks and is tilted. The flume measures relatively well but has minor leak on its upstream side.

Headgate looking downstream

Repair(s) or Improvement(s) Currently Needed: The SMP Technical Advisory Team (TAT) recommends bank stabilization upstream of the diversion, headgate repair or replacement, including installation of new wedges and a handle, and flume repair. Bank stabilization would help prevent the stream bank from failing and headgate and flume improvements would increase efficiency.

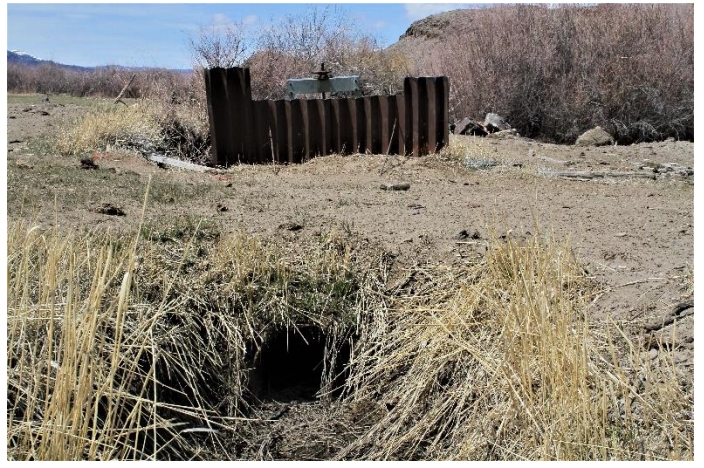
Headgate outlet

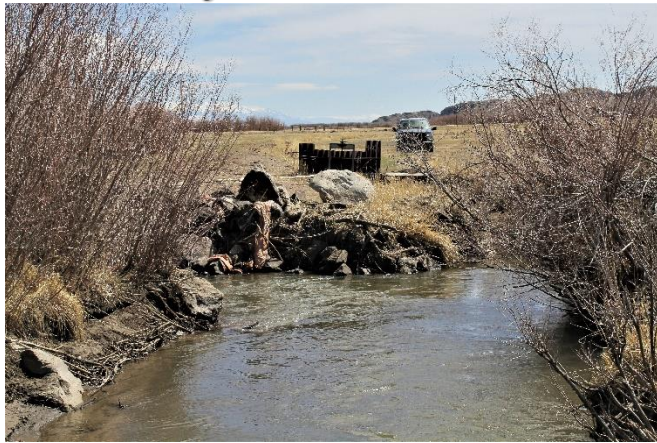
Headgate and diversion dam

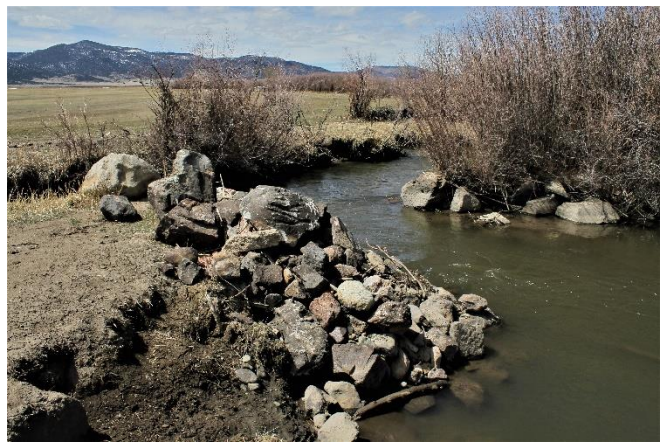
Diversion dam

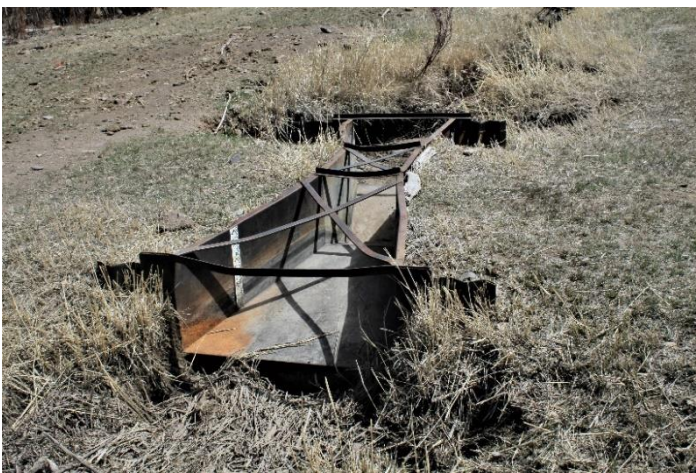
Flume looking downstream

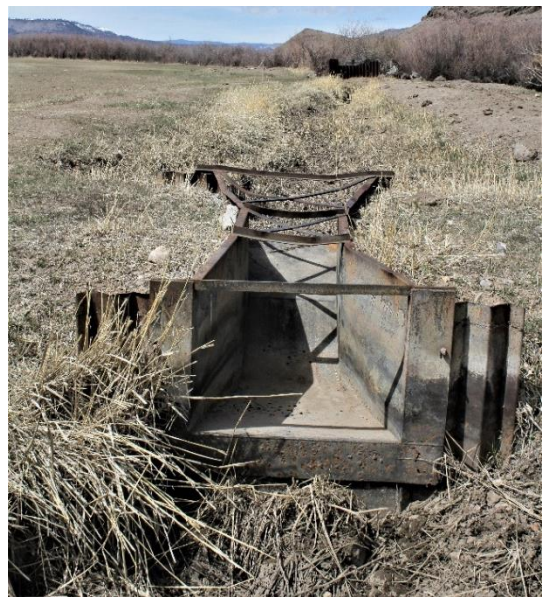
Flume looking upstream
