SAGUACHE CREEK DIVERSION INFRASTRUCTURE INVENTORY

Structure Name: FORD D 1 AND 2

Date: April 11, 2019

Saguache Creek Stream Management Plan

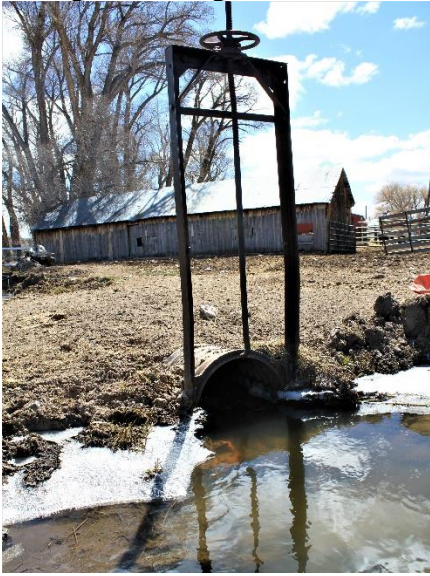
Structure Description: This ditch's point of diversion is shared with the Ford Ditch. Approximately 0.4 miles downstream of the Ford Ditch headgate, the ditch bifurcates and the left branch services the Ford Ditch 1 and 2 headgate an additional 1.1 miles down the ditch. A 2' wide slide gate serves as the diversion dam and the overflow gate. The headgate has no cover and the flume is tilted.

Headgate looking downstream

Repair(s) or Improvement(s) Currently Needed: The SMP Technical Advisory Team (TAT) recommends headgate replacement and flume improvement or replacement for improved function.

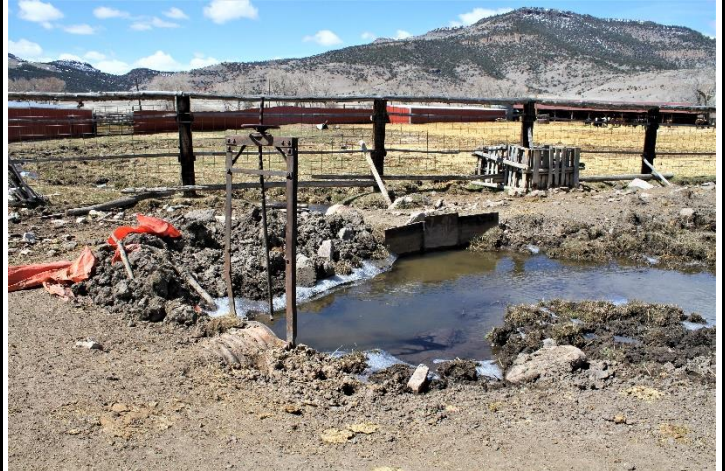
Headgate and overflow gate

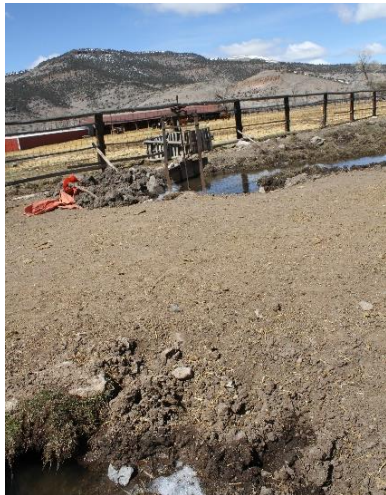
Headgate outlet

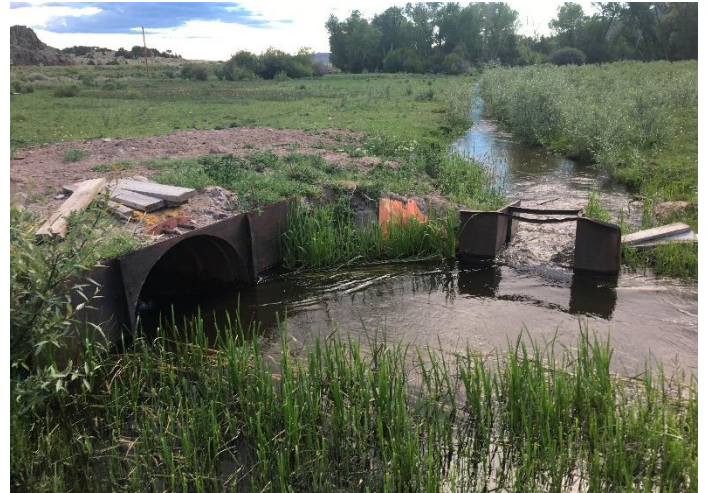
Branch in Ford Ditch (culvert on left services Ford Ditch 1 and 2)

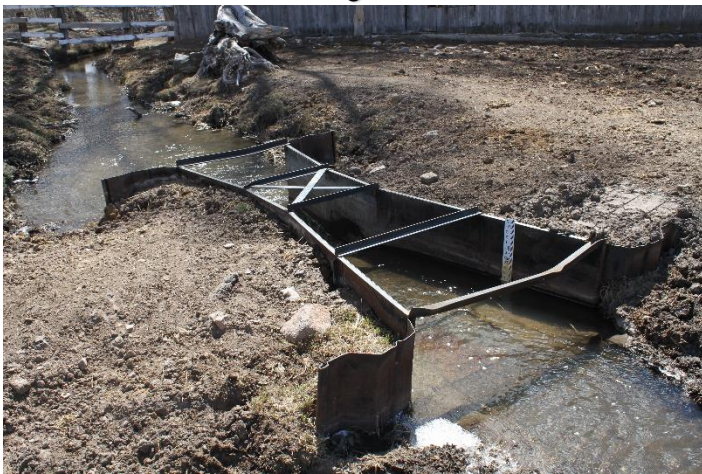
Flume looking downstream

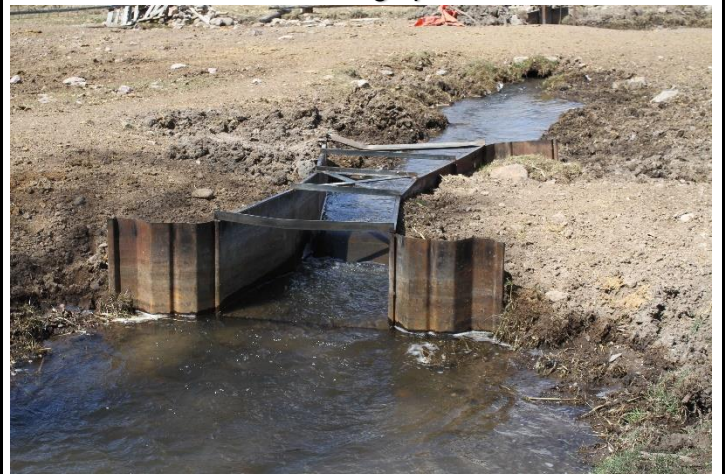
Flume looking upstream
