SAGUACHE CREEK DIVERSION INFRASTRUCTURE INVENTORY

Structure Name: FRIESE D 1

Date: April 12, 2019

Saguache Creek Stream
Management Plan

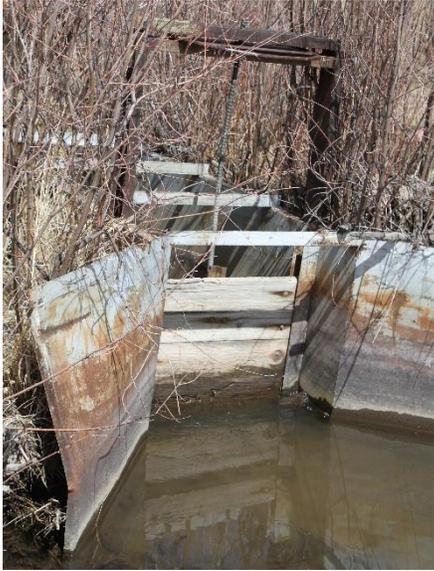
Headgate looking downstream

Structure Description: This diversion is located just downstream of Friese Ditch 2, on the opposite bank and at the apex of a meander. A boulder diversion dam directs water to the headgate, located on the north bank of the stream. The headgate functions but leaks significantly. Downstream of the diversion dam, a scour pool has formed and the north bank of the stream is eroding. The diversion also creates a partial barrier to fish passage.

Repair(s) or Improvement(s) Currently Needed: Given these issues, the SMP Technical Advisory Team (TAT) recommends improving the diversion and repairing the headgate's leak. A new diversion would provide fish passage and mitigate downstream erosion. Alternatively, the point of diversion for Munro Ditch 2 could be combined with this structure's diversion. This would reduce overall maintenance and improve sediment transport processes.
