SAGUACHE CREEK DIVERSION INFRASTRUCTURE INVENTORY

Structure Name: FULLERTON D 3

Date: August 8, 2019

Saguache Creek Stream Management Plan

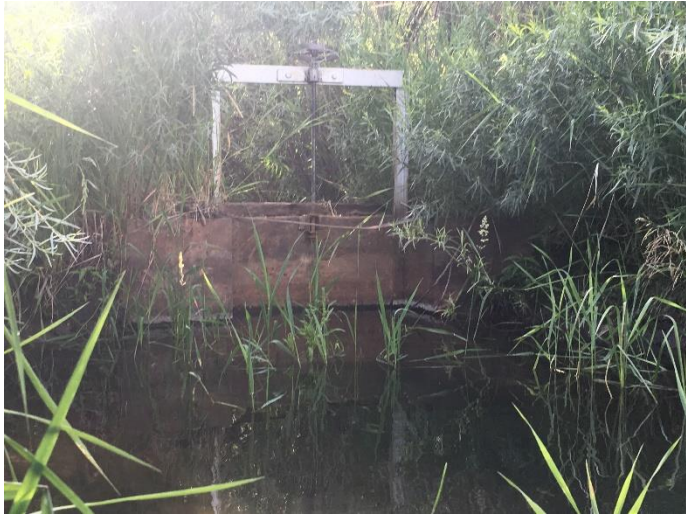
Headgate looking downstream

Structure Description: This structure is located downstream of the Fullerton Ditch 2 on the Werner Arroyo. The diversion dam is a combination of a check board structure and stacked rocks, but the check boards were recently removed due to debris accumulation. The headgate leaks and its frame is twisted. The flume is tilted and in poor condition due to vegetative growth and sediment accumulation.

Repair(s) or Improvement(s) Currently Needed: The SMP Technical Advisory Team (TAT) recommends replacing the diversion and headgate and resetting the flume. Improvements to the diversion and headgate would allow the water user to more effectively divert water despite sediment and debris accumulation. Resetting the flume would ensure long-term measurement accuracy.
