SAGUACHE CREEK DIVERSION INFRASTRUCTURE INVENTORY

Structure Name: GEORGE BALL D

GEORGE BALL DITCH

Saguache Creek Stream
Management Plan

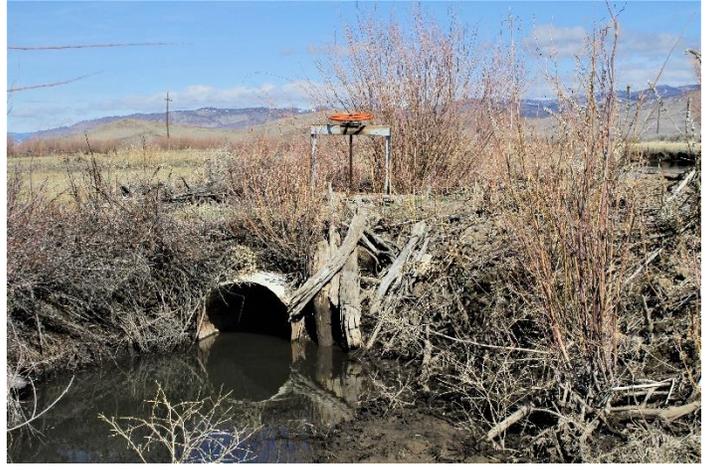
Headgate outlet

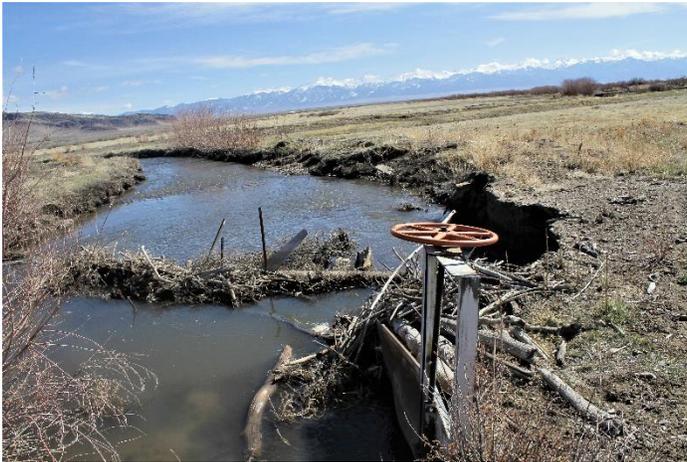
Headgate and diversion dam

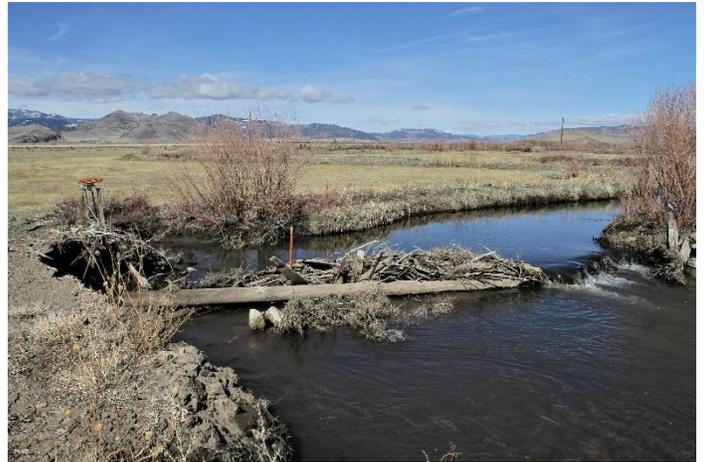
Diversion dam

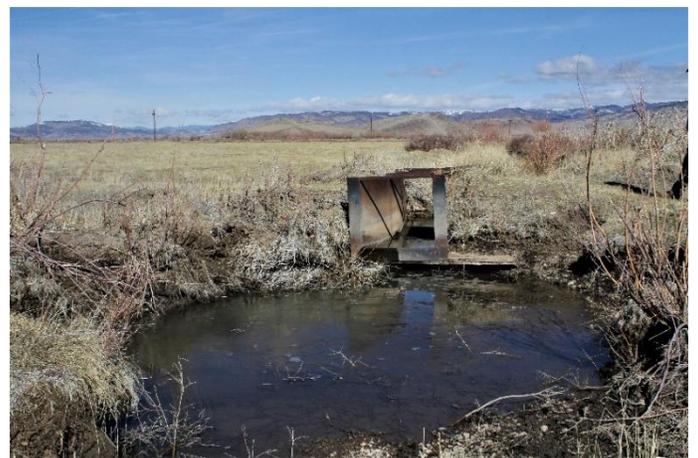
Flume looking upstream
