SAGUACHE CREEK DIVERSION INFRASTRUCTURE INVENTORY

Structure Name: GOTTHELF SAMORA D

GOTTHELF SAMORA DITCH

Saguache Creek Stream
Management Plan

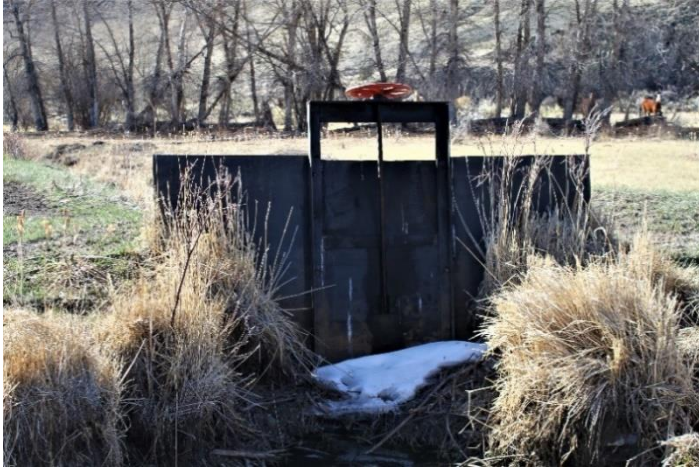
Headgate looking downstream

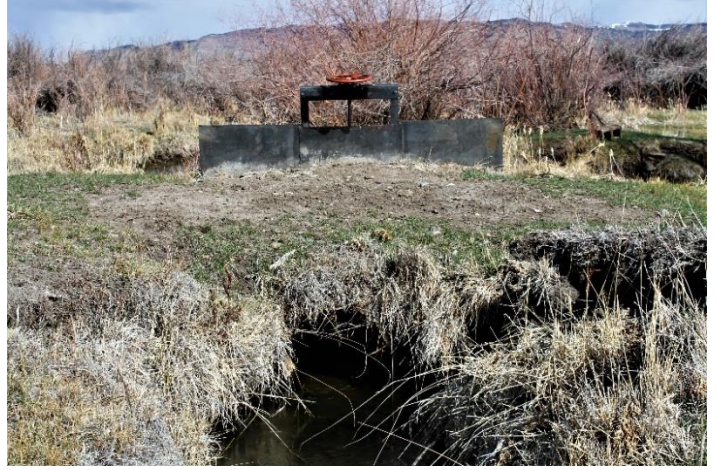
Headgate outlet
