SAGUACHE CREEK DIVERSION INFRASTRUCTURE INVENTORY

Structure Name: HEARN D

HEARN DITCH

Saguache Creek Stream Management Plan

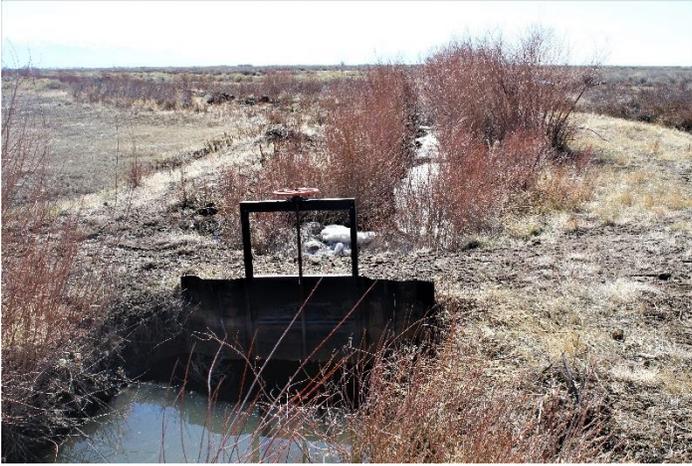
Headgate Type: Manually operated 3' wide rectangular screw gate

Headgate Condition:	A <input checked="" type="checkbox"/>	Diversion and Other Condition:	A <input type="checkbox"/>	Stream Miles from Saguache Creek Terminus (Point of Diversion):	Structure Submerged: Yes <input type="checkbox"/>
	B <input type="checkbox"/>		B <input type="checkbox"/>	25.9 mi	No <input checked="" type="checkbox"/>
	C <input type="checkbox"/>		C <input checked="" type="checkbox"/>		
	D <input type="checkbox"/>		D <input type="checkbox"/>		
	F <input type="checkbox"/>		F <input type="checkbox"/>

Headgate looking downstream

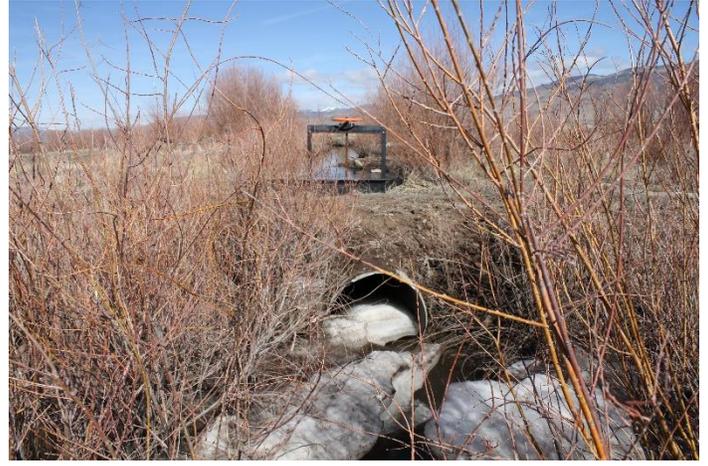
Headgate outlet

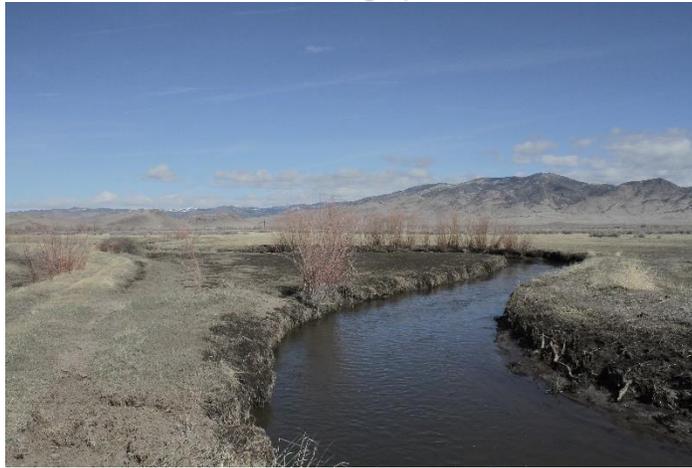
Channel looking upstream

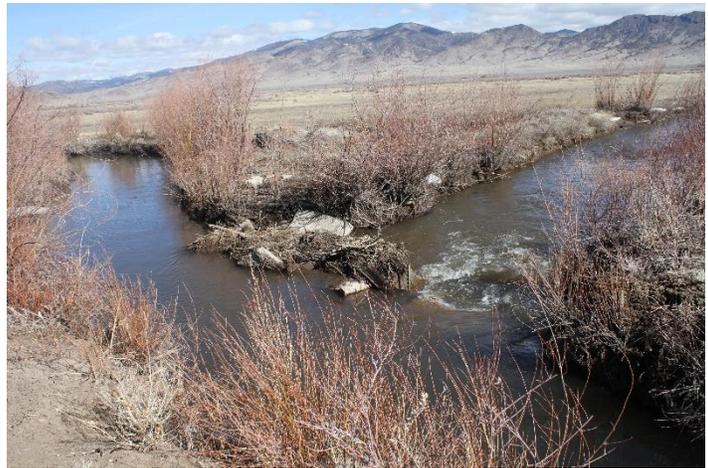
Structure Description: This diversion is located at the apex of a meander in the stream. A diversion dam made of t-posts, boulders, and concrete directs flow to a 30 ft feeder channel on the south bank of the stream and to the headgate, which functions well. The diversion appears to limit sediment transport capacity at this location and forms a barrier to fish passage during low flows.

Diversion dam

Repair(s) or Improvement(s) Currently Needed: The SMP Technical Advisory Team (TAT) recommends replacing the diversion with an improved structure. A new diversion would improve fish passage and sediment transport capacity. As noted above, this structure could be combined with the Wall and/or George Ball diversions. Consolidation would reduce maintenance and reduce sediment transport impacts.

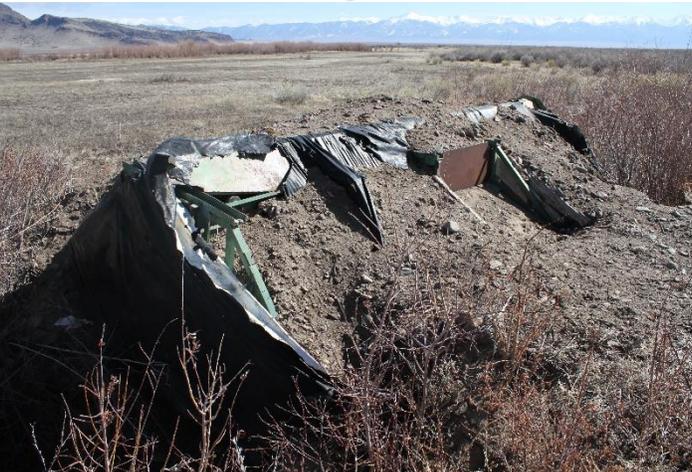
Flume looking downstream

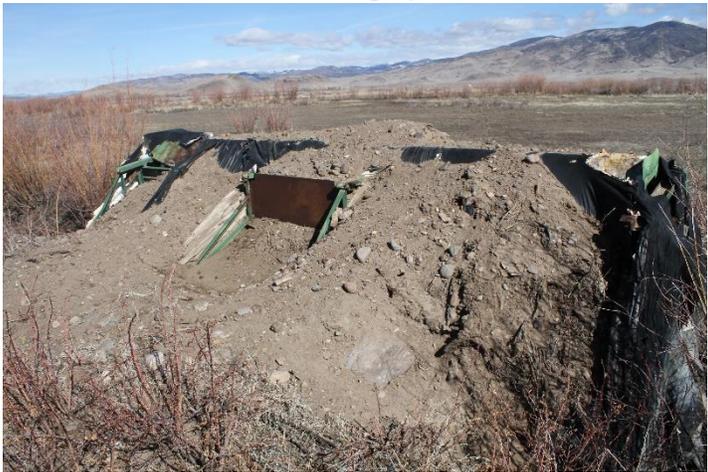
Flume looking upstream
