SAGUACHE CREEK DIVERSION INFRASTRUCTURE INVENTORY

Structure Name: HOUGLAND D

Date: April 12, 2019

Saguache Creek Stream Management Plan

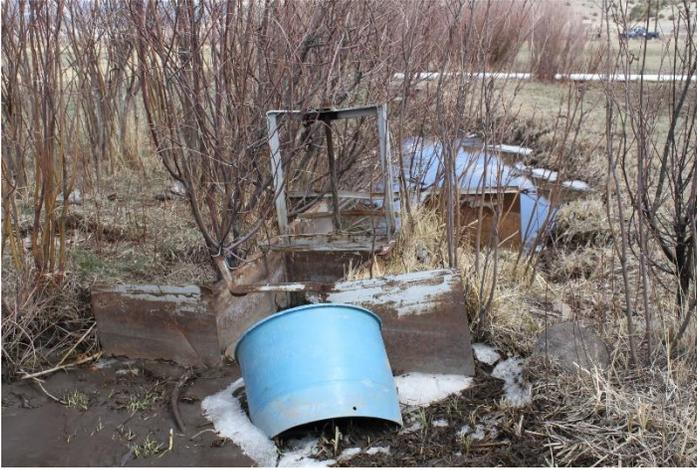
Structure Description: This structure is located on the outside of a meander between Hodding Creek and Mill Creek. A boulder diversion dam directs water to the headgate, which is located on the south bank of the stream. The headgate is tilted and does not function well. The diversion dam is narrow and tall, leading to scour downstream and creating a barrier to fish passage. The meander on which the diversion is located is tightening and may be cut off during a high flow event.

Headgate looking downstream

Repair(s) or Improvement(s) Currently Needed: The SMP Technical Advisory Team (TAT) recommends resetting the headgate so that it is level and fixing the headgate's leak. Bank stabilization and riparian revegetation is recommended to mitigate erosion around the headgate and prevent the adjacent meander from being cut off.

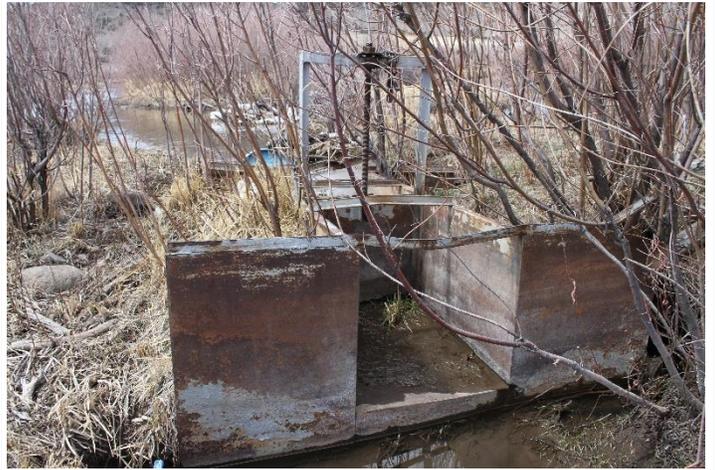
Headgate outlet

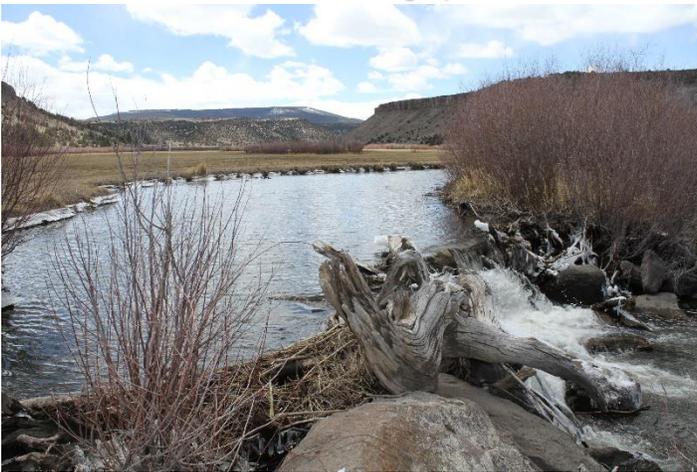
Diversion dam looking upstream

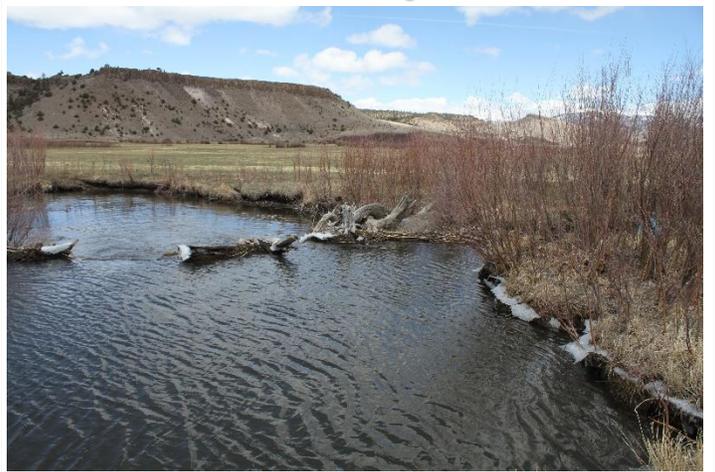
Diversion dam looking downstream

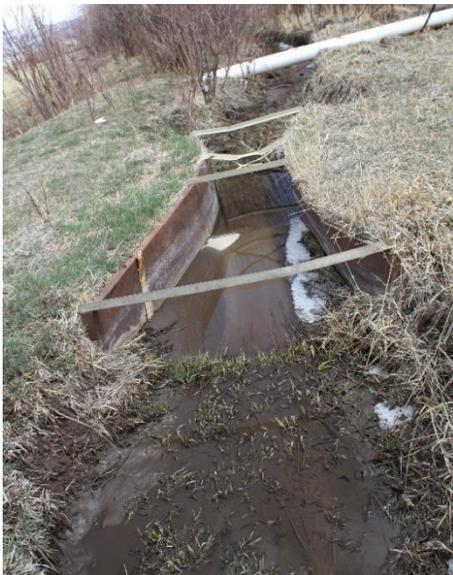
Flume looking downstream

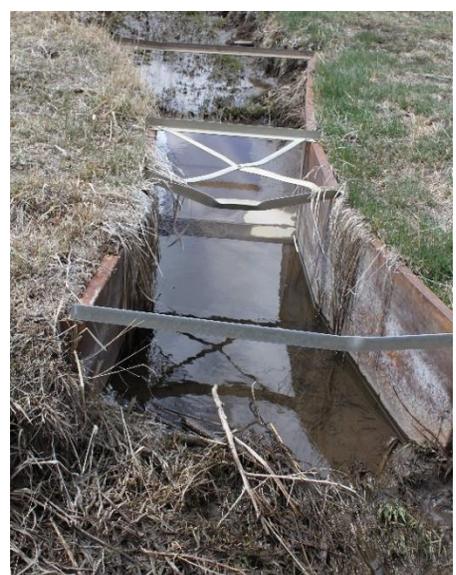
Flume looking upstream
