SAGUACHE CREEK DIVERSION INFRASTRUCTURE INVENTORY

Structure Name: I L GOTTHELF D

IL GOTTHELF DITCH

Saguache Creek Stream Management Plan

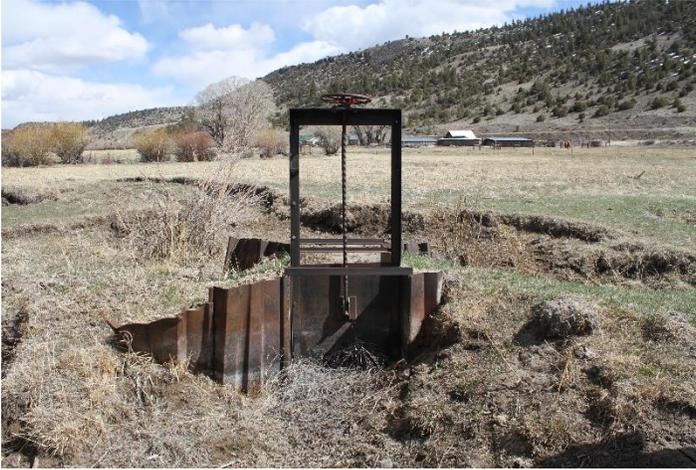
Structure Description: This structure is located at the upstream end of a meander. A boulder diversion dam directs water to the headgate, which is located on the south bank of the stream. The headgate is tilted and its headwall is bulging. The stream is unstable in this location, with the possibility of channel avulsion. The bank just upstream of the diversion is eroding, which may cause issues for this structure in the future.

Headgate looking downstream

Repair(s) or Improvement(s) Currently Needed: Given these issues, the SMP Technical Advisory Team (TAT) recommends replacing the diversion dam and repairing the headgate. A new diversion dam would reduce maintenance and improve sediment transport at this location. Headgate improvements would improve ditch efficiency.

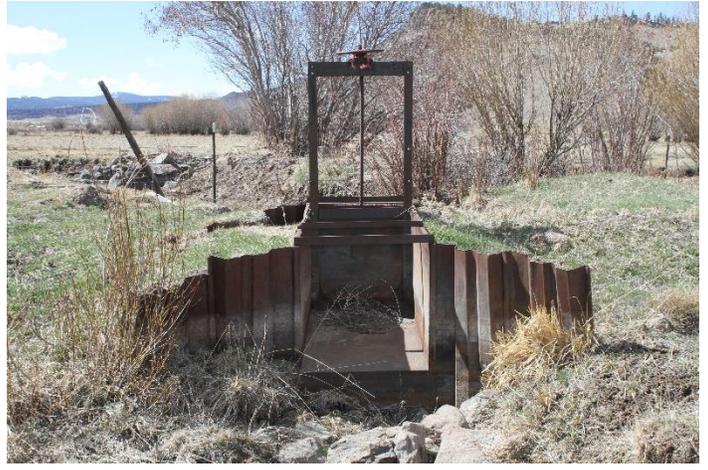
Headgate outlet

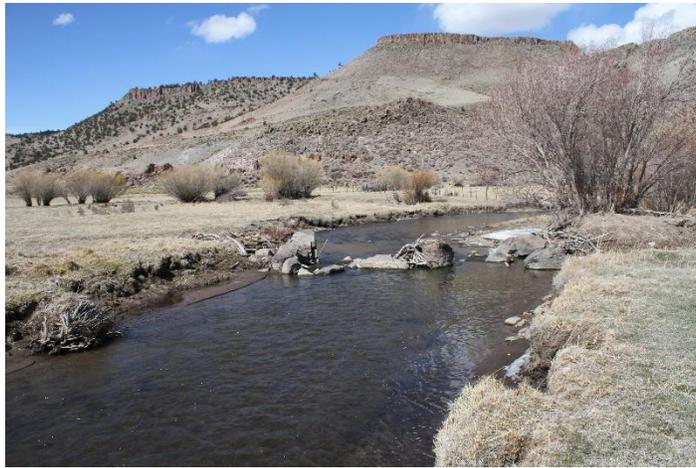
Headgate and diversion dam

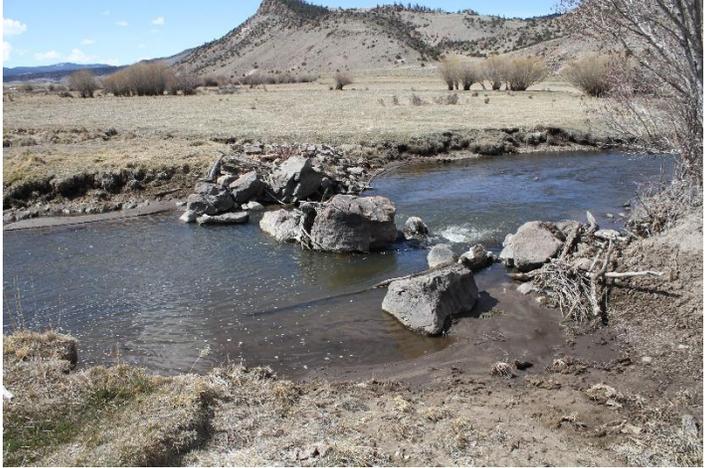
Diversion dam

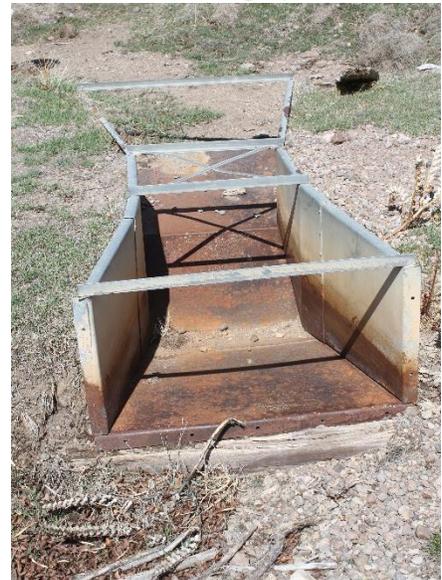
Flume looking upstream
