SAGUACHE CREEK DIVERSION INFRASTRUCTURE INVENTORY

Structure Name: IRWIN D

IRWIN DITCH

Saguache Creek Stream Management Plan

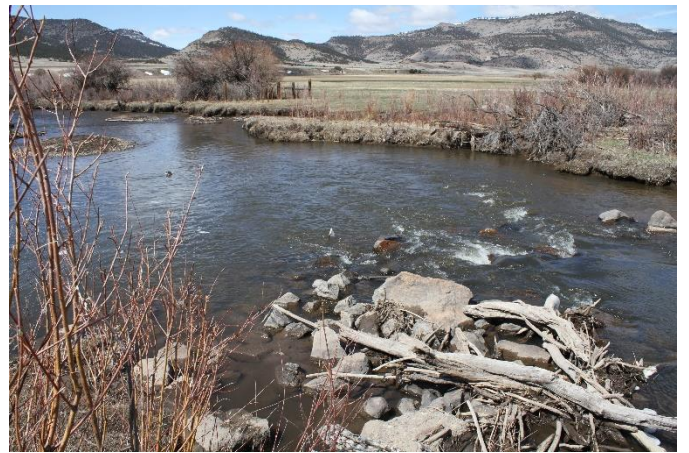
Diversion dam
