SAGUACHE CREEK DIVERSION INFRASTRUCTURE INVENTORY

Structure Name: JEEP SCANDRETT D

Date: July 3, 2019

Saguache Creek Stream
Management Plan

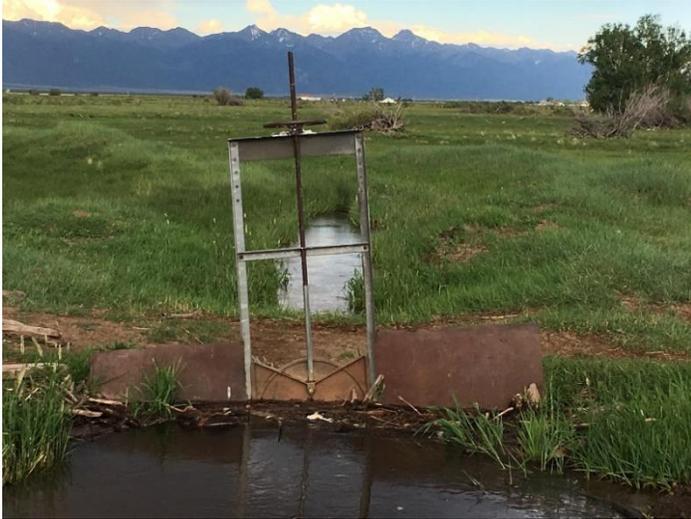
Headgate looking downstream

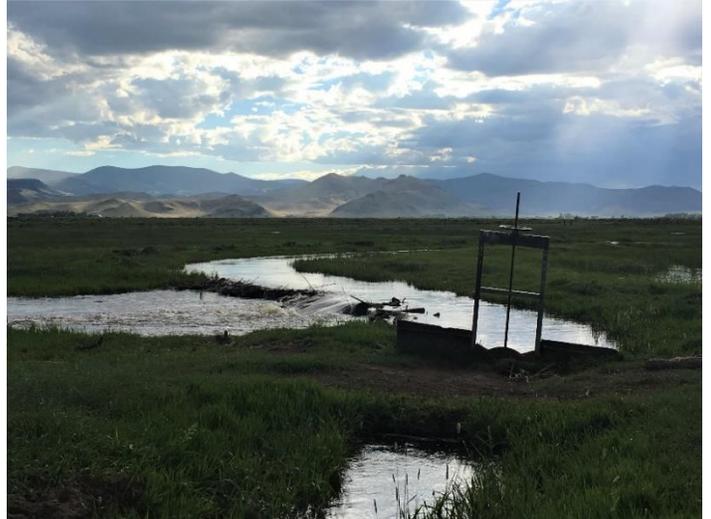
Headgate outlet

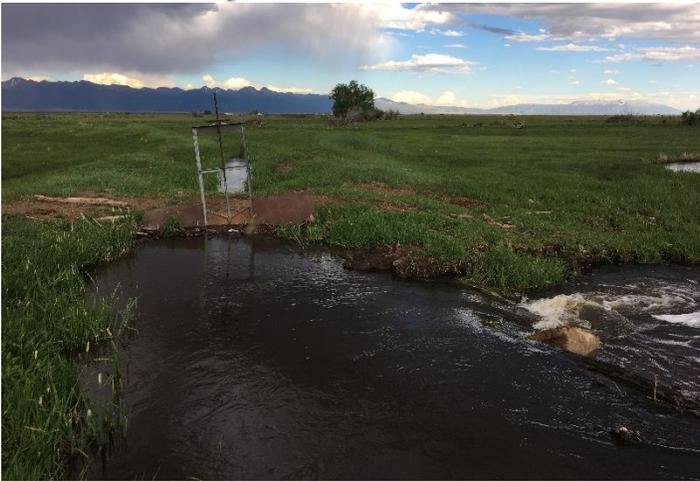
Structure Description: A diversion dam of boulders and woody debris directs water to the headgate, located on the north bank of the stream. The diversion is located on the outside of a tight meander. The diversion dam functions poorly during low flow, collects debris, and does not have adequate sediment transport capacity.

Headgate and diversion dam

Repair(s) or Improvement(s) Currently Needed: The SMP Technical Advisory Team (TAT) recommends improving the diversion to more effectively divert water and to improve sediment transport. Alternatively, combining the diversion dam with that of the Slane Scandrett may improve this ditch's function and reduce maintenance.

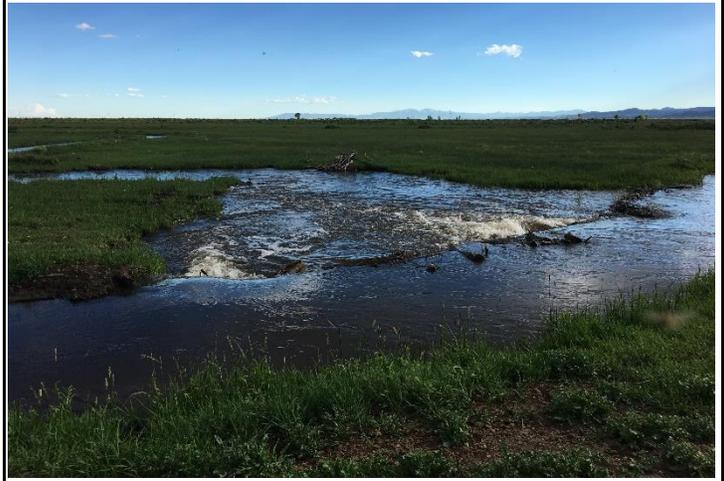
Diversion dam

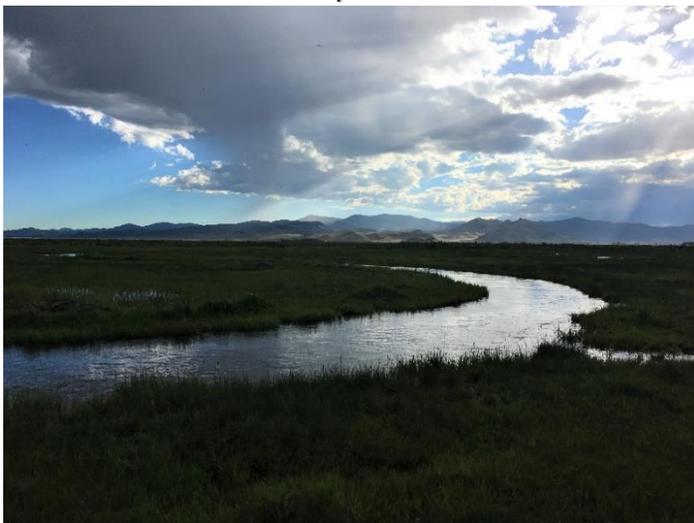
Stream channel upstream of diversion

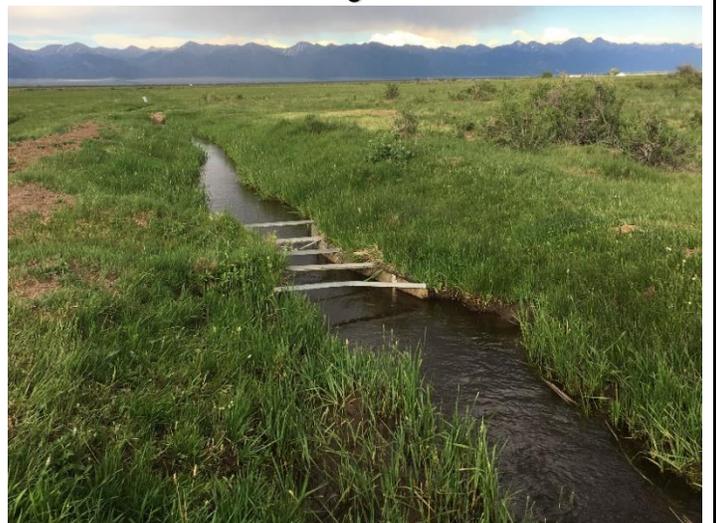
Flume looking downstream
