SAGUACHE CREEK DIVERSION INFRASTRUCTURE INVENTORY

Structure Name: LAUGHLIN D

Date: August 8, 2019

Saguache Creek Stream
Management Plan

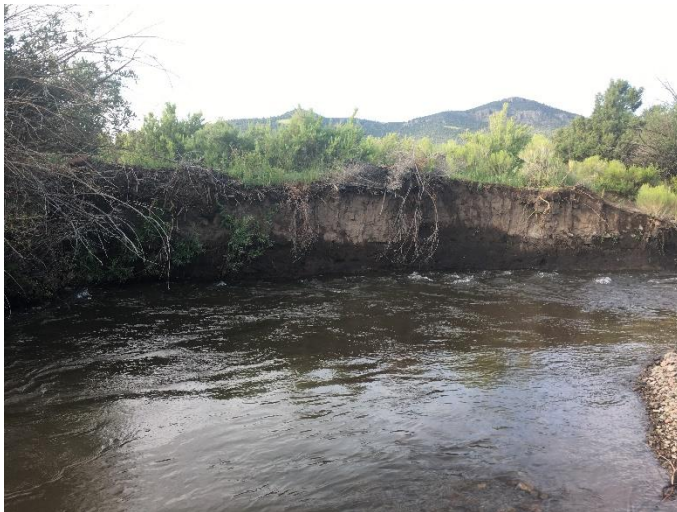
Structure Description: This diversion does not have a headgate on the Saguache Creek mainstem. Instead, water is delivered to the ditch via other diversion structures. The ditch crosses Saguache Creek via a 10 ft PVC pipe and delivers irrigation water south of Saguache Creek. Just upstream of this structure, the south bank of the stream is experiencing accelerated erosion.

South bank erosion looking upstream

Repair(s) or Improvement(s) Currently Needed: The SMP Technical Advisory Team (TAT) recommends bank stabilization to prevent further erosion and/or potential damage to this structure.

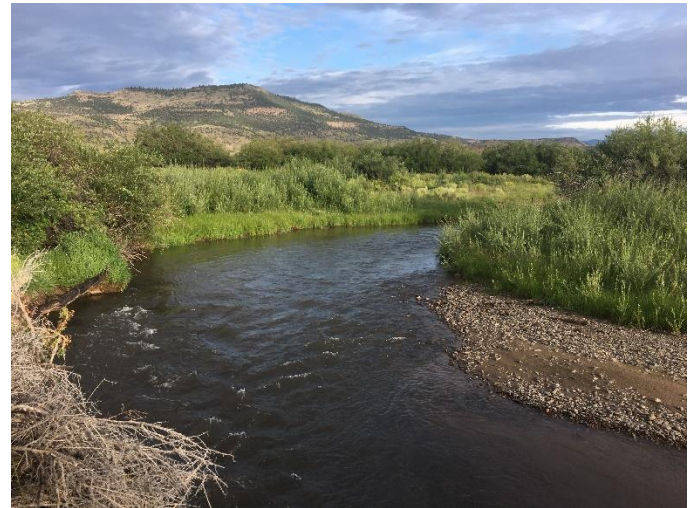
Stream channel looking upstream

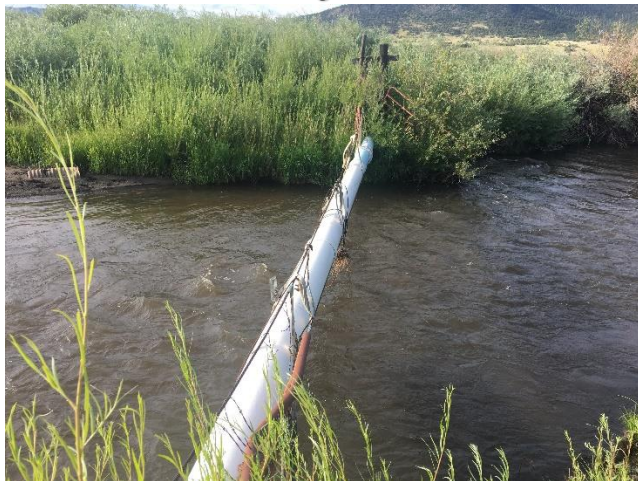
Flume looking downstream

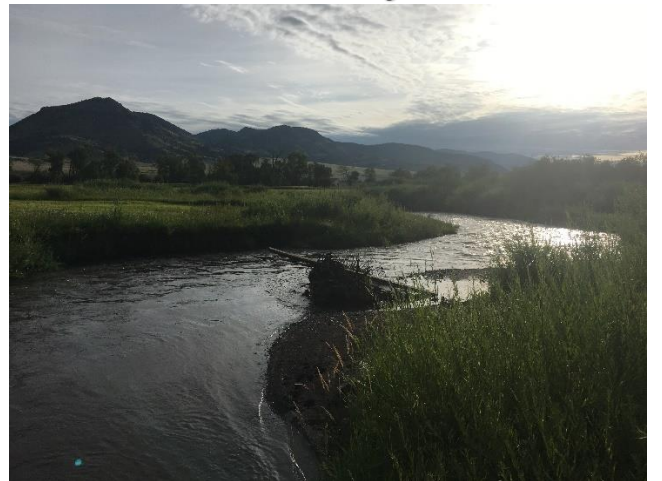
Stream channel looking downstream
