SAGUACHE CREEK DIVERSION INFRASTRUCTURE INVENTORY

Structure Name: MCCREE D

Date: April 4, 2019

Saguache Creek Stream Management Plan

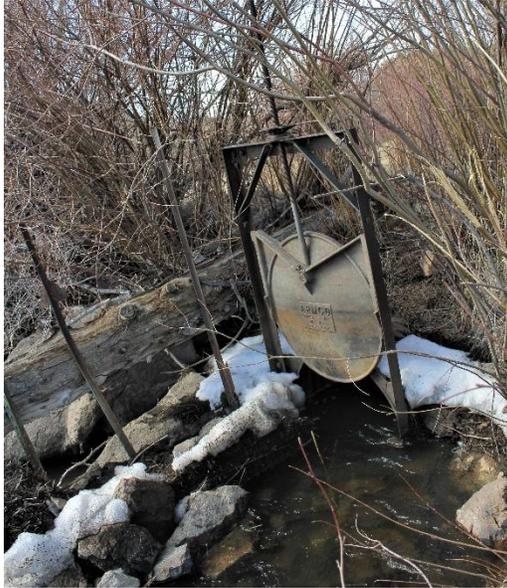
Headgate looking downstream

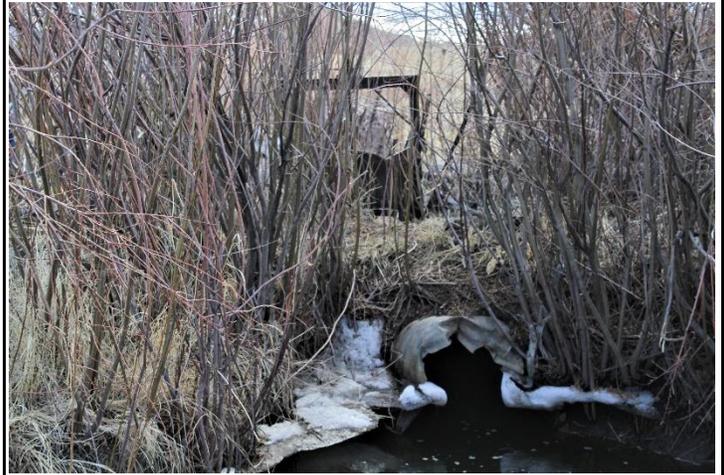
Headgate outlet

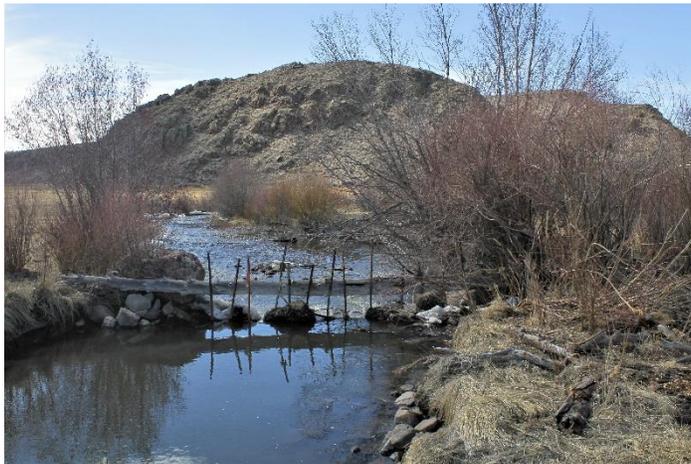
Headgate and diversion dam

Repair(s) or Improvement(s) Currently Needed: Given the issues affecting this structure, the SMP Technical Advisory Team (TAT) recommends upstream bank stabilization and diversion dam enhancement. Bank stabilization would help protect the headgate. An improved diversion such as an improved rock weir would reduce maintenance while still effectively diverting water at a range of flows. Alternatively, the point of diversion for the Commodore Ditch could be combined with this structure's diversion. Consolidation would reduce maintenance as well as impacts to stream function.

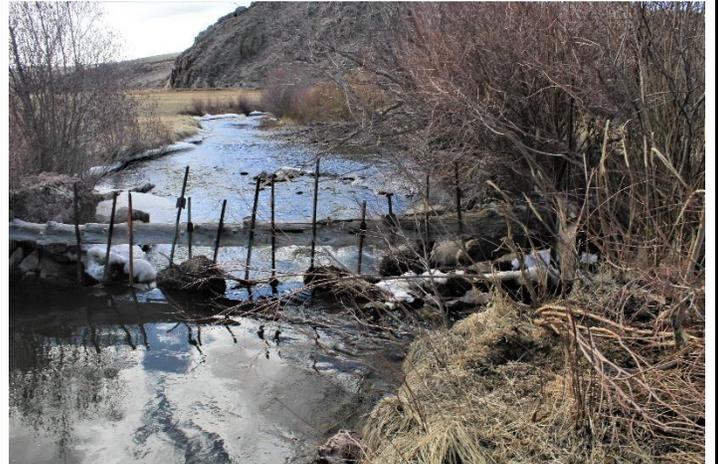
Structure Description: This structure is located just upstream of County Rd 31 CC. The diversion dam is made up of boulders, t-posts, and a large tree. The t-posts are braced against the tree and allow check boards or other materials to be installed for adjustments in head pressure. The diversion dam is located on the downstream end of a meander and directs water to the headgate, which is located on the east bank of the stream. Bank erosion is an issue at this location, particularly upstream of the diversion. Bank stabilization structures have been installed downstream of this structure.

Diversion dam

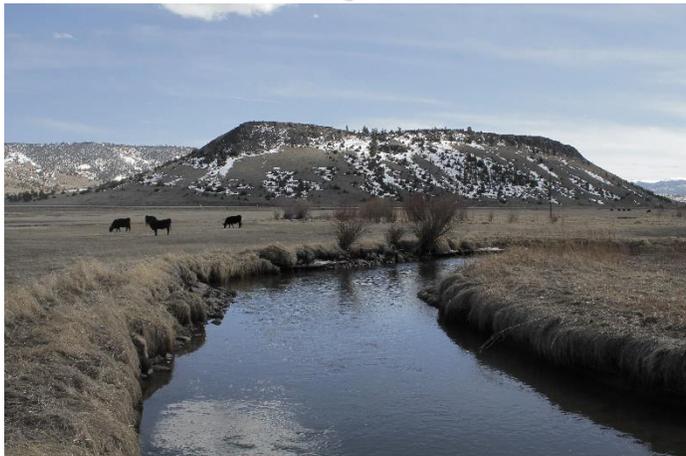
Flume looking downstream

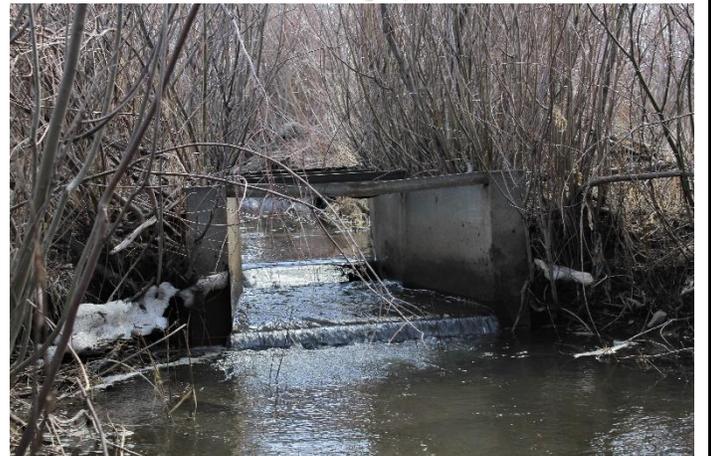
Flume looking upstream
